The Main Reasons for Great Damages of Reinforced Concrete Buildings on 12th November 2017, Sarpol-e Zahab Earthquake

ABSTRACT

Sarpol-e Zahab Earthquake; Reinforced concrete buildings; Seismic performance; Vulnerability assessment

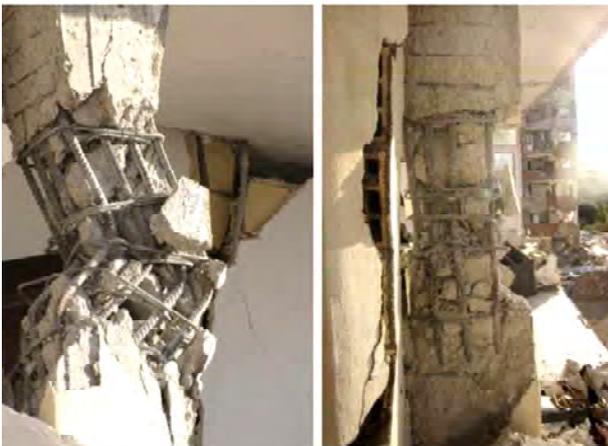
Figure 5. Sample of structural Damage in Sarpol-e Zahab, and Shahid Shiroudi Mehr buildings.

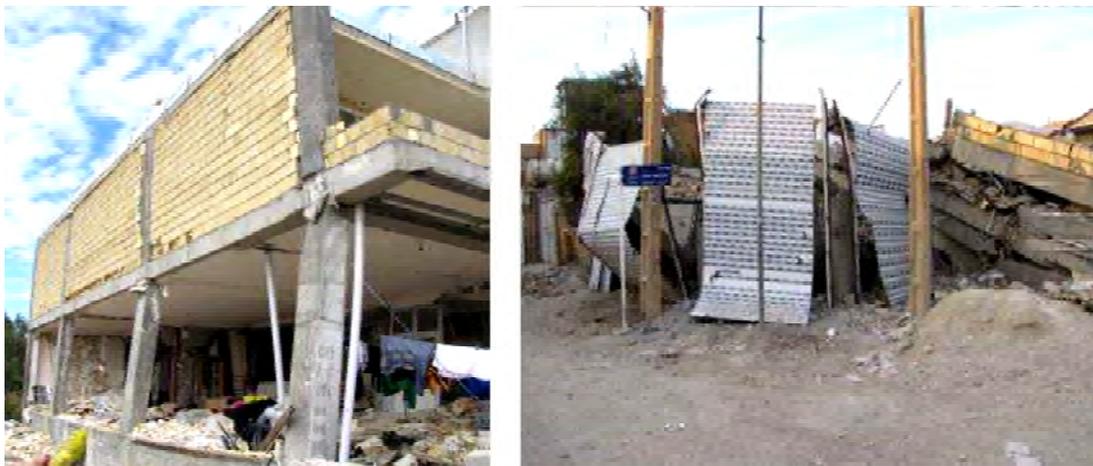
Figure 6. Soft story collapse mechanism in 12th November 2017, Sarpol-e Zahab earthquake.

It should be noted that at the first moment after an earthquake, the buildings did not show apparent severe damage, though, all the buildings damaged by soft first story effects were pulled down. This clearly demonstrates the fact that the aftershock evaluation of infrastructures can play a key role in controlling these probable gaps. Maybe, the important infrastructures should occupy immediately after mainshocks and the advanced vulnerability assessment of structures subjected to aftershocks can reveal this type of imperfections [12, 19].

configuration designed based on seismic codes might be changed. As a result, large deformations of weakened floors might cause substantial P- Δ effects which can lead to plastic hinge formations in columns. It should be noted that if the soft story influences might not take into account in structural design, irreversible damage might trigger both the structural and nonstructural components including the local collapse, or even the total collapse of the building [8, 19-20].

Seismic design codes recommend the phrase of "weak beam-strong column" as a practical way to reduce the probability of the collapse of structures by soft-story influences. The idea is that the beams and horizontal elements of the structure should break, creating plastic hinges, always before the columns. In addition, it is preferable that the beams in the upper levels always break before the beams of the lower levels. Therefore, creating plastic hinges in beams can enable the structure to dissipate the seismic energy without total collapse of the structure [21]. In the past generations of Iranian National Building Code, Design and Implantation of RC buildings, Part 9, particularly in the last edition published in 2013, in part 4-2-4-23-9, the flexural strength of columns should be 20% more than that of the adjoining beams as indicated in ACI 318-05 Sect. 21.4.2.2. This part has been proposed for the buildings designed for high ductility (special moment frame). However, there are not any limitations for ordinary and intermediate performance levels suggested in seismic design codes. A huge number of structures is residential, which can be categorized in intermediate or ordinary performance levels. It seems that Iranian National Building Codes can be equipped with provisions to mitigate the casualties caused by this failure mode in the future earthquakes [15-22].

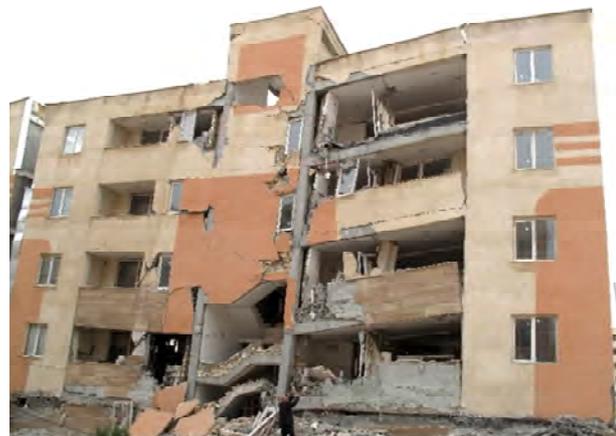
advance warning. One of the most fundamental columns to satisfy shear capacity of structural elements in concrete structures is the compressive strength of concrete used to create structural sections. It should be noted that the shortage in the special compressive strength of the concrete can aggravate the probability of shear failures seen in Ezgeleh earthquake. Due to this paramount significance, the Iranian National Building Code, presents the minimum value of the compressive strength of the concrete equal to 20 (MPa) for RC structures with the intermediate ductility. Other factors which can play a key role to make this failure mode are the height of the weak-story, existence of mezzanine floor, rigidity and distribution of columns in weak-story, overhang and cantilever projection existence in weak-story, infill wall material properties, soil class and properties, floor number, seismic conditions [15, 23-27]. In Figures (8) and (9) the collapses caused by this failure method have been depicted.

Figure 8. Earthquake damages caused by weak-story in Eslamabad Mehr buildings.

In general, to mitigate the effect of this type of irregularity caused by wall affects, separating the infill panels from margin columns by gaps, and adding cross structural elements in the weak story can help the structure to withstand under strong ground motions. Figure (10) shows the rehabilitation methods proposed to improve the resistance factors of the weak-story [27].

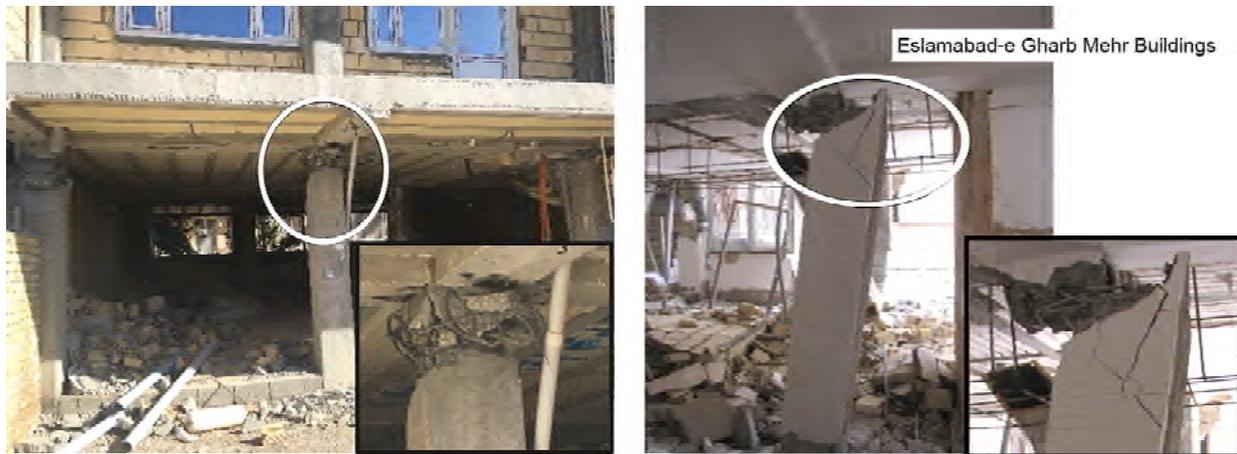
Figure 9. Fracture of a weak story RC column during the earthquake.

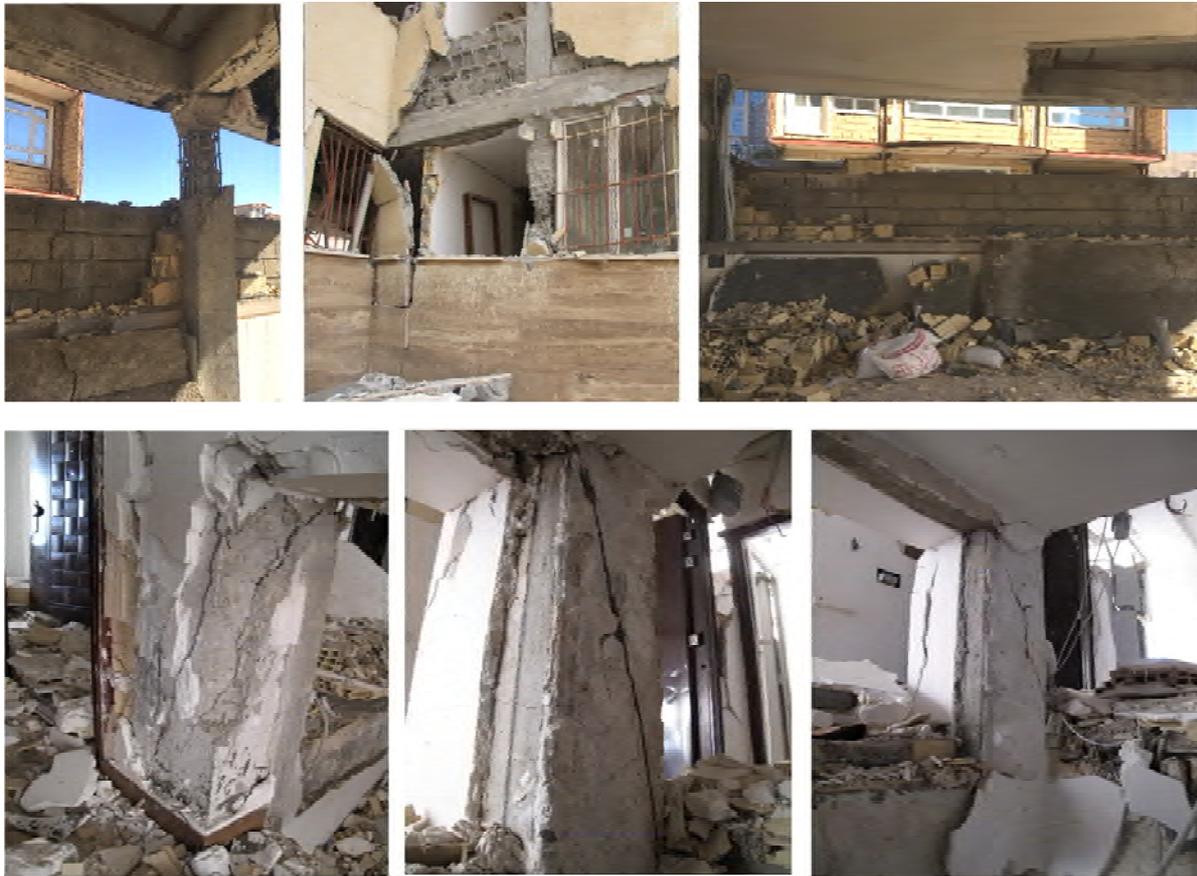
supports at the end of the concrete elements, have made this effect as a common failure mode in all past earthquakes in Iran [30]. For instance, the examples of this type of failure in Sarpol-e Zahab Earthquake are depicted in Figure (11).

Figure 11. Short column effects in Sarpol-e Zahab, Mehr buildings.

To reduce the short column effects in RC structures in the future, separating the infill walls from the boundary structural frames with adequate gaps that would help the column to bend freely, can be an effective way. In this case, it should be noted that to control the out-of-plane failure mode of infill walls, a steel beam with a U-shaped section between the infill wall and the RC frame can be implemented to prevent the infill panel failure in the out-of-plane direction [26-28].

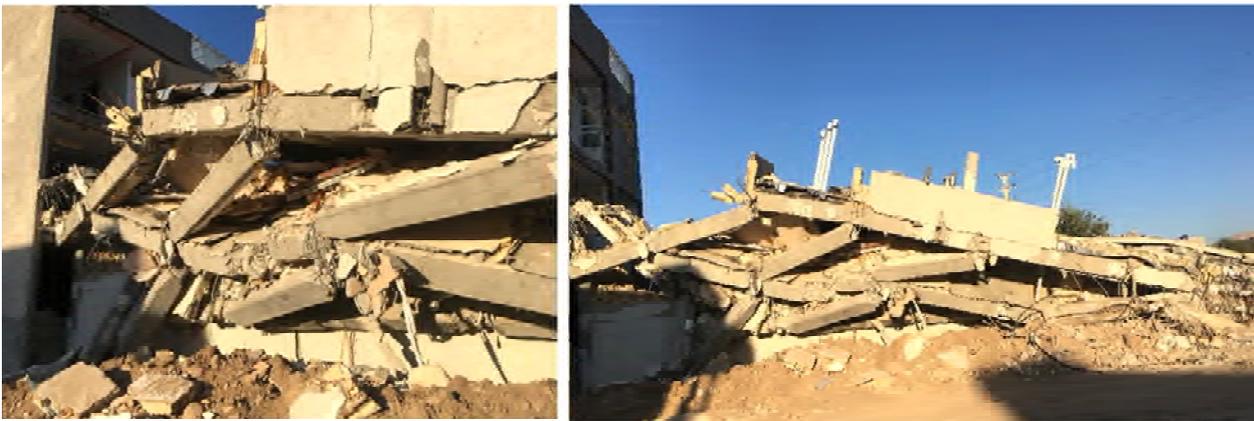
Figure 12. The pancake collapse of structures under Sarpol-e Zahab earthquake.

initial collapse in vertical load-resisting elements, partial and complete separating of the roof system, and the failure of other components by the impacts and the weight of collapses can be the other characteristics of the pancake collapse [31-32].

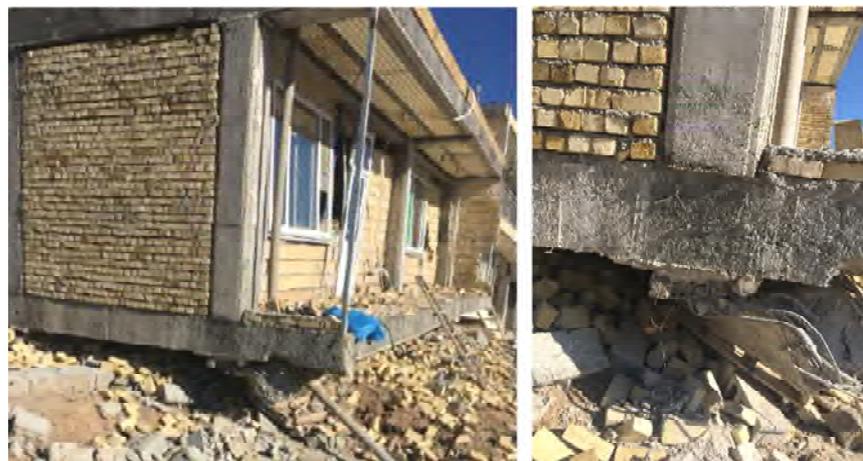
Excitations and forces caused by strong ground motions act at a point called "the center of mass" of structural floors. However, resisting forces perform at the center of lateral resistance named "center of rigidity" of the structures. Therefore, the differences between the center of mass and the center of rigidity can result in torsional problems for the structure. This difference has a direct relationship with the great torsional moments, which can twist the building around the rigid core. These great torsional moments are capable of causing extensive damage and uncontrollable failures in columns and

concrete walls named "Knife Cut" damage pattern. Figure (13) illustrates this type of failure mode in Sarpol-e Zahab earthquake [33-36].

Figure 13. The torsional collapse of the structures subjected to Sarpol-e Zahab earthquake.

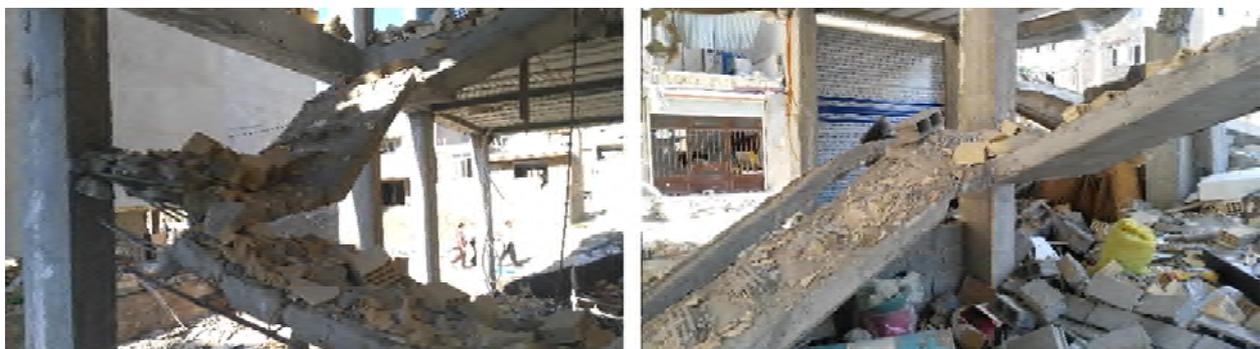
Figure 14. Staircases separated the structures by the brace performance due to poor implementations.

not any signs of damage in beams and columns in the structure, the staircase has been separated completely and the brace performance of that imposed this type of failure to staircases. It should be noted that the stability, proper design, and the accurate implementation of staircases can play a key role to reduce the number of casualties, particularly, in area with untrained people who use staircases to go out of the buildings during the earthquakes. Another reason caused a huge number of damaged staircases is the lack of appropriate joints to the surrounding columns. In Figure (16) the reinforcements have been pulled out because of ignoring the standard bending of bars at the conjunction of the staircase and the column. In addition, in some cases, the collapse of the staircases were due to the poor implementations in considering the adequate overlapped lengths [37].

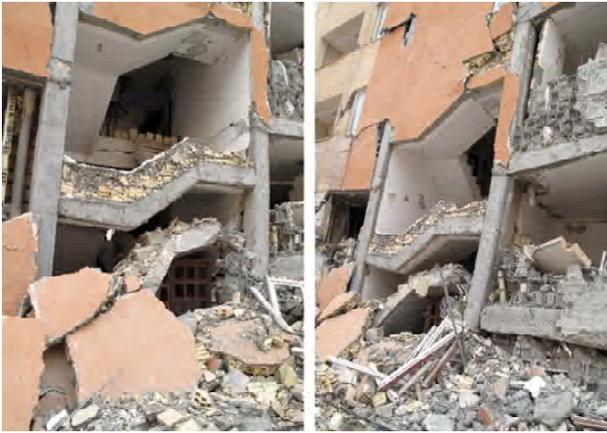
Figure 15. Staircases separated the structures at the level of first floor.

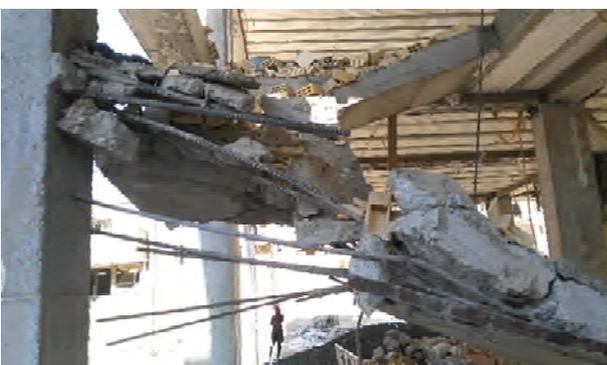
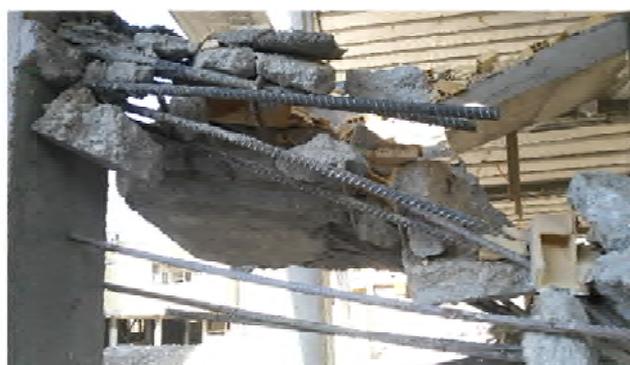
Figure 16. Pulled out bars because of ignoring the standard bending of bars at the conjunction of the staircases and columns.

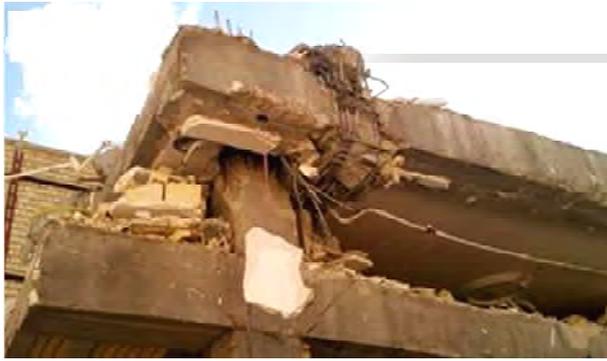
Punching shear is a type of reinforced concrete slab failure subjected to high localized forces. In flat slab structures that occurs at column support points. This type of failure is catastrophic because of the lack of visible signs prior to the failure. Figure (18) illustrates punching collapse of an RC structure in Sarpol-e Zahab earthquake. The damage might be as a result of poor implementations of reinforced shear bars or low quality of the concrete used at the conjunction of the slab and the column [37].

Figure 18. Punching shear in an RC structure during the 12th November 2017 earthquake.

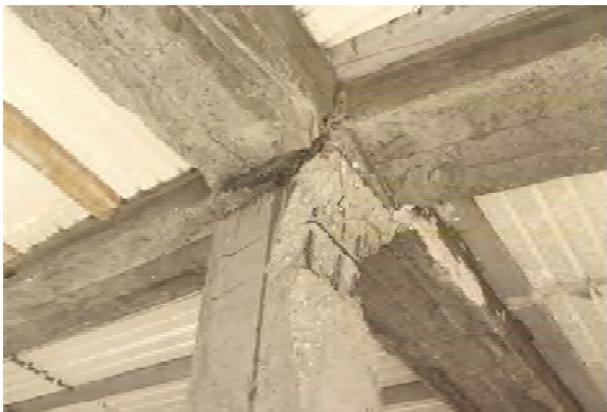
(a) Flexural Damage at the Top of the Column

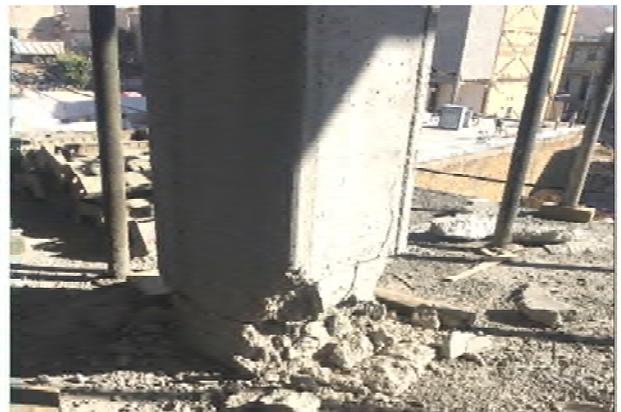
(b) Loss of Concrete Cover That Caused by Flexural Damage

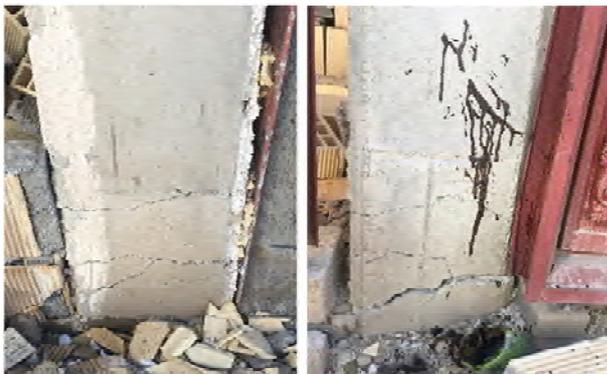
(c) Visible Horizontal Cracks That Caused by Flexural Damage

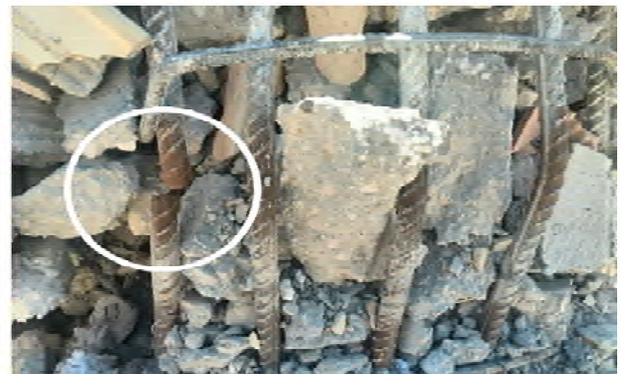
(d) Rapture of bars

flexural failures observed during Sarpol-e Zahab earthquake have been illustrated. For instance, in Figure (19d), imperfections to build the cover of columns unsymmetrically, might reduce the gross section area of the columns and the stress concentration in the layer of cover. Therefore, the core of the elements might play a role to separate some parts of the cover in the first cycle of earthquake and a significant amount of flexural capacity of the columns would be lost by the first cracks [8-40].

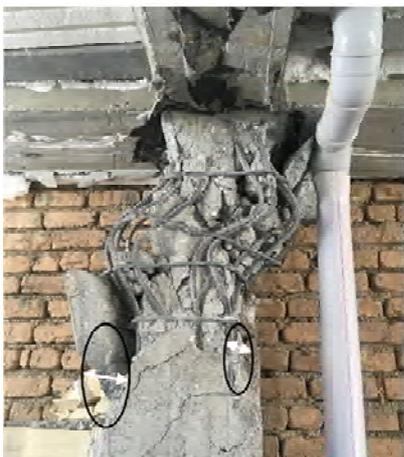
(e) Column Failure with Buckled Longitudinal Bar and the Unequal Cover at the Slides of the Column

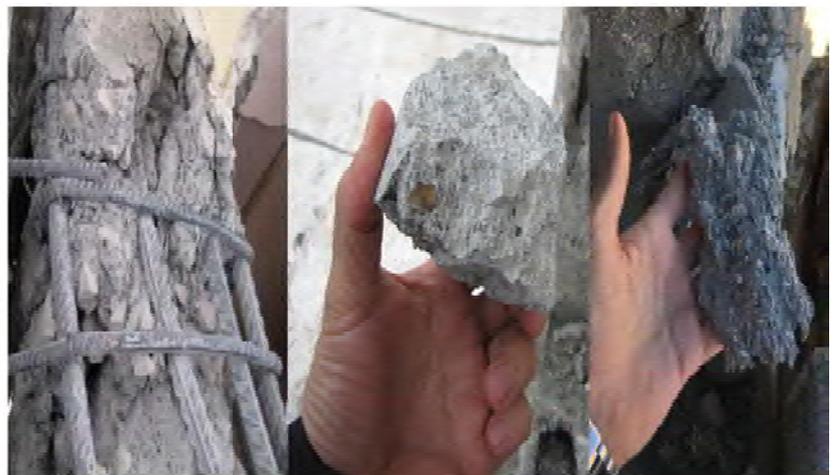
(f) Low Quality Materials

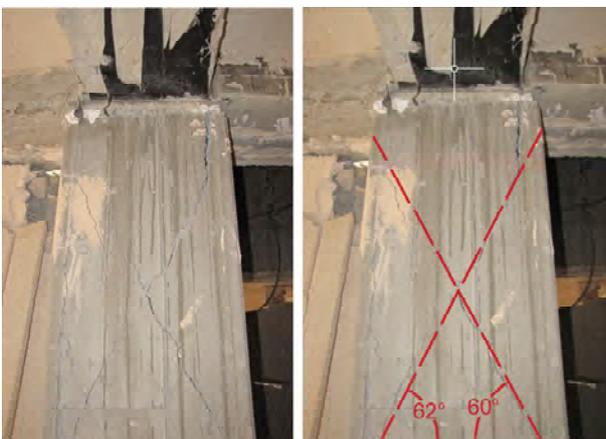
In Figures (20) to (22), this sign of shear failure has been seen by the survey team in Mehr buildings and the Imam Khomeini hospital of Eslamabad-e Gharb, respectively. The reason of this type of damage is the low quality of concrete and the poor implementations in considering the rules for shear reinforcements [37-39].

Figure 20. Diagonal cracks caused by shear forces (Eslamabad-e Gharb Mehr buildings).

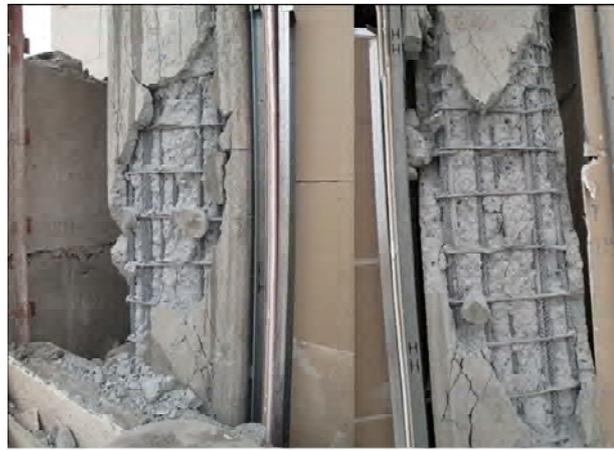
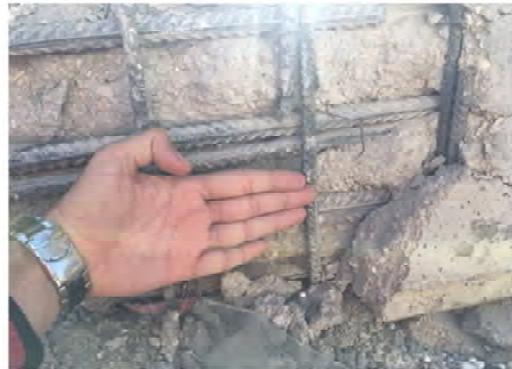
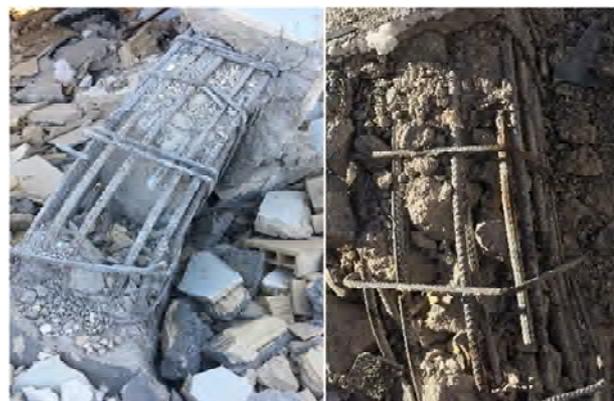
Figure 21. Imperfections in implementation of transverse reinforcements, Eslamabad-e Gharb hospital.

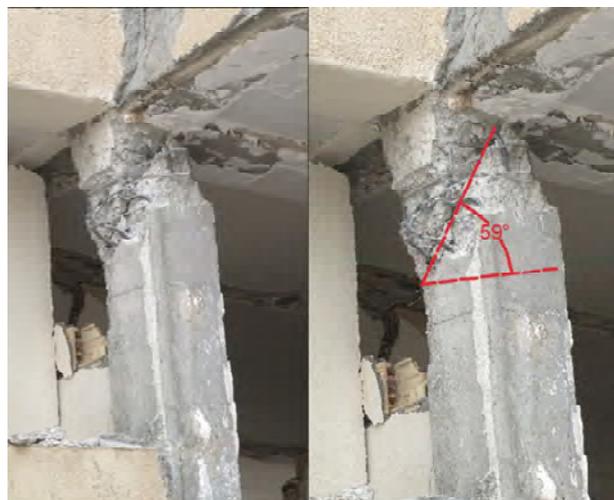
Figure 22. Shear failure, Eslamabad-e Gharb Mehr building.

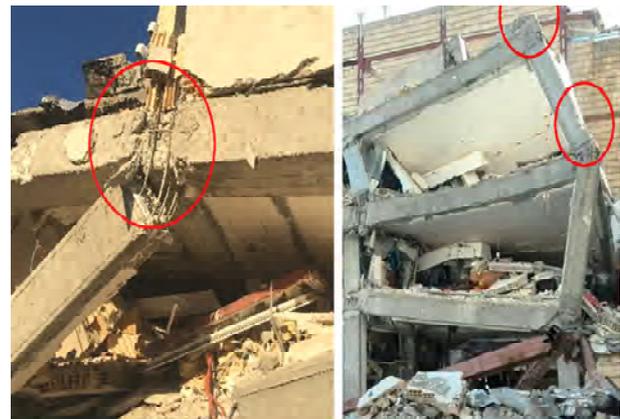
Figure 24. The shear failures due to the lack of ductility in joints.

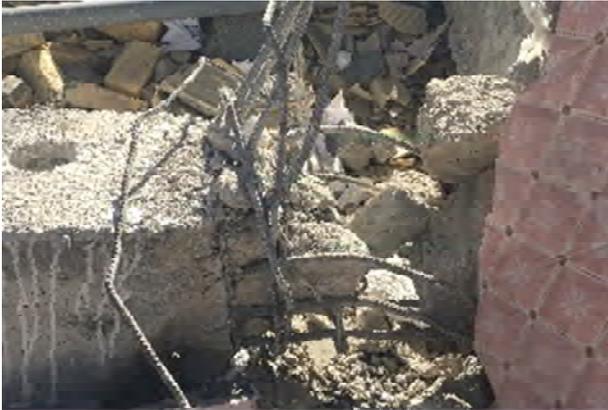
- Sliding the bars in the concrete due to the low quality of concrete in the panel zone to make a coherent environment for reinforcements and concrete. This type of damage in Sarpol-e Zahab

Figure 26. Sliding the bars in concrete due to the low quality of materials.

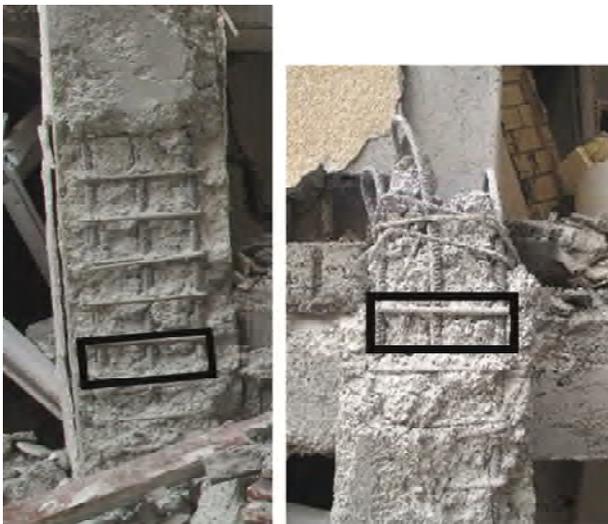
- The fault in considering wider distance of transverse reinforcements near the panel zones can cause shear failure in structural elements as shown in Figure (27).

Figure 27. Imperfections in transverse reinforcements spacing in Eslamabad-e Gharb, Mehr buildings.

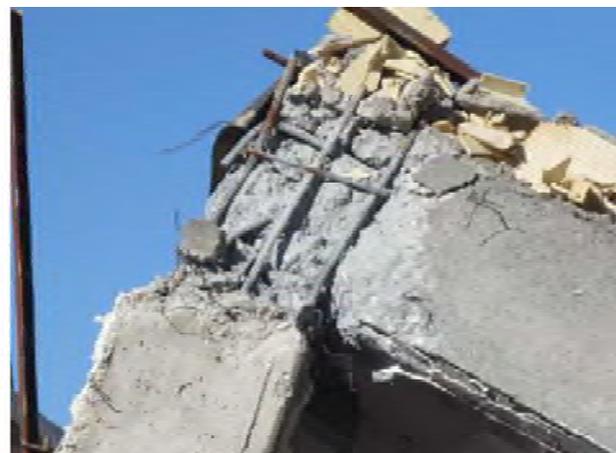
- Imperfection in using 90 degree hooks at the end of the longitude bars. Generally, in concrete components, in order to achieve ductile performance and transmit of the forces between concrete and the bars, it is essential to use hooks at the end of the structural components. The Iranian National Building Codes, Design and Implantation of RC buildings, Part 9, in sections 9-21-2-2 and 9-21-2-3 as Figure (28), present the rules that guarantee the seismic performance of the structural elements [8-17].

Figure 29. Imperfection in using 90 degree hooks at the end of the longitude bars.

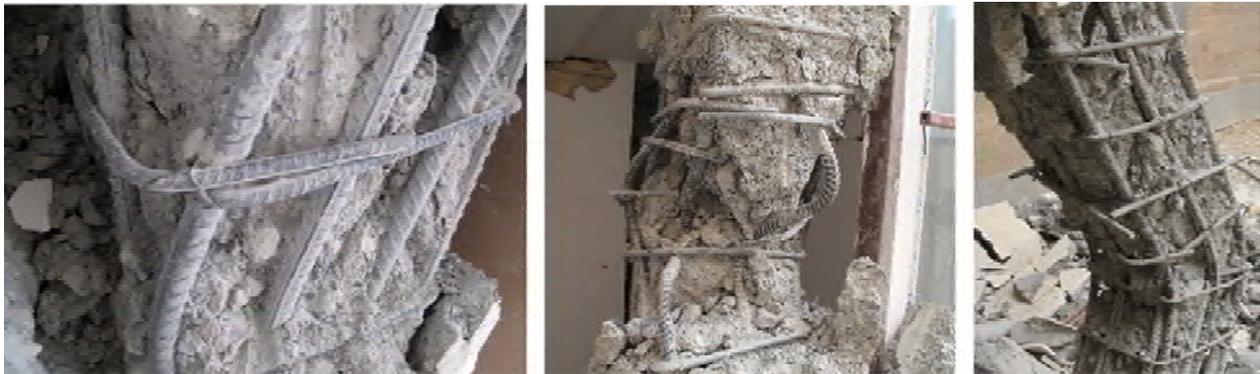
Figure 30. Imperfection in using 135 degree hooks in transverse reinforcements.

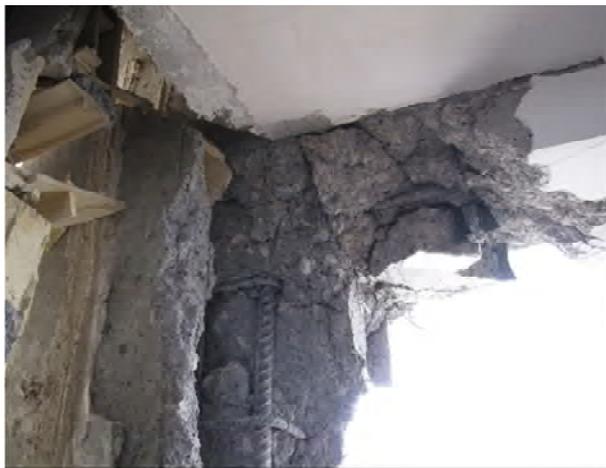
Beams might be destroyed by shear, bonding, or sliding cracks. Figure (31) shows this type of cracks in concrete beams in structures subjected to Sarpol-e Zahab earthquake. Other types of

Figure 31. Failure at the bottom flange of a beam with slab.

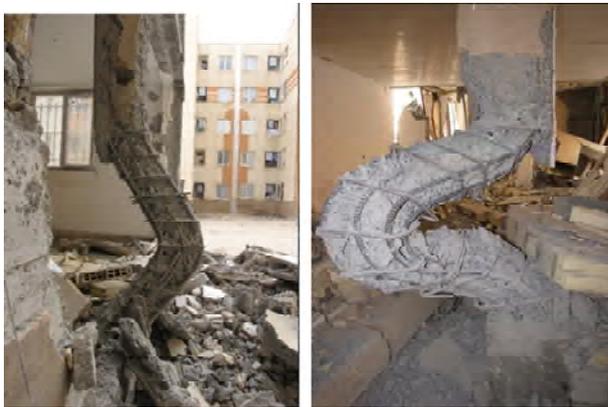
Fundamental parameters participate in buckling of RC columns that can be categorized as: Axially loaded RC columns, the effective length of individual columns, eccentrically loaded RC columns, effective length of columns in frames, ways of considering the effect of inclination due to the construction imperfection, construction rules of columns, determining additional eccentricities by the use of design aids tables, and two independent checks. Figure (33) shows this type of failure in Eslamabad-e Gharb Mehr building.

Figure 33. Buckling of structural columns in Eslamabad-e Gharb, Mehr buildings.

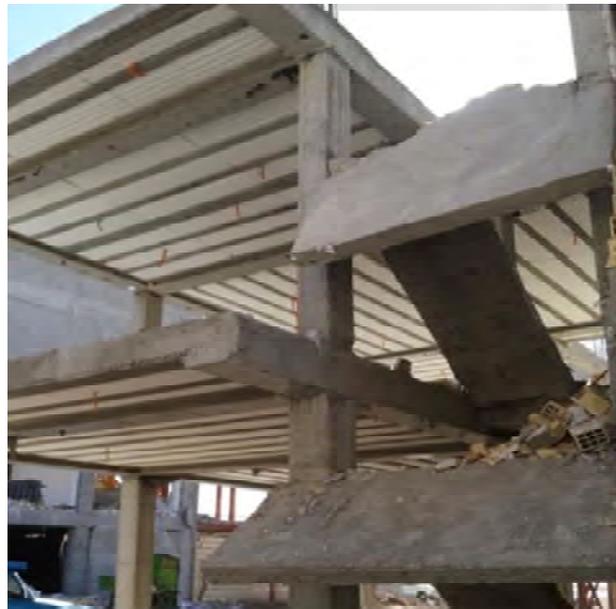
RC systems including ribbed slabs, cantilever staircase slabs, or flat slabs without stiffening by shear walls are susceptible to large lateral deflections and might suffer from heavy structural damages under strong earthquake. Failure of concrete cantilever slabs of staircase because of insufficient amount of slab reinforcement in Sarpol-e Zahab earthquake is illustrated in Figure (34).

Figure 34. Failure of concrete cantilever slabs of staircase.

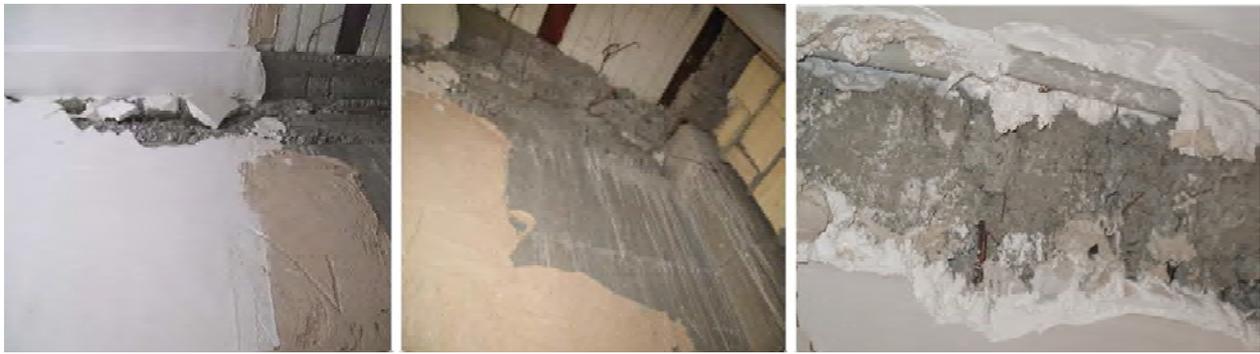
Figure 36. The low quality of concrete used in Eslamabad-e Gharb, Mehr buildings.

Although the plans of a lot of blocks of Eslamabad-e Gharb Mehr buildings are the same, two adjacent RC buildings built by a contractor have been damaged severely because of the low quality of concrete used in these structures. In Figure (36) the inappropriate concrete used to build shear walls in Eslamabad-e Gharb Mehr buildings has been depicted.

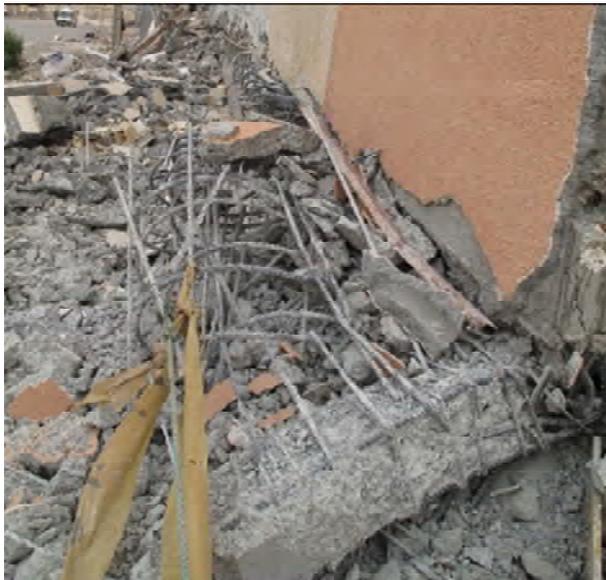
Figure 37. The inadequate anchorage of longitude reinforcements in Eslamabad-e Gharb, Mehr buildings.

Figures (37) to (39) illustrate the web buckling of one outstanding leg of a shear wall in a 5-story building. In the first generation of Iranian National Building Code, Design and Implantation of RC buildings, Part 9, walls were not detailed for ductility; therefore, this fact results in inadequate horizontal and vertical reinforcement, particularly at critical regions in the walls. During the process of evaluations of past earthquakes, older walls actually do not have reinforcements to prevent the brittle confinement or buckling failures. Although this gap

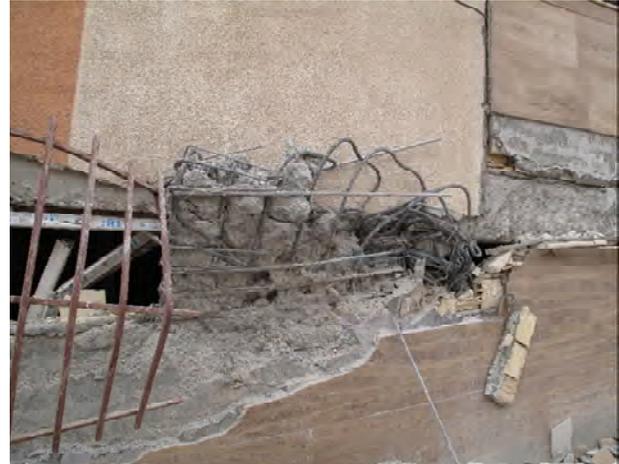
Figure 38. The failure of shear wall because of inadequate anchorage of longitude reinforcements in Eslamabad-e Gharb, Mehr buildings.

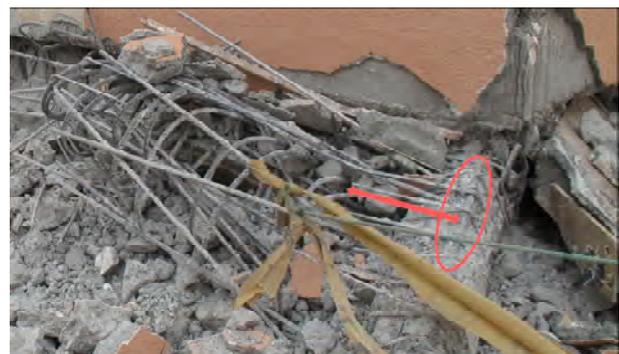
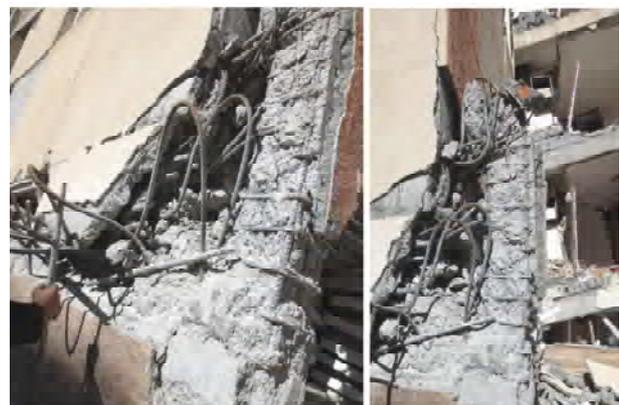
Figure 39. The imperfection in the continuity of boundary elements and the shear wall.

has been improved in new editions of Iranian National Building Codes, Design and Implantation of RC buildings, Part 9, the walls carried out for Eslamabad-e Gharb Mehr buildings due to the imperfections in implementation of the longitude of lap-splices, hooks, and the continuity of the wall and boundary elements have been suffered a huge damage [17].
