# Performance of Masonry Buildings in November 12, 2017, Sarpol-e Zahab - Ezgeleh Earthquake ( $M_w$ 7.3)

Sarpol-e Zahab - Ezgeleh Earthquake; Masonry structures; Failure types; Seismic code

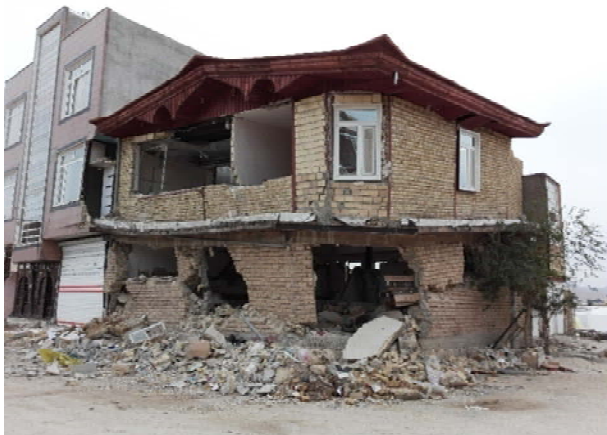
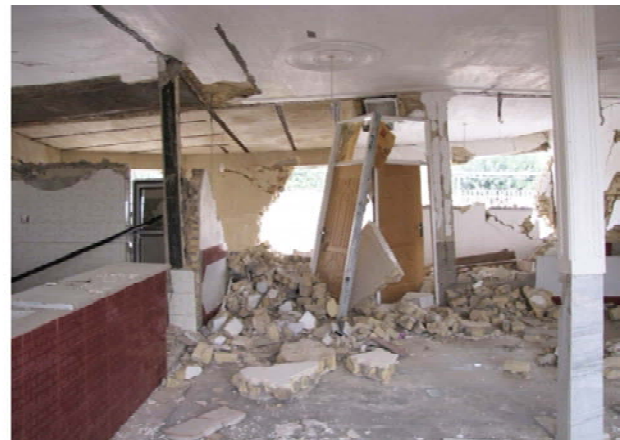
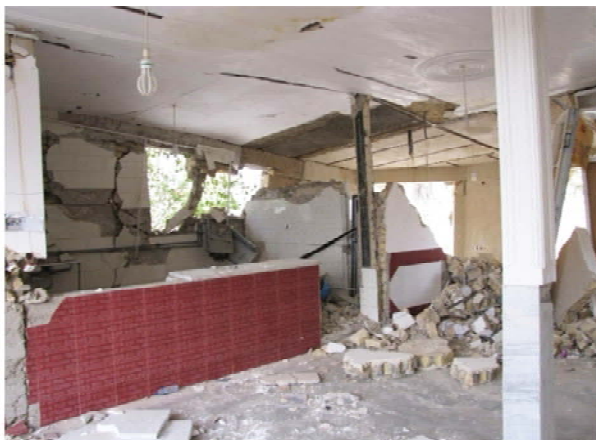
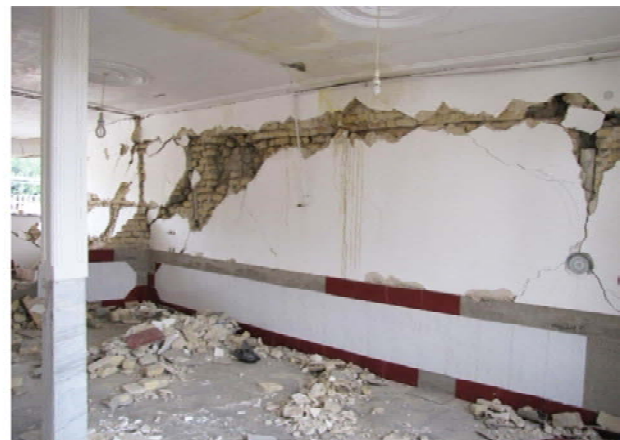
building to be less than the lateral seismic demand. This issues are known as a source of damages in the masonry buildings. Figure (4) shows a two-story, damaged residential building. As is shown, load bearing walls are provided only in the border of building. Considering second story of building and existing of the openings in surrounding walls, the amount of existing and effective bearing walls was less than the amount of seismic demand on these walls and caused large drifts in first story. It should be noted that poor quality of mortar, inappropriate use of confining elements and vertical extension of building can also be mentioned as other factors of damages in this case.

**Figure 4.** Instance of residential masonry building damaged due to the inadequate amount of bearing walls.

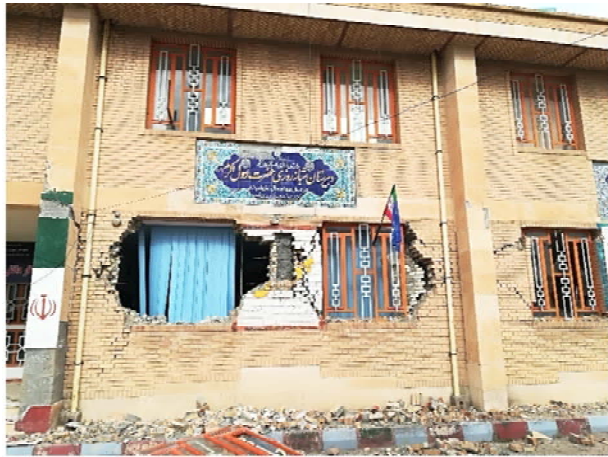
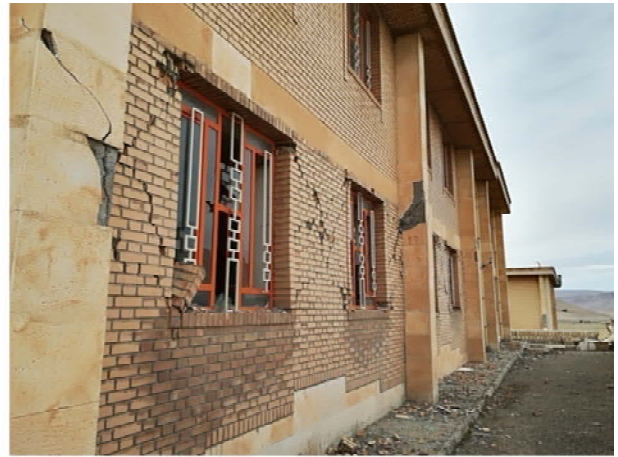
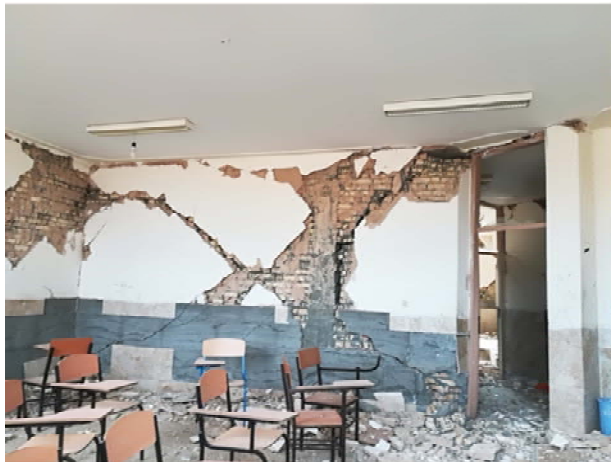
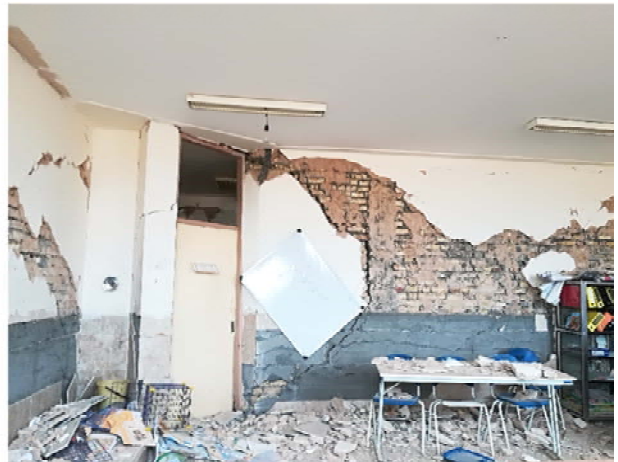
Figure (5) shows damages caused by inappropriate use of openings in masonry walls. Oversized and disproportionate openings, reduced the walls lateral strength and caused extensive damages in surrounding walls. In addition, existing of the opening reduced the lateral stiffness of the building that caused damages in other elements of masonry building like support elements especially in the first story.

**Figure 5.** Instance of damages due to the inappropriate use of openings.

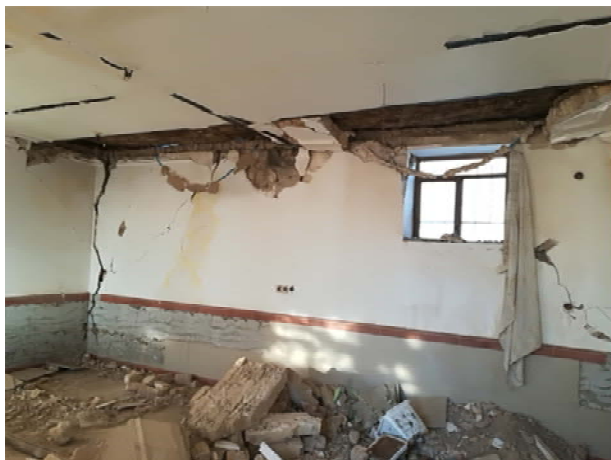
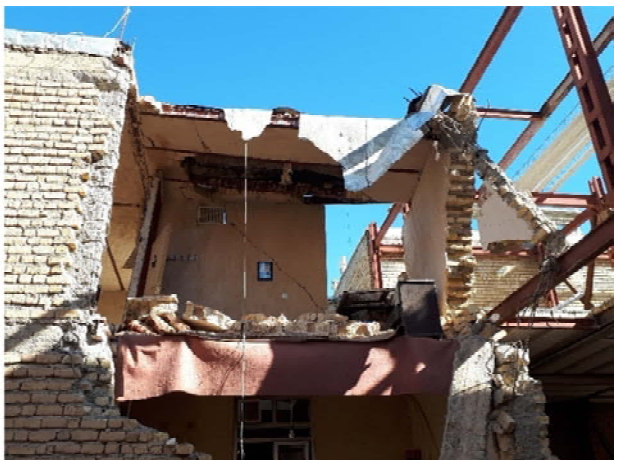
the official codes. Due to the intrinsic structure and common construction method, one-way slabs are known as integrated roof system, which has adequate in-plane stiffness. However, traditional methods of construction make the jack-arch roofs vulnerable under seismic load. Figure (6) shows some of

**Figure 6.** Low integrity of jack-arch roofs.

damages caused by weakness of this type of roofs.

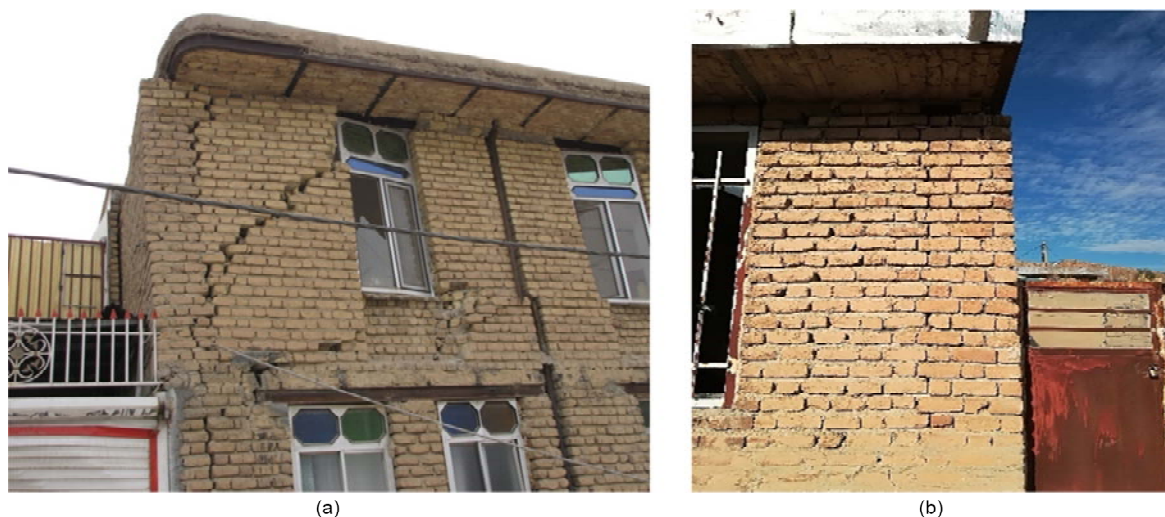
Connection between roof and supporting walls are another issue that takes a key role in performance of masonry buildings. As declared in Iranian seismic code and NBRI-8, it is necessary to set a concrete or steel tie-beam as interface elements between roof and supporting walls in order to establish a reliable path for inertia forces of roof to be transferred to supporting walls. The joists of roof should be restrained by connecting to the tie-beam in an appropriate manner. According to the observations, in many cases, regulations of Iranian seismic code and NBRI-8 about the connection of roof and supporting walls were ignored and caused damages to masonry buildings. A masonry building consists of jack-arch roof, placed on masonry walls is shown in Figure (7a). The absence of interface tie-beam caused sliding of roof on supporting walls. Another instance of weak connection between roof and its supports is shown in Figure (7b).

Figure 7. Disconnection between roof and supporting wall.

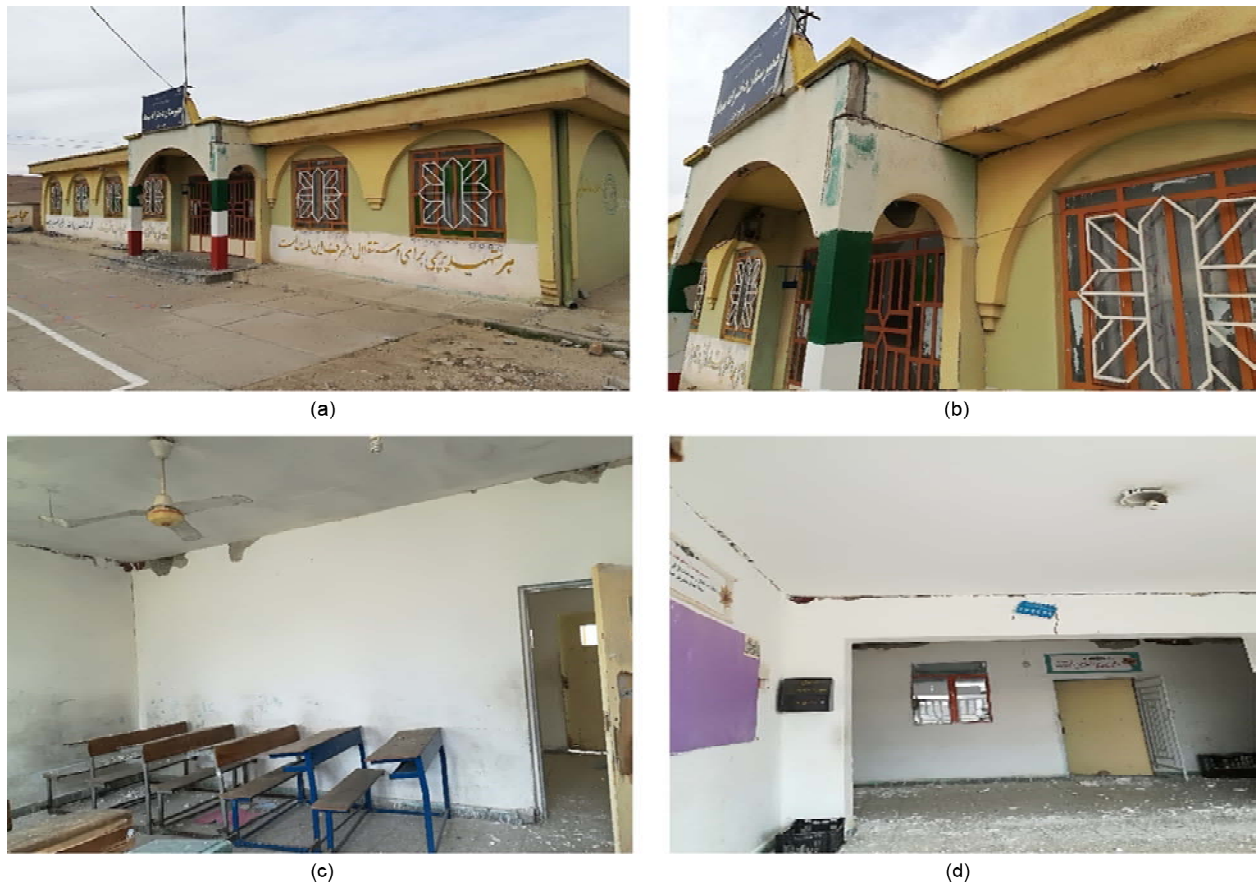
It should be noted that in some cases, the roof detachment from supporting walls saved the masonry building from further damages. Figure (8) shows a case of masonry building in which roof-wall detachment in early excitations led to a reduction in the seismic forces acting on the masonry walls and prevent more damages in building.

**Figure 8.** A case of detachment between roof and supporting wall led to a reduction in the seismic forces acting on the masonry walls.

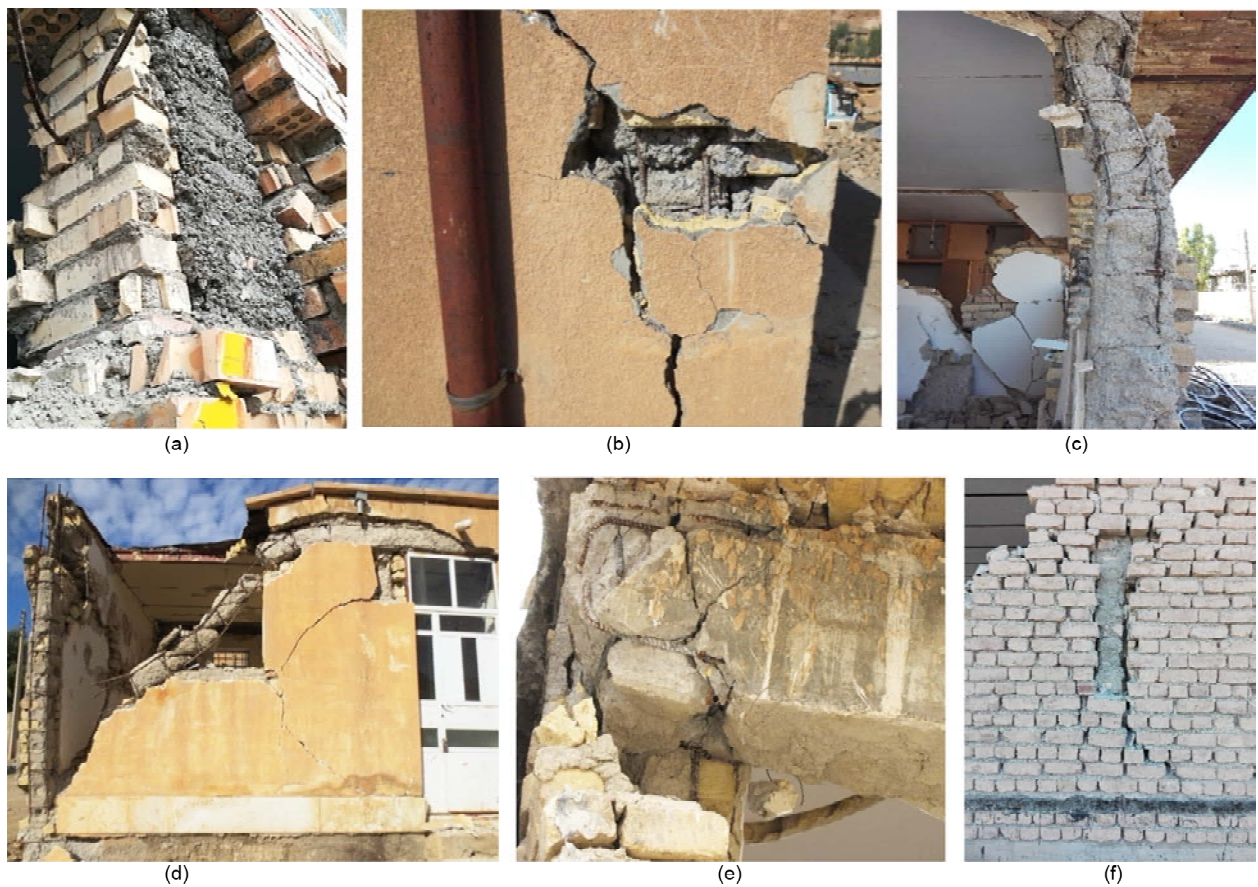
- ❖ Poor quality of the concrete used in tie-beams and tie-columns: According to observations, segregation and honeycombing in RC confining elements were observed as the result of poor mixing of concrete, poor aggregation, insufficient cement and high water/cement ratio of concrete (Figures 9a and 9b).

- ❖ Failure to comply with the regulations about the standard hook of reinforcement bars: Code regulations about standard hooks in official codes consist of radius and angle of bent of bar and length of bar that continues after the bent. These regulations are prescribed in order to transfer the stress between concrete and reinforcement bars. Ignoring proper anchorage of the tie elements reinforcement causes early collapse of masonry buildings as shown in Figure (9c).

- ❖ Failure to comply with the regulations about the connection of confining elements: connections between tie-beams and tie-columns takes a key role in integrity of CM walls. Iranian seismic code introduces regulations about the connections of confining system. Damages caused by ignoring these regulations are shown in Figure (9d).

- ❖ Excessive spacing of transverse reinforcements: As mentioned in Iranian seismic code, maximum spacing of stirrups should be less than the depth of concrete element and 25 cm. This limitation is decreased to 15 centimeters in critical length near the connections. As can be seen in Figures (9c)

**Figure 9.** Instances of defects in confining elements and resulting damages.

and (9e), excessive spacing of transverse reinforcement throughout the tie elements was responsible of some damages and failures in masonry buildings.

- ❖ Insufficient integration between wall and confining elements: in confined masonry buildings, integration between wall and confining columns are provided by tothing the interface between wall and column or by using the dowel bars crossed within the column to the wall. Lack of attention to these instructions had negative effect on confining behavior and caused damages (Figure 9f).

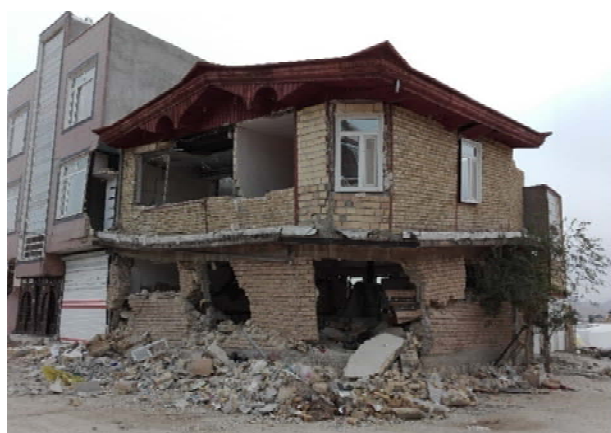
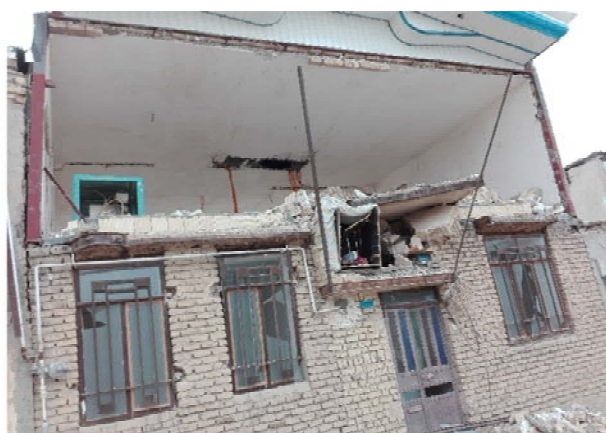
regulations about symmetry, length to width ratio and projections or setbacks of plan. In many horizontally extended buildings in earthquake affected area, implementation of separation joints caused the above-mentioned regulations to be satisfied. However, vertical extension caused damages in some cases. Adding new stories to an existing building increases the mass of structure and the inertia force that developed during the earthquake. Ignoring the code-based regulation for building extension, causes the existing walls not to be able to withstand the developed forces. Figure (10a) shows a masonry building that is extended vertically by adding a new story on the old existing part. Damages in the old part of building can be seen in Figure (10b). This building is tagged as highly damaged by the IIEES earthquake damages assessment team. Another instance of masonry building that is damaged due to aforementioned reason is presented in Figure (11a). Another

**Figure 11.** Other instances of vertical extension of existing masonry building.

defect in vertically extended buildings is the use of material or structural system that is different from old section's one. This issue cause in irregularity in height of the building and is the responsible of some damages (Figures 10a and 11b).

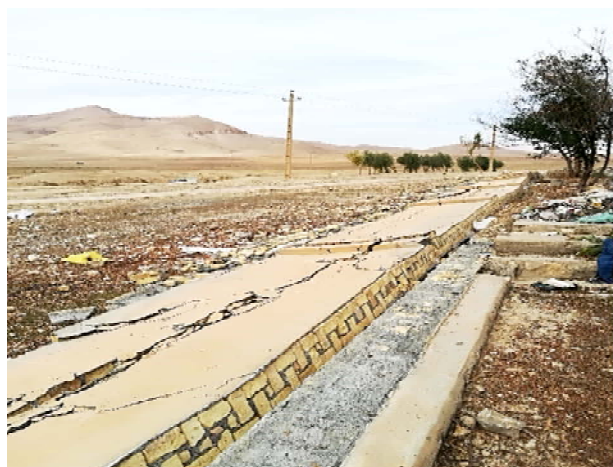
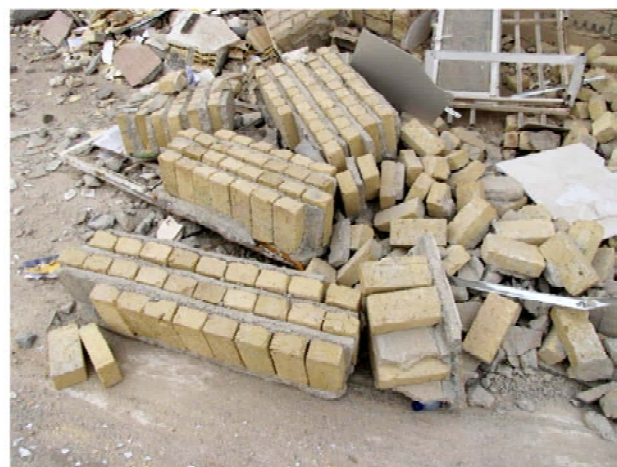
Masonry walls are made of two main parts: mortar and masonry units. In the case of confined masonry walls, concrete confining elements are another elements that play an important role in structural behavior. Poor quality of materials of mentioned components was the main cause of damages in many cases. Generally, the strength of masonry units are greater than the strength of mortar and limited weakness in masonry units does not have much impact on structural behavior of masonry buildings. By contrast, weakness of mortar reduces the integrity between mortar and masonry units and causes damages in masonry walls. Figure (12) presents cases of damages due

Figure 12. Instances of the use of poor quality mortar and resulted damages in masonry walls.

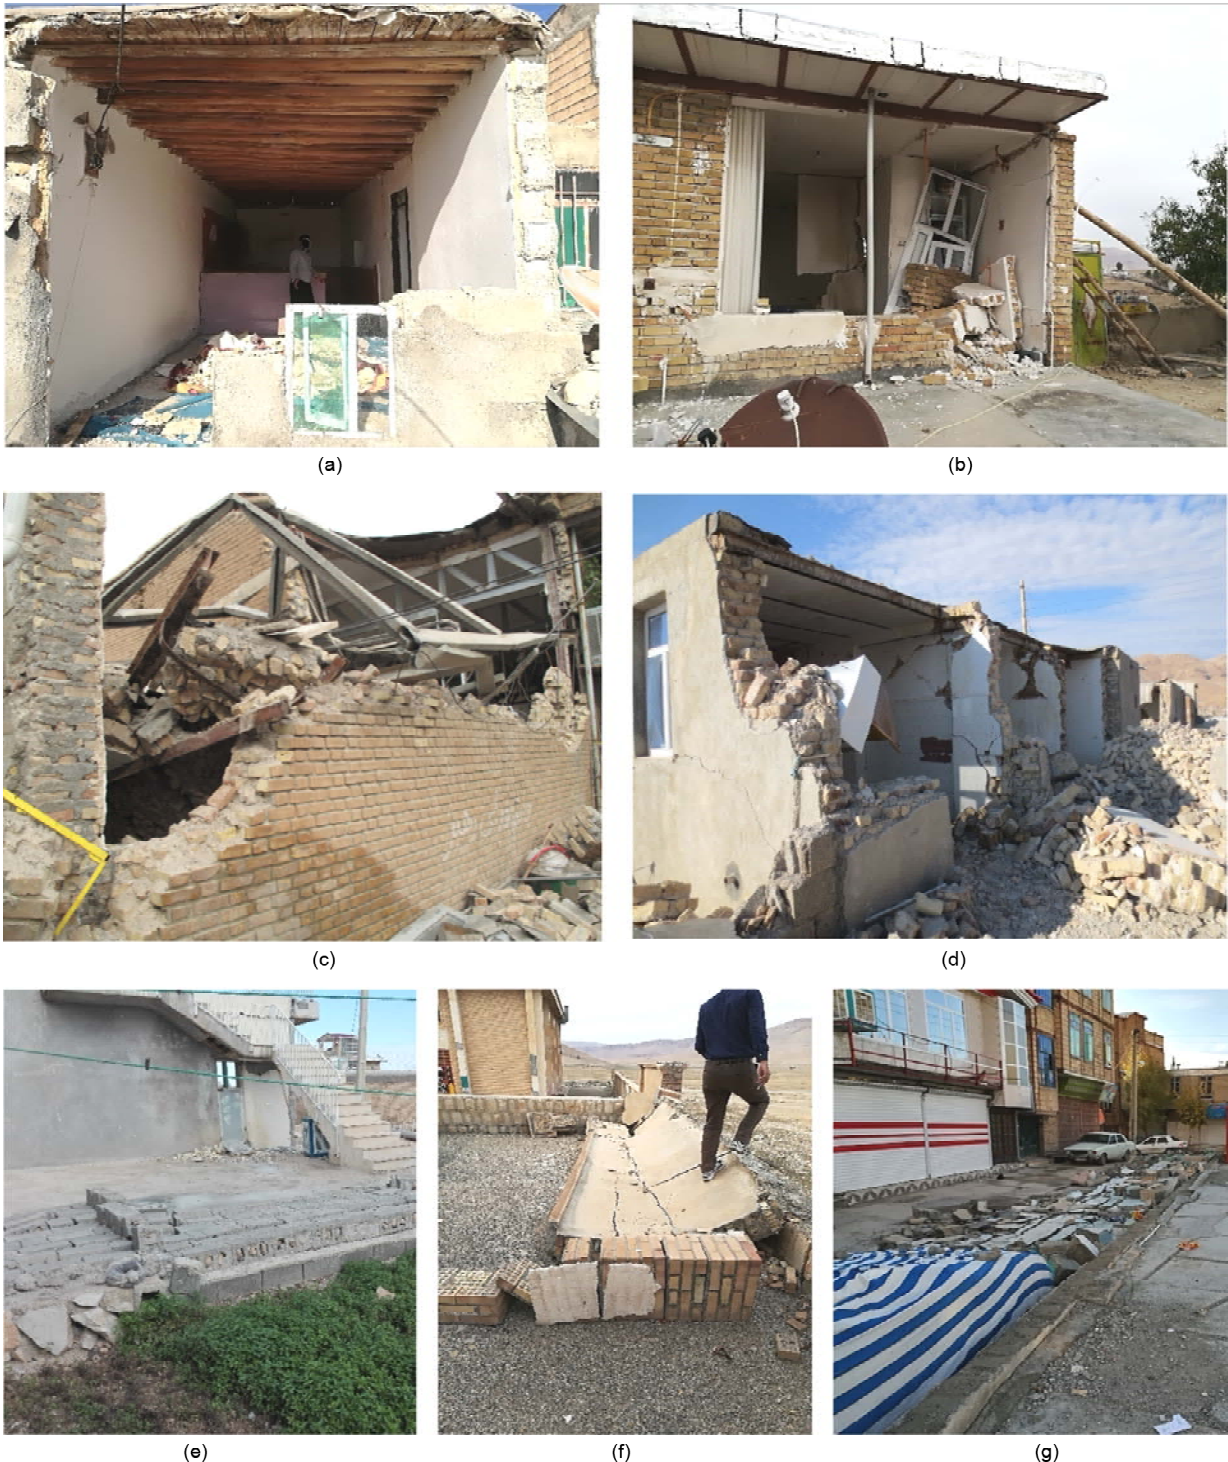
Figures (13a) to (13c), lack of proper interlock between masonry wall and returned wall caused OP collapse. Figure (13d) shows a masonry wall with proper corner bond. However, high mass of the wall resulted high amount of OP inertia force and caused OP collapse of the wall. In the case of Figure (13c), long unsupported length of the wall is another reason of OP collapse. The issue of the walls with long unsupported length caused damages

in many cases of the surrounding walls especially of schools' yard. Instances of the walls that collapsed due to the long unsupported length is presented in Figures (13e) to (13g).

Figure 13. Instances of OP failure of URM walls.

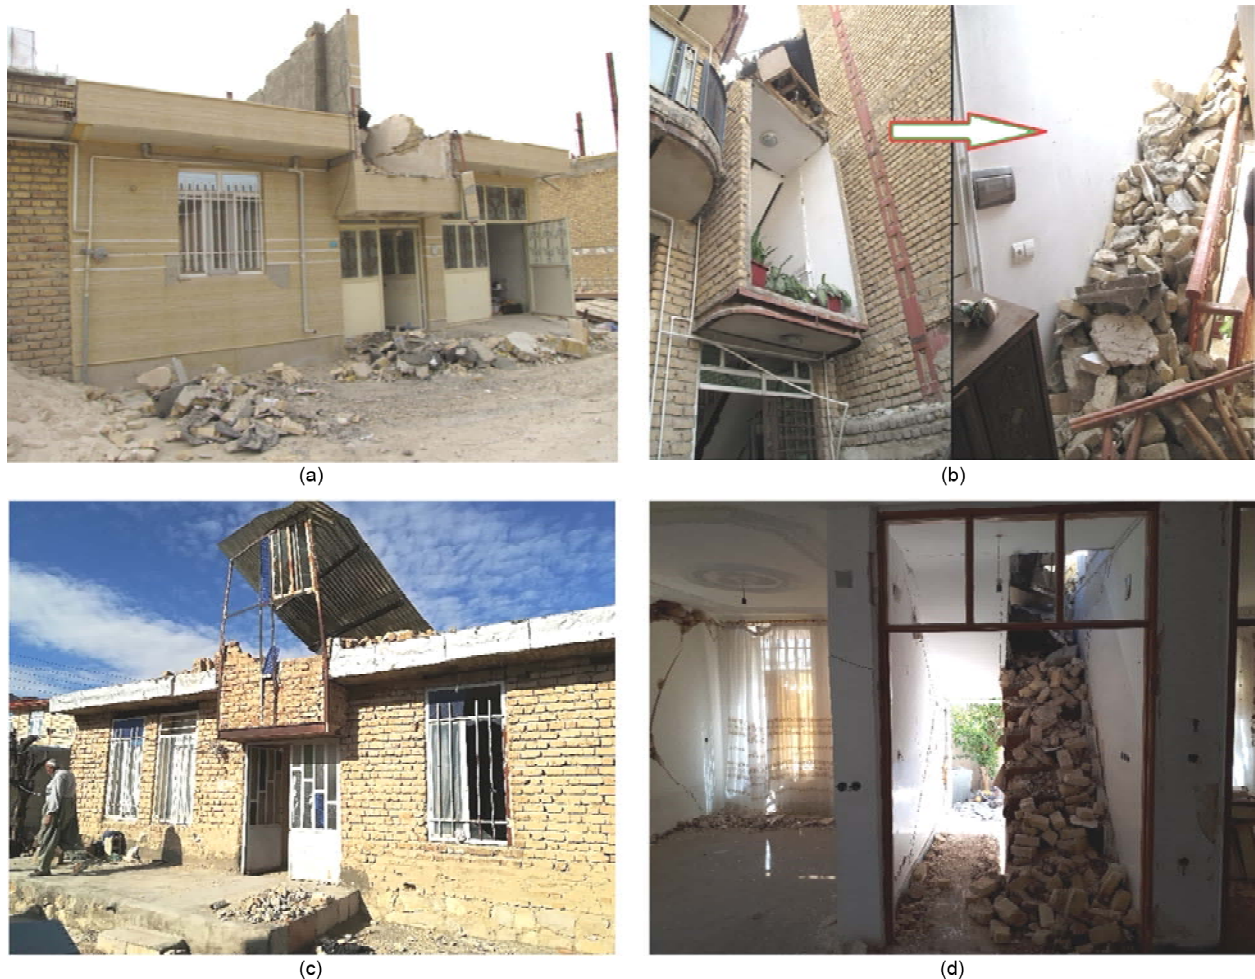
consequently are affected by larger amount of inertia forces than the lower stories. This cause more OP damages in roof staircase level. Some instances of damages in these walls are presented in Figure (14). In many cases, the damages caused debris to fall into the stair case and blocked the way out of the inhabitants (Figures 14b and 14d).

Figure 14. Instances of failures in roof access enclosures.

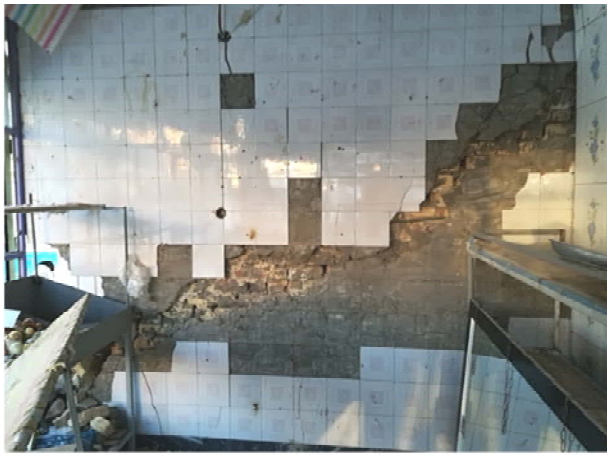
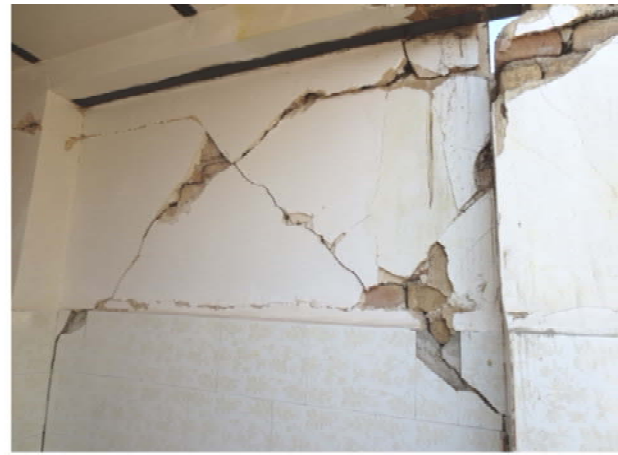
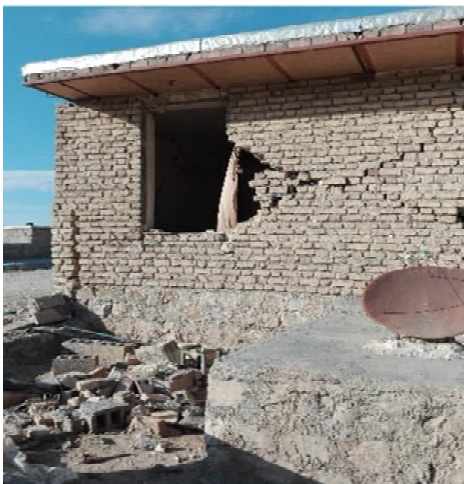
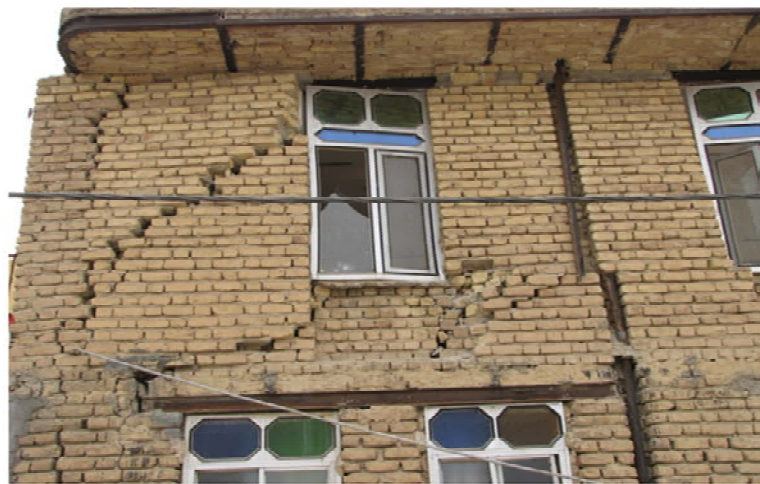
Diagonal Shear (DS) failure appears as diagonal cracks which may be developed either through masonry blocks (which is known as diagonal tension failure) or through bed and head joint (which is known as stair step crack). The case of diagonal tension cracking has rarely happened in Sarpol-e Zahab - Ezgeleh earthquake. This was due to the fact that the strength of masonry blocks (brick, clay or cement tile or stone) is normally greater than the strength of mortar. By contrast, the stair step cracking is the most common failure mode of URM walls. Figure (15a) shows an instance of DS failure mode appeared as stair step cracking. Figure (15b) shows a wall that half of its height is covered by overlay of ceramic tiles and cement grout. Presence of this layer of overlay forced the X pattern of cracking to be developed on the top part of the wall. DS failure mode in the piers near the openings is shown in Figures (15c) and (15d).

Figure 15. Instances of diagonal shear failure mode of URM walls.

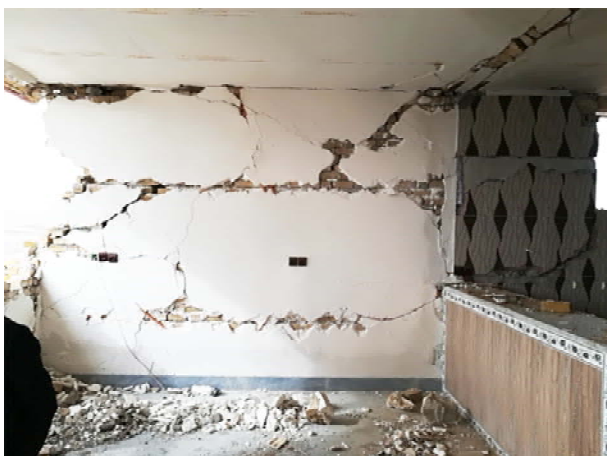
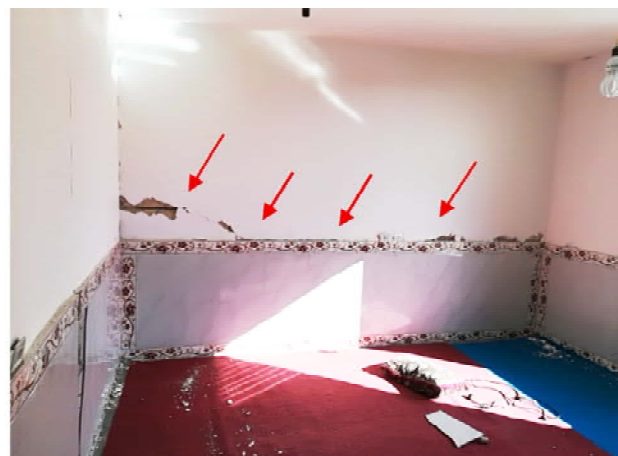
Sliding Shear (SS) is known as a ductile mode of failure in masonry walls [4]. Poor quality of mortar and low vertical load acting on the wall are main reasons of occurrence of SS failure mode. Figure (16a) shows an instance of SS failure mode

developed in horizontal plane form. In many cases, horizontal plane of SS were formed on the top level of the wall. It is necessary to note that the presence of overlays that increase the lateral stiffness of the wall can change the pattern of SS failure. As shown in Figure (16b), the use of overlay of stone

Figure 16. Instances of sliding shear failure mode of URM walls.

and cement grout in bottom half of the wall, forced the horizontal plane of crack to be developed in the margin of the overlaid part.

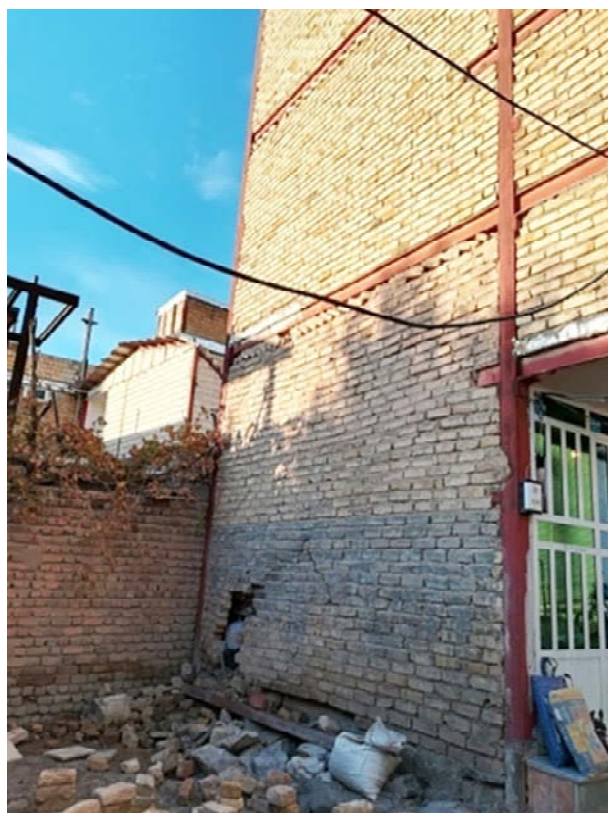
In the case of slender walls or walls with high shear resistance, flexural failure mode would be likely to be occurred. Various events like cracking in the heel, overall rocking of wall and compression cracking in the toe may be occurred in this mode of failure. It should be noted that, typically, flexure failure comes with other failure modes. Due to the material and geometric properties of walls, flexural failure mode rarely observed due to this earthquake. One case of this mode of failure is shown in Figure (17).

Figure 17. Instance of flexure failure mode of URM wall.

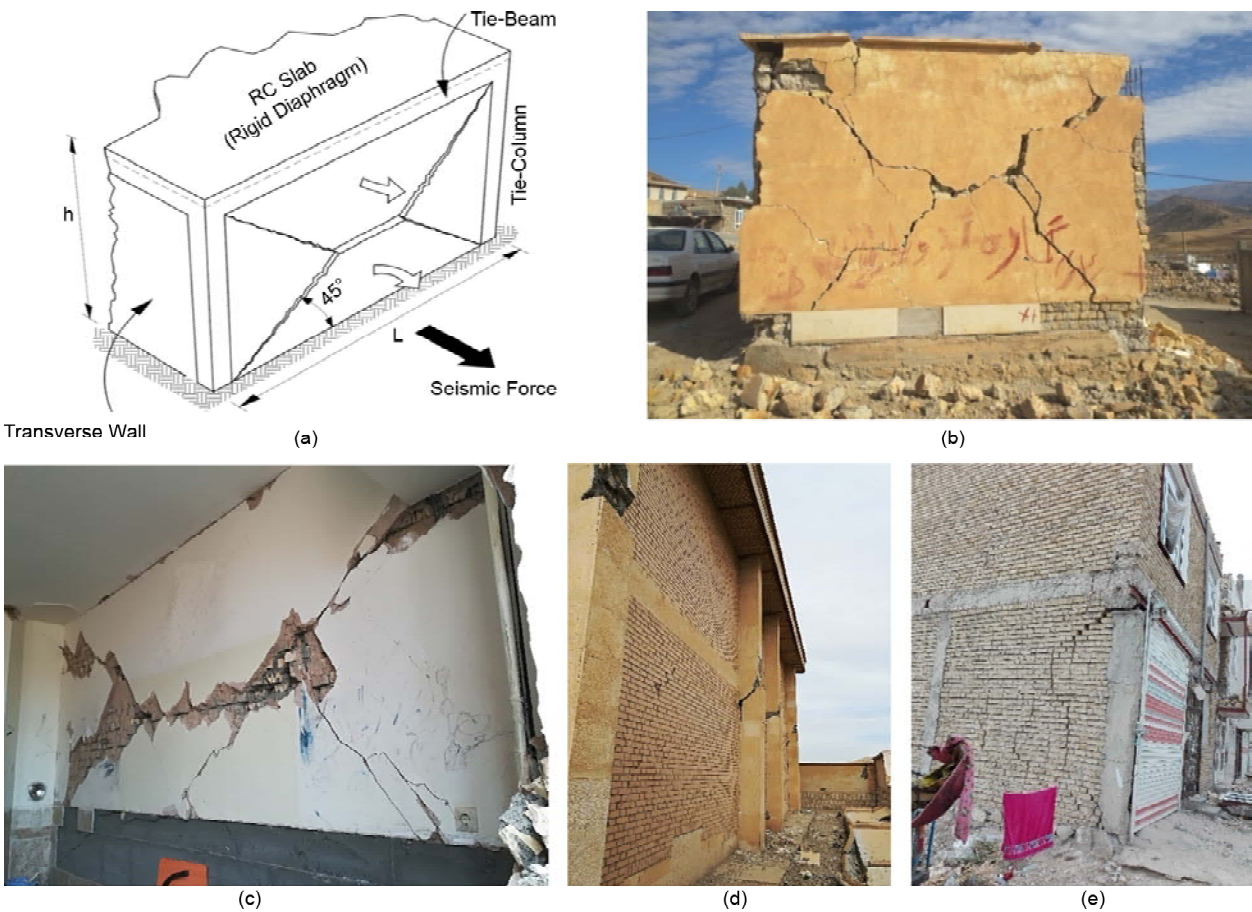
One type of OP damage of CM walls is related to the inertia forces developed in the wall due to the mass of the wall and OP seismic induced acceleration [7]. Typical crack pattern of this type of OP damages is presented in Figure (19a). Instance of this type of damage is shown in Figures (19b) and (19c). This type of OP failure mode, mostly observed in upper stories of CM buildings which induced acceleration are greater than lower stories. Another type of OP failure mode of CM walls may be observed in the CM masonry buildings with rigid diaphragm and large drifts in stories. Due to the integrity between the masonry wall and the confining elements in CM buildings, the drift of the story can be transferred to the walls and cause OP failure of masonry walls in the case of large drifts orthogonal to the plane of the wall.

Figure 19. (a) Typical crack pattern of OP failure of CM walls due to the inertia force [8], (b, c) Instances of OP damage of CM walls due to the inertia force, (d, e) Instances of OP damage of CM walls due to the large inter-story drifts.

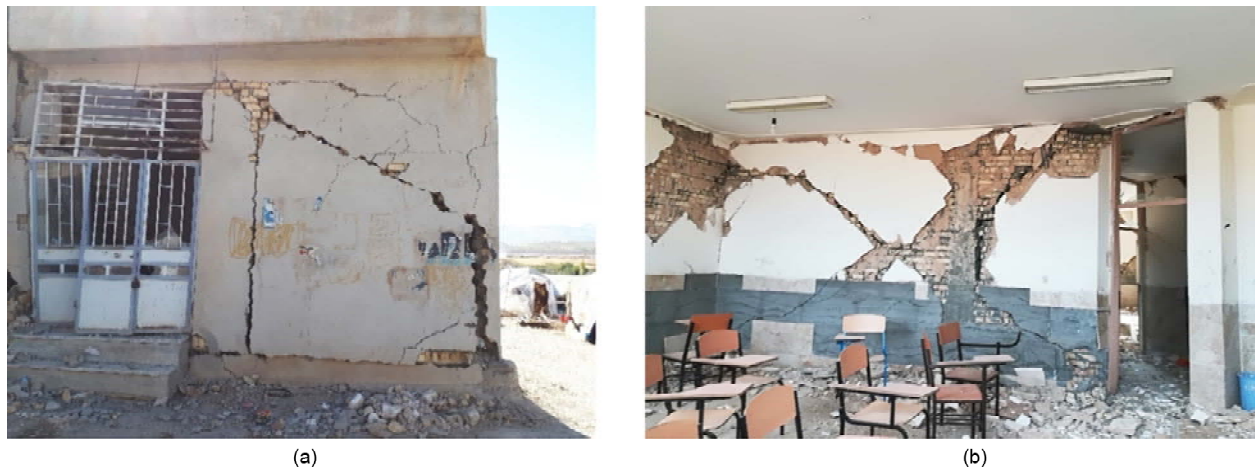
**Figure 20.** Instances of shear failure of confined masonry walls.

properties of tie-columns and the amount of integrity between tie-columns and masonry walls play the key role in seismic behavior of CM walls [8]. Generally, the shear failure of CM walls are initiated by forming diagonal cracks in masonry part of the wall and ends with propagating the cracks to RC confining elements. This type of failure is the most common failure mode of CM walls in Sarpol-e Zahab - Ezgeleh earthquake. Instances of this failure mode are presented in Figure (20).

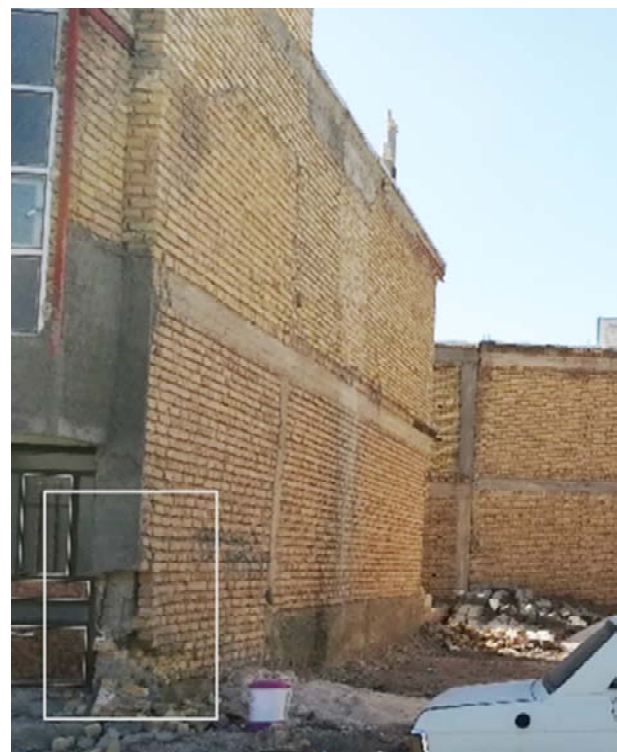
Another failure mode of CM walls is known as flexural failure mode and associated damages are mostly due to the tension and compression stresses resulting from the combination of axial force and bending moment acting on the wall. Because of the mechanical properties of masonry materials and geometric properties of masonry walls that are commonly used in earthquake affected area, flexure failure mode of CM walls is rarely occurred. An instance of this type of failure is presented in Figure (21). As can be seen, compression stresses caused toe crushing in the both of brick and RC parts of CM wall.

**Figure 21.** Instance of flexure failure mode in CM wall.

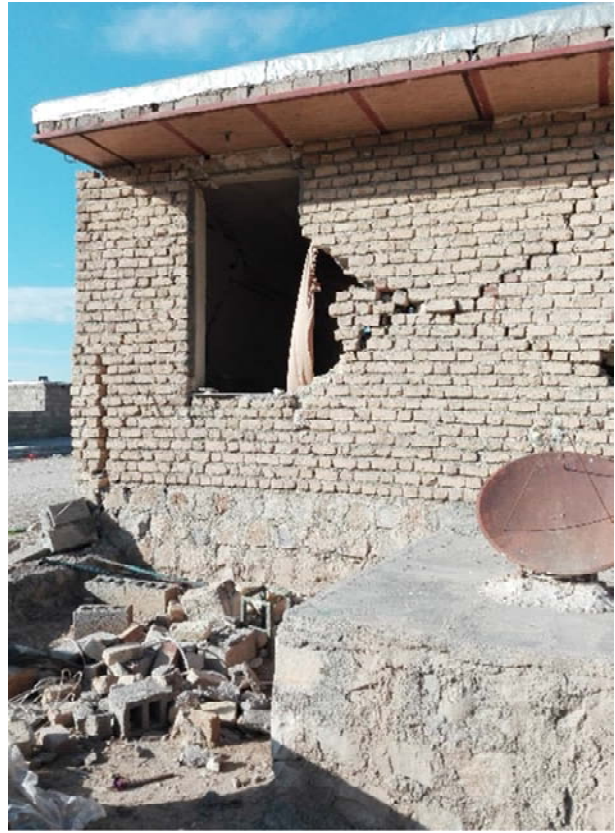
A case of masonry pier that is damaged in the diagonal manner is presented in Figure (22). In site survey is not conducted on this case; however, the values of  $f'_{dt}$ ,  $f'_m$  can be obtained based on the default values presented in Iranian Code-360 for masonry walls for different conditions of materials used in masonry wall (poor, mediocre and good condition). Based on the observation of exposed condition, the materials of pier are in poor condition and the values of 0.03 and 2.6 MPa can be used for  $f'_{dt}$ ,  $f'_m$  respectively. The value of  $v_{me}$  is not available and consequently the value of  $V_{bjs}$  cannot be calculated. The pier has dimensions of 3600-2200-200 mm as length, height and thickness, respectively. The gravity load of the roof that induced to the pier is about 45 kN, and the pier has the weight of about 37.5 kN. Consequently,  $P_E$  and  $f_a$  equal 82.5 kN and 0.108 MPa respectively. In addition, the pier has the fixed-fixed condition and  $\alpha$  equals 1.

Considering above-mentioned values for variables used in Equations (1) to (4), the value of  $V_r$ ,  $V_{dt}$ ,  $V_{tc}$  are obtained as 121.5, 75.6, 127.8 kN, respectively.

Figure 22. The case study of masonry pier.

Based on these values, one can predict the occurrence of diagonal tension failure in this pier. As can be seen in Figure (22), the dominated failure mode is diagonal sliding mode that is consistent with the result concluded by calculations. It should be noted that there are signs of sliding shear failure mode in this pier, indicating that the value of  $V_{bjs}$  is close to the value of  $V_{dt}$  and consequently  $v_{me}$  equals 0.1 MPa approximately.
