## Lessons from the February 2011 M6.3 Christchurch Earthquake

Gregory A. MacRae

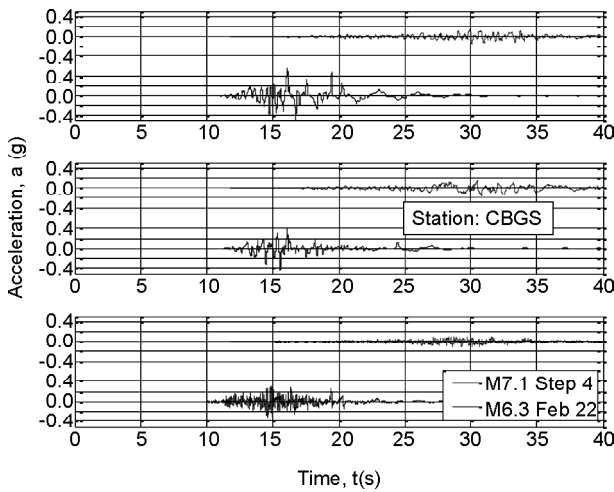
**Figure 1.** Christchurch Botanical Gardens records (from Brendon Bradley, U. Canterbury, New Zealand, based on GNS data).

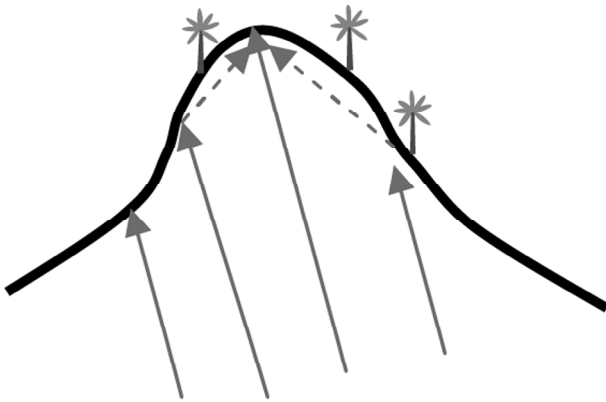
**Figure 2.** Ridge effect (Focussing of rays).

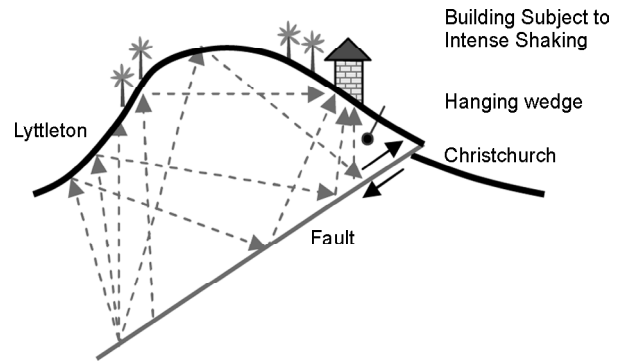
6. There was a hanging wall effect, which amplifies the high frequency shaking. This is illustrated in Figure (3) and it affected the structures on the hills [2]. Here, waves are reflected back to the surface by the fault. Energy gets trapped in the hanging wedge/wall and reflected waves can be combined with direct waves (not shown) to obtain very strong shaking at a site.

**Figure 3.** Hanging wall/wedge effect (From Berrill [2]).

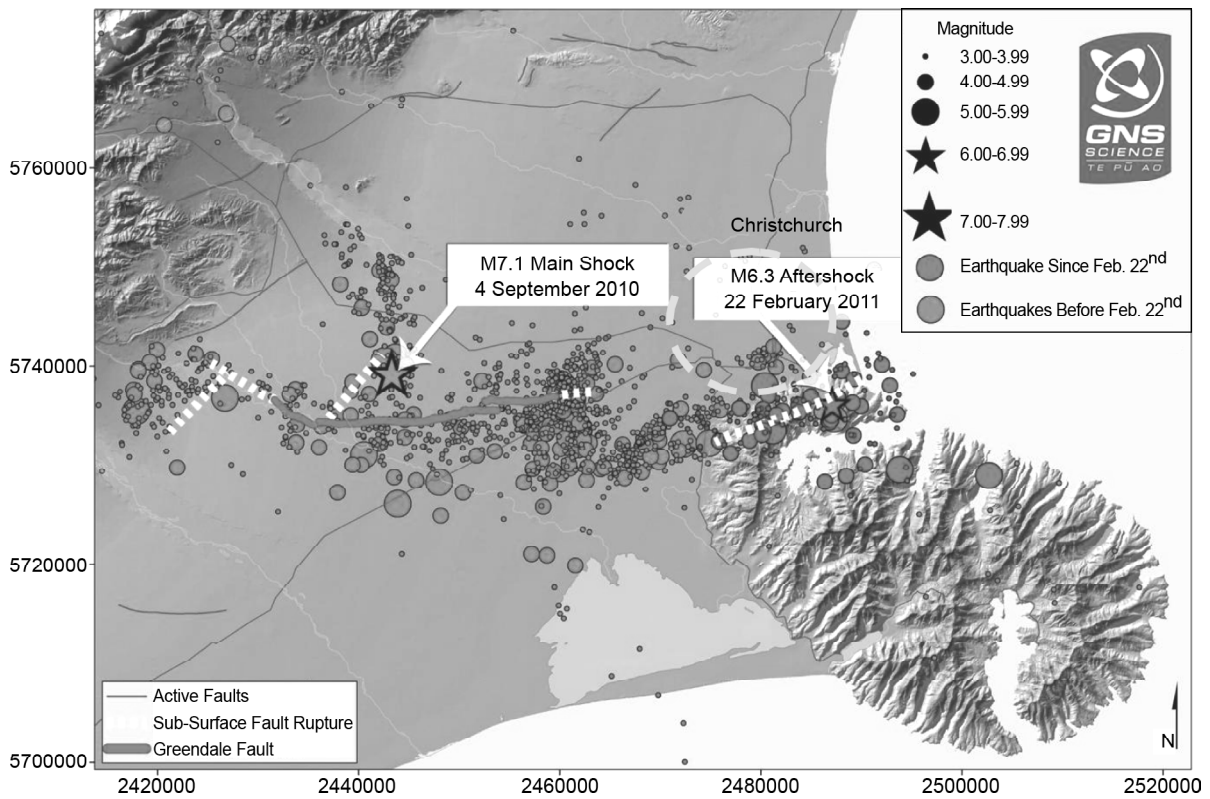
The location of the 2011 M6.3 fault is shown by the yellow line in Figure (4) while that of the 2010 M7.1 fault is shown by the red line. It should be noted that the fault lines do not meet up, so investigations have been undertaken by geologists and seismologists about the possibility of a further

Figure 4. Approximate fault and aftershock locations (Modified from GNS Science).

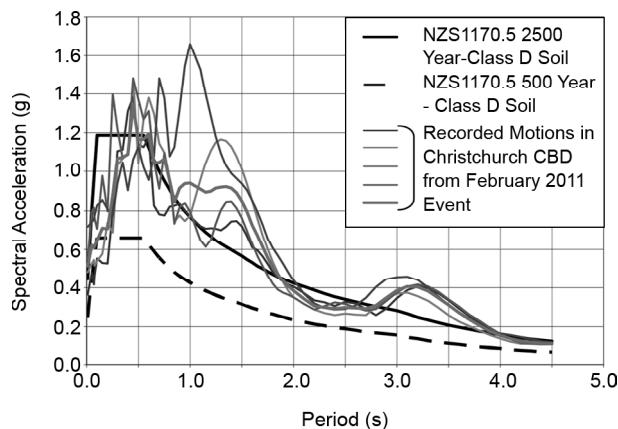
The response spectra of ground motions recorded at some CBD (central business district) sites are compared with the design spectra in Figure (5). The dashed black line is the 500 year design spectra, while the solid black line is 1.8 times this value. This is nominally considered to be the maximum credible earthquake (MCE). It may be seen that the CBD shaking was often considerably greater than both of these curves; often significantly more than 2

Figure 5. 22 February 2011 M6.3 earthquake response spectra (Courtesy Geonet).

times the design level. There is also a hump in the response spectra at a period of about 3 s, which is consistent with the basin effect described in point 5 above. In a design level earthquake we generally expect structures to be damaged to a repairable extent so that they can be reused, whereas in an MCE event (close to the levels of shaking that were experienced) we generally hope that structures may be severely damaged but do not collapse so that life is preserved.

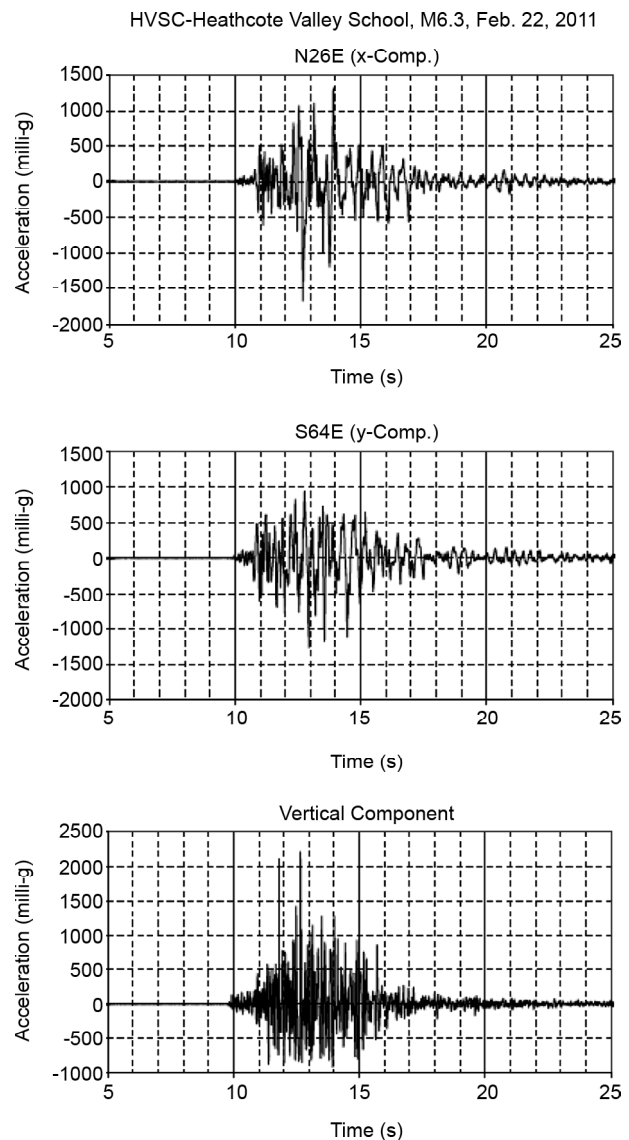
One of the largest levels of shaking occurred at a school in a valley beside the port hills as shown in Figure 6. The two horizontal components of ground acceleration were very high with the PGA (peak ground acceleration) of 1.68 g and 1.27 g, respectively. According to Berrill [2], for about 20 years the strongest horizontal peak acceleration recorded was the 1.25 g from Pacoima Dam, in the epicentral region of the 1971, M6.4 San Fernando earthquake in northern Los Angeles. It indicates that the shaking was very strong. The vertical accelerations were very high in the positive direction but close to 1 g in the negative direction. The peak downward (negative) acceleration will likely occur when the instrument is at the peak upward displacement. A value of 1.0 g

indicates that the equipment, the slab, and the building was probably lifted up in the air and separated from the ground. When it came down it bounced on the ground causing impact with the soil and the positive accelerations shown. It is similar to the behaviour of a person bouncing on a hard trampoline. On hills close to this school, some large rocks rolled and bounced down the hill into residential houses. There was also some damage at the school itself, with masonry walls in 2 buildings which had moved, and an unreinforced masonry heating building and chimney that had come down. Apart from that, the school buildings looked to be unaffected.

**Figure 6.** Heathcote valley School damage (from Berrill [2] using Geonet data).
