# Reconnaissance Report of July 16, 2007 Niigata-Ken Chuetsu-Oki, Japan, Earthquake

**M.R. Ghayamghamian<sup>1</sup>, Tetsuo Tobita<sup>2</sup>, Susumu Iai<sup>2</sup>, and Gi-Cheon Kang<sup>2</sup>**

**Keywords:** Damage survey; Niigata-Ken Chuetsu-Oki of July 16, 2007; Directional damage; Geotechnical and structural damage

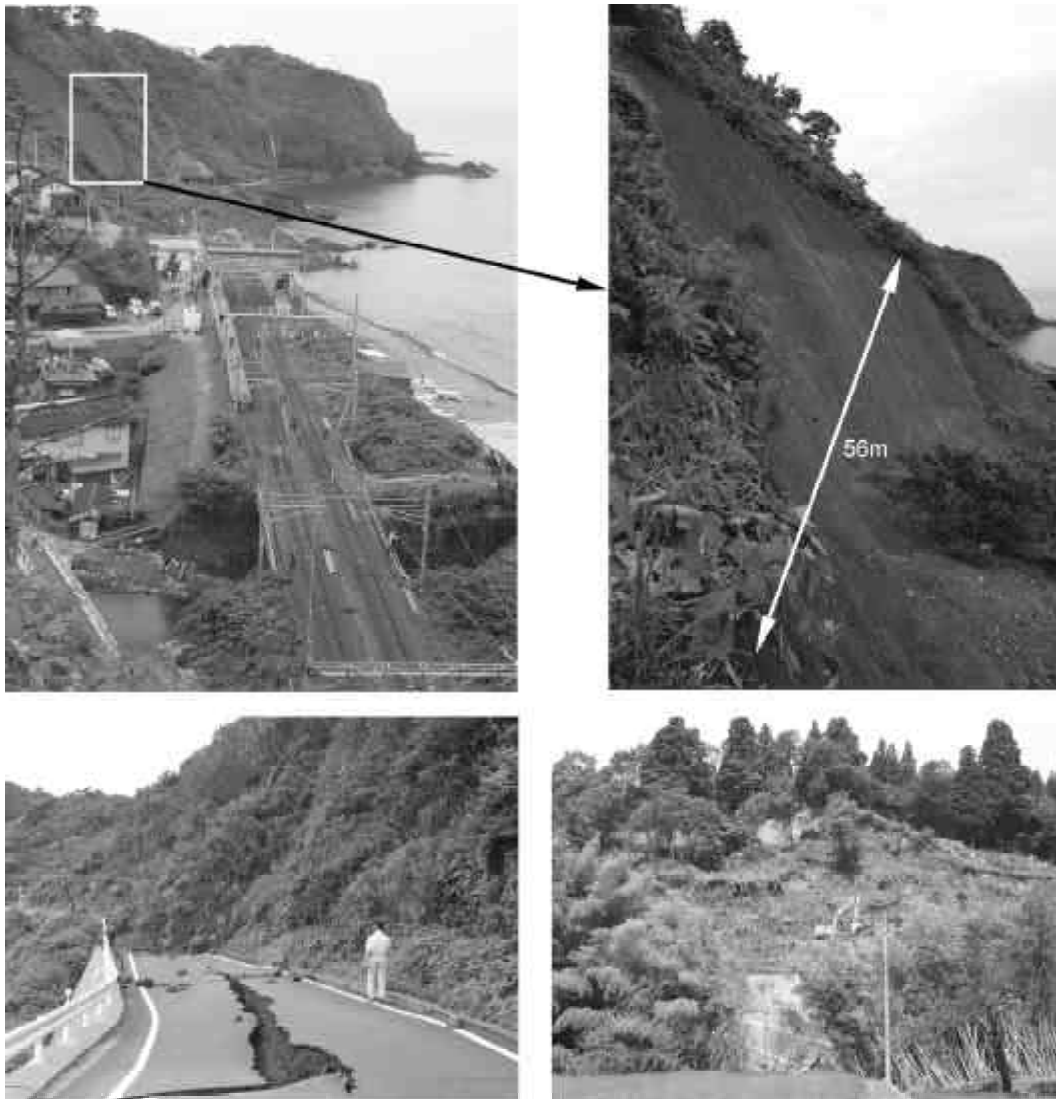
**Figure 9.** The landslides observed near the Ohmigawa station of JR Shin-Etsu line, Kan-non misaki (Cape Kan-non), and near the route 8 at Senbon that connects Kashiwazaki to Nagaoka.

the observed landslides where their locations in the area can be seen in Figure (2). Damage due to liquefaction to the utility poles, roads and buildings were mostly observed in Kashiwazaki fishery port and Matsunami 2 in Kashiwazaki city. The Matsunami 2 was originally farm lands and sand dunes that gradually changed to a residential area from 1973 to 1976. The area is 14 ha and east part of the developed

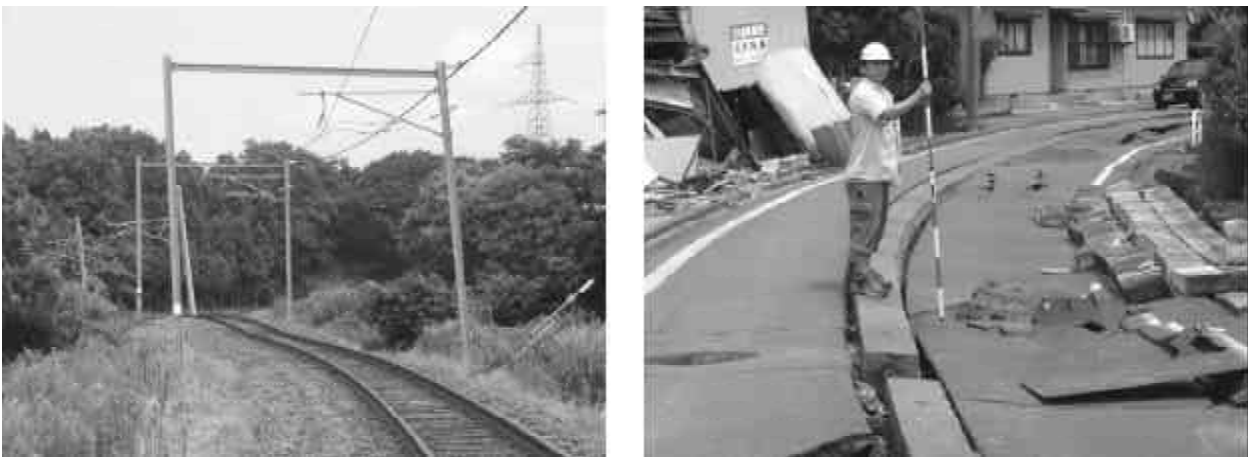
land suffered heavy damage due to liquefaction. The occurrence of liquefaction after the large shaking with an eruption of muddy water at 2m height is described by eye witnesses, see Figure (10). Settlement of a railway embankment due to the loss of the bearing capacity of its base ground was found in Doh-Ai with no evidence for liquefaction, see Figure (11). Cross-sectional dimension of the

**Figure 11.** Settlement of the railway embankment in Doh-Ai and damaged road pavements near the railway.

embankment after deformation is 6.8m at the crest, and 16m at the toe. Its height after deformation is 1.2m. Road pavements near the railway settlement were damaged possibly due to liquefaction of filled material that is used for construction of swage pipes and manholes, see Figure (11). This may indicate that major soil type in this area is cohesive and contains low permeable material. In Kashiwazaki

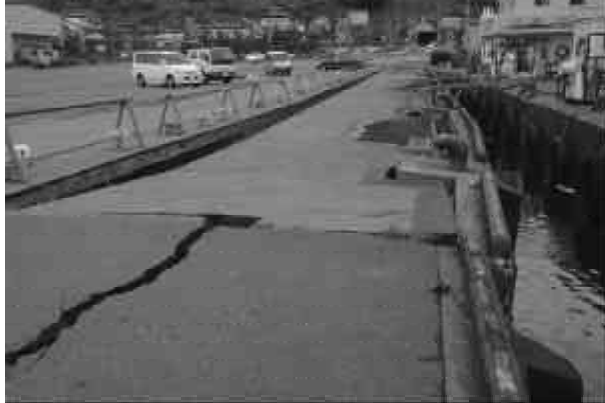
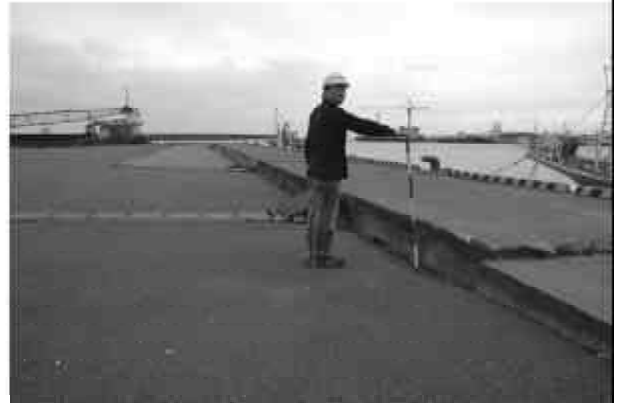
fishery port, the settlement of apron near 0.5m was observed. Furthermore, the sheet pile type quay wall with tie rods deformed around 1m toward the sea, see Figure (12). Large ground fissures due to liquefaction were found in the Sabaishigawa Kaishu-Kinen park, Makhara, and Kashiwazaki. The Kaishu-Kinen park was constructed on a sandbar along the Sabaishi river, see Figure (13).

**Figure 12.** Damage to sheet pile type quay wall with tie rods in Kashiwazaki fishery port due to settlement where the evidence for liquefaction was also found.

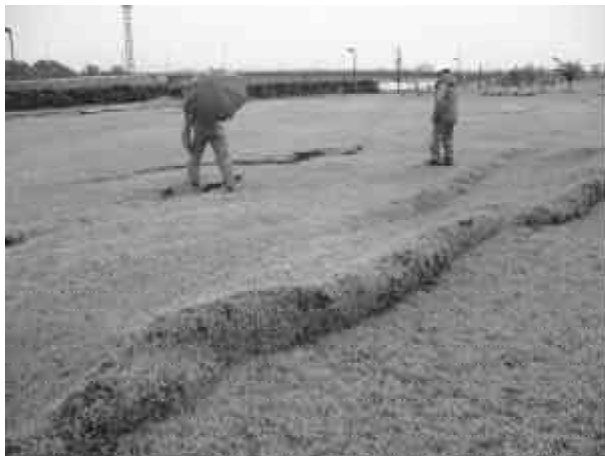
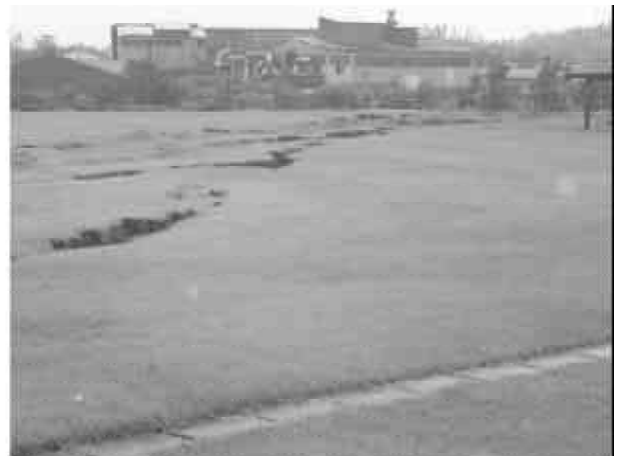
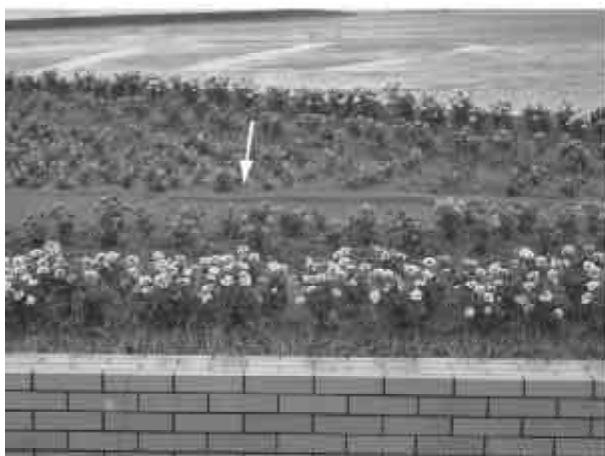
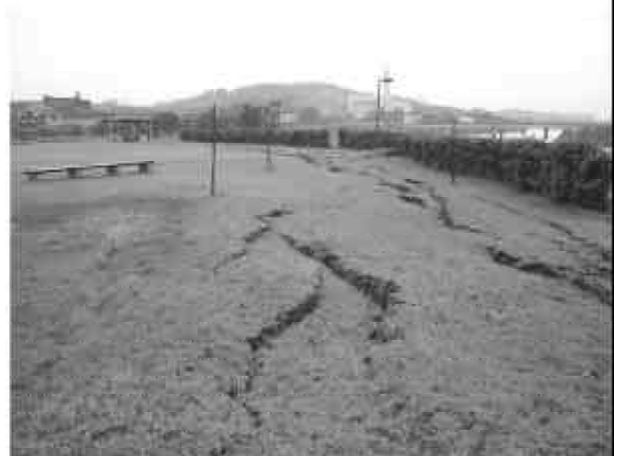
**Figure 13.** Large ground fissures due to liquefaction at the Sabaishigawa Kaishu-Kinen Park in Makhara-Kashiwazaki. The park was constructed on a sandbar along the Sabaishi river.

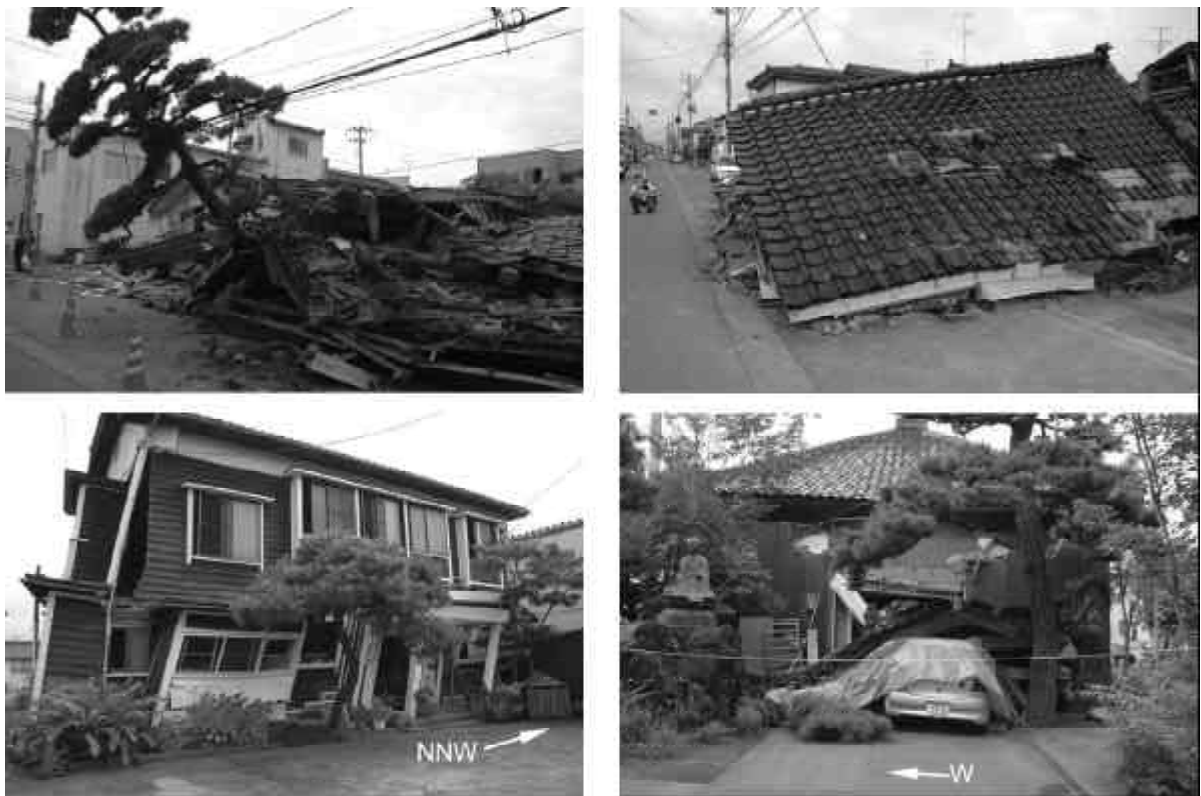
structural damage or collapsed). Most of the building damage is classified as *D1* and *D2* near the Kashiwazaki city hall. However, many wooden houses with Grade 5 and 6 damage were observed along the Higashi Hon Machi street (regions 2 and 3). Figure (16) shows typical collapse of wooden houses together with their collapse direction observed in this street. The Highashi Hon Machi street was almost directed along *EW* direction with a lenient slop in its south side. Besides this observation, the scares damage along the other streets was found that is mostly categorized as a *D2* or *D3* types. The place that damage *D6* was observed is shown in the map in Figure (14). Although it was not possible to visit all the damaged buildings, the ntensity based on collapsed buildings seems to be lower than the one announced based on instrumental *JMA* seismic intensity (6+ comparable to *IX* in *MMI* scale).

Figure 16. Observed damaged to the wooden houses in Highashi Hon Machi street together with their direction of collapsing.

An investigation of damage to the buildings revealed that most of the collapsed wooden houses are directed in *EW* directions fallen to the west. This indicates that the motion may polarize in especial direction due to either deep geological irregularity or near-source effects [1]. To provide more facts, the velocity and displacement time histories are calculated from the recorded acceleration time histories in the Kashiwazaki station. Then, the particle motion in horizontal plane is investigated as shown in Figure (19). This figure reveals a strong polarization of motion in *NW-SE* direction that is in accordance with the observed direction of collapsed buildings.

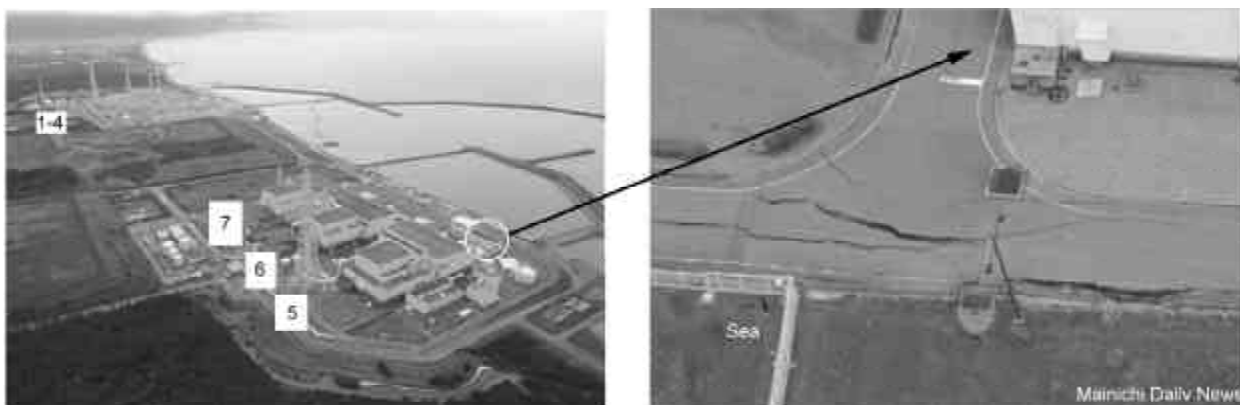
reactors that generate 8,200,000kw power for Tokyo area. It suffered serious damage in auxiliary facilities only during earthquake, see Figure (17). An electrical transformer at the plant fired and it could not be quickly extinguished due to the broken water pipes, Figure (18). Meanwhile, a small amount of water containing radioactive materials had leaked from a unit at its Kashiwazaki-Kariwa nuclear power plant. The contaminated water was also released into the ocean, but officials said it had produced no effect on the environment. The *PGA* of  $680\text{cm/s}^2$  was recorded at the nuclear power plant site. This was 2.5 times stronger than those its reactors had been designed to withstand. According to the Tokyo Electrical Power Company (*TEPCO*) website, the responsible company of Kashiwazaki nuclear power plant, the units were constructed on engineering bedrock for design *PGA* of  $270\text{cm/s}^2$ . A report by the Niigata prefectural government has stated that about 700 billion yen would be lost from the suspension of operations at Kashiwazaki-Kariwa nuclear power plant. Furthermore, prefectural authorities also estimated that Niigata farmers would lose between 100 billion and 200 billion yen due to consumer fears about radioactive fallout from the nuclear power plant. The Riken company, which manufactures ring piston for most automobile companies such as Toyota and Nissan,

**Figure 17.** The Kashiwazaki nuclear power plants consist of 7 reactors showing the damage due to liquefaction and ground settlement.

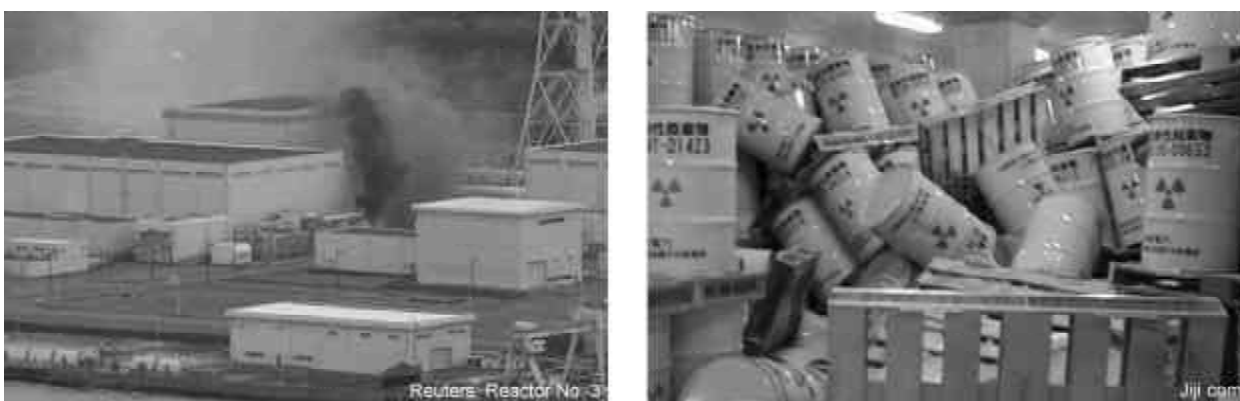
**Figure 18.** Fire in an electrical transformer at the nuclear power plant and displaced barrel of nuclear waste. The radioactive materials were also leaked to the ocean and contaminated the environment.
