## Performance of Unreinforced Masonry Buildings in Canterbury Earthquakes

Rajesh P. Dhakal

### ABSTRACT

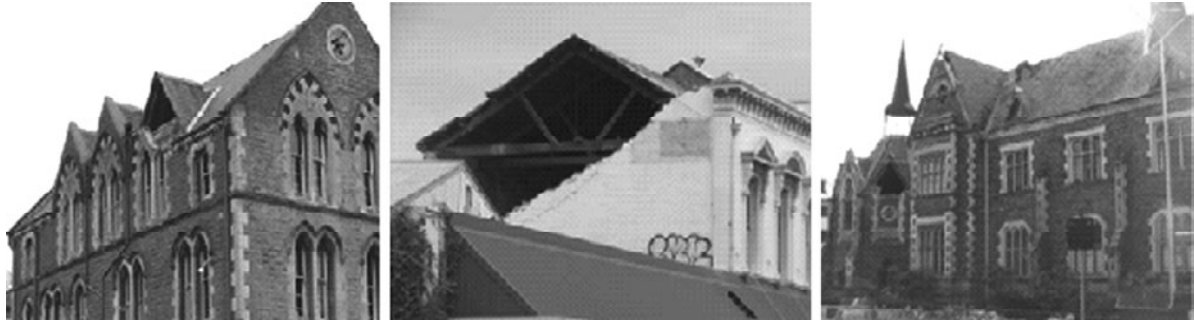
**Damage to gable end walls, see Figure (3):** Although gable walls are known to be the weakest component in *URM* buildings [7], they were intact in many *URM* buildings. In some cases the gable walls were still in their place but in a severely damaged state with several cracks. It was unlikely that these gable walls were taking vertical loads in addition to their self weights. In several *URM* buildings, a part of the gable walls had collapsed, often onto an adjacent building.

Figure 3. Typical damage to gable walls in the September 2010 earthquake.

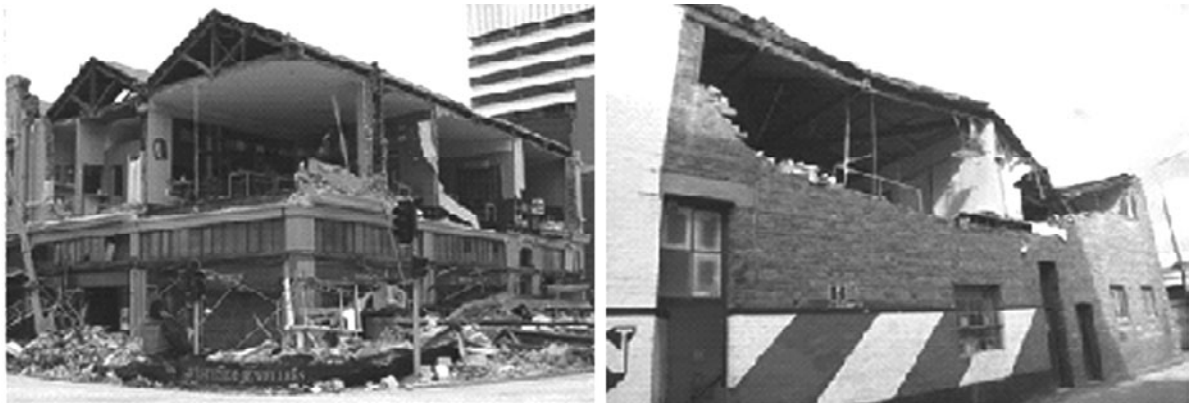
**Out-of-plane failure of solid walls, see Figure (4):** Out-of-plane failure of masonry walls

Figure 4. Typical out of plane failure of solid masonry walls in the September 2010 earthquake.

was one of the most common sights in the media following the September earthquake. In some cases, masonry walls collapsed even when they were apparently not taking any vertical loads except the self-weight (obvious from the fact that the roof structure was intact despite the collapsed walls). The main reason for out-of-plane failure of solid *URM* walls was the lack of adequate anchorage of the wall with the diaphragm. Alternately, if short masonry walls constructed with good mortar are tied firmly to the return walls at the ends, they could have satisfactory out-of-plane performance, but strong return wall connections were also missing in most cases.

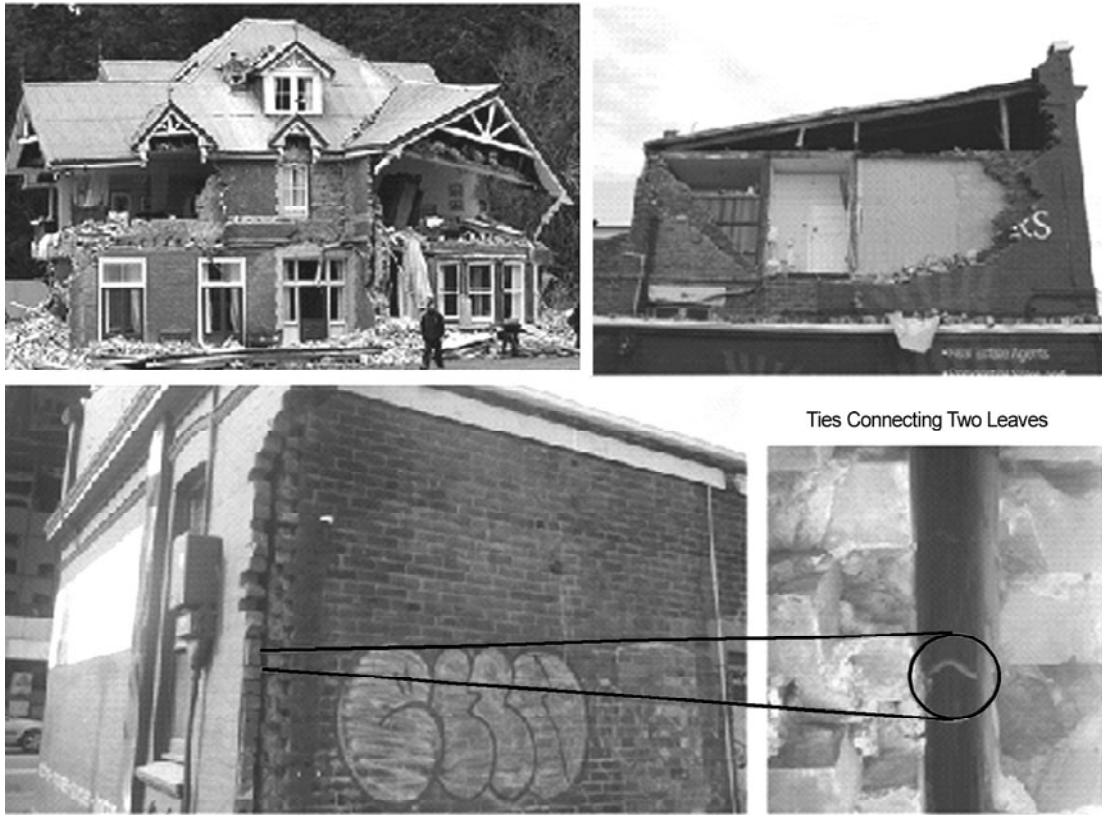
**Failure of cavity walls, see Figure (5):** Cavity walls are not as common as solid or multi-wythe walls in *URM* buildings in Christchurch. In a few cases where cavity walls were present, the ties connecting the two leaves were found inadequately detailed or corroded. For example, in the photo shown in Figure (5), the cavity ties were made of thin steel wires embedded in the two leaves without any end hooks. It was very unlikely that the tie had any noticeable ability to resist the separating tendency

of the two leaves. In such cases, it is no surprise that the front leaf collapsed in out-of-plane direction. In several cases, even the inner leaf failed because after the collapse of outer leaf, the slender inner leaf was unable to resist the vertical load imposed on it.

Figure 5. Typical failure of cavity walls in the September 2010 earthquake.

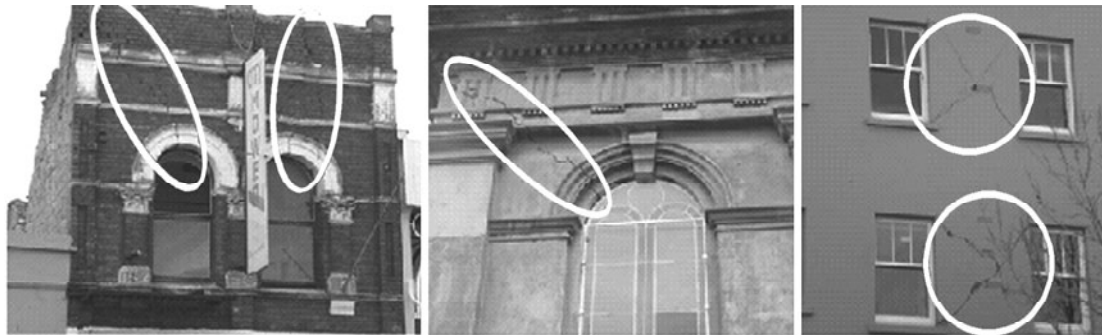
**In-plane damage to masonry walls, see Figure (6):** Diagonal in-plane cracks were visible in most *URM* walls. In infill masonry buildings too, diagonal cracks were present in the infill panels and *URM* piers between doors/windows. Diagonal cracks in *URM* walls typically started from a top corner of the wall and terminated at a window/door corner (or the apex where an arch existed above a window or door). In some walls, vertical cracks were also noticed, see Figure (6). In brick masonry, the cracks travelled in a stair-like path through the mortar joints. On-site inspection of the mortar used in some of the collapsed *URM* building was conducted, and the mortar could easily be crumbled by fingers; suggesting that the mortar had a low strength.

Figure 6. Typical in-plane failure of masonry walls in the September 2010 earthquake.

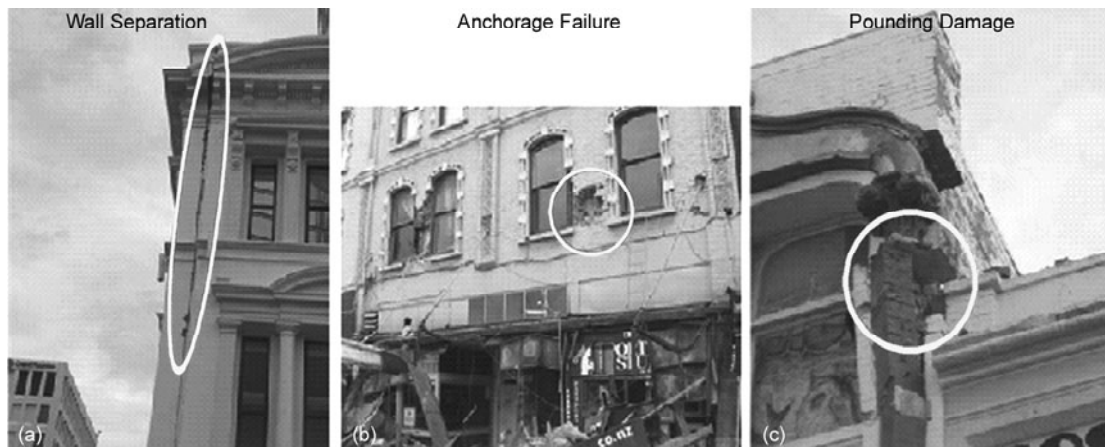
**Other types of damage, see Figure (7):** *URM* buildings also suffered other types of damage such as separation of return walls, anchorage failure,

Figure 7. a) Separation of return walls; b) Anchorage failure of masonry wall; c) Pounding damage observed in the September 2010 earthquake.

pounding damage. In some buildings, the connection between orthogonal walls at the corner opened up, making the walls (or their parts) vulnerable to out-of-plane collapse. In several buildings, the ties supporting canopies were anchored to the walls, and the anchors suffered punching failure [8]. In some cases where buildings were in a row without any gap in between; the out-of-phase response of two adjacent buildings caused the buildings to hit against each other; thereby inducing pounding damage. Despite the presence of several pounding prone buildings, the extent of pounding damage in September earthquake was not very high [9].

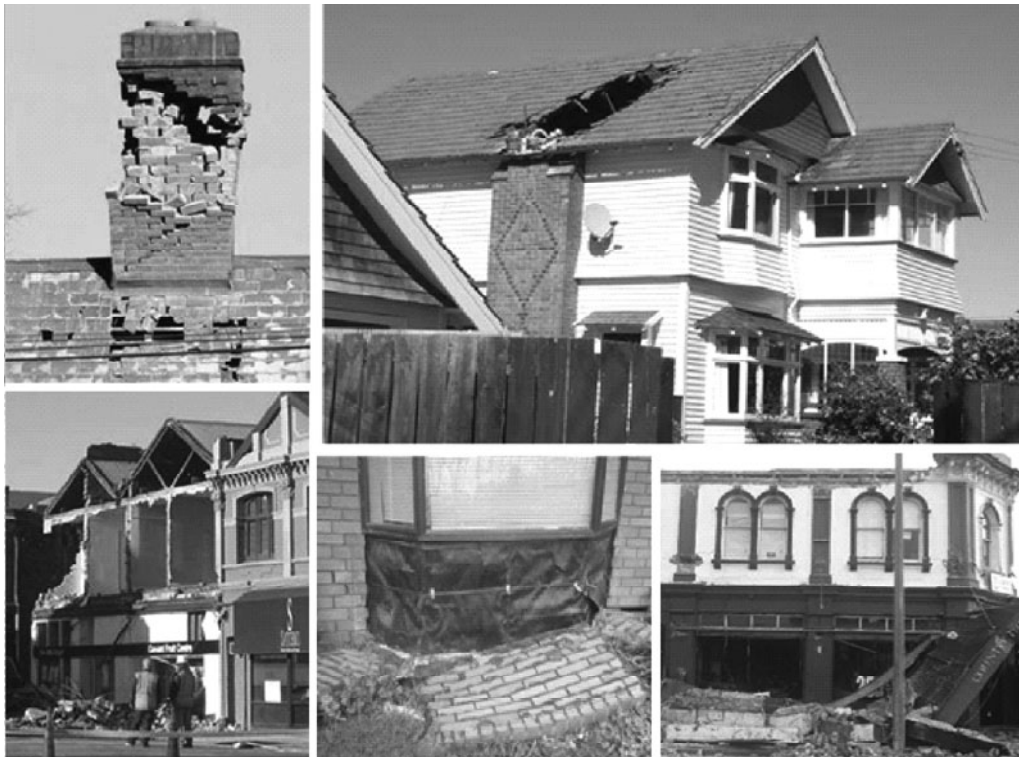
**Damage to secondary URM elements, see Figure (8):** In URM buildings as well as other types of old buildings; secondary elements such as chimneys, parapets, facades, infill, partitions made of URM are not uncommon. More than half of the brick chimneys in Christchurch were reported to be damaged and/or collapsed [8]. Similarly, severely damaged and collapsed brick parapets and facades were common sights in Christchurch buildings. In many cases, blocks of collapsed brick masonry components fell off other components as they fell. A significant risk was posed by these collapsed URM elements to the buildings, people and vehicles in the vicinity [10].

**Figure 8.** Failure of brick masonry chimneys, facades, walls and parapets observed in the September 2010 earthquake.

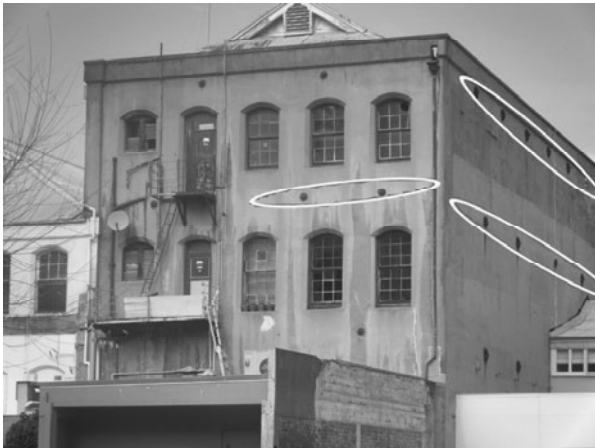
was based on subjective judgement rather than on quantitative design calculations. However, as the level of shaking was not very demanding, especially for this type of short period buildings, even inadequately anchored walls were not fully tested. In general, apart from a few cases (describe later) these anchors were successful in avoiding out of plane failure of the anchored walls.

**Figure 9.** URM building with walls anchored to the floor/roof via a grid of bolted anchor ties.

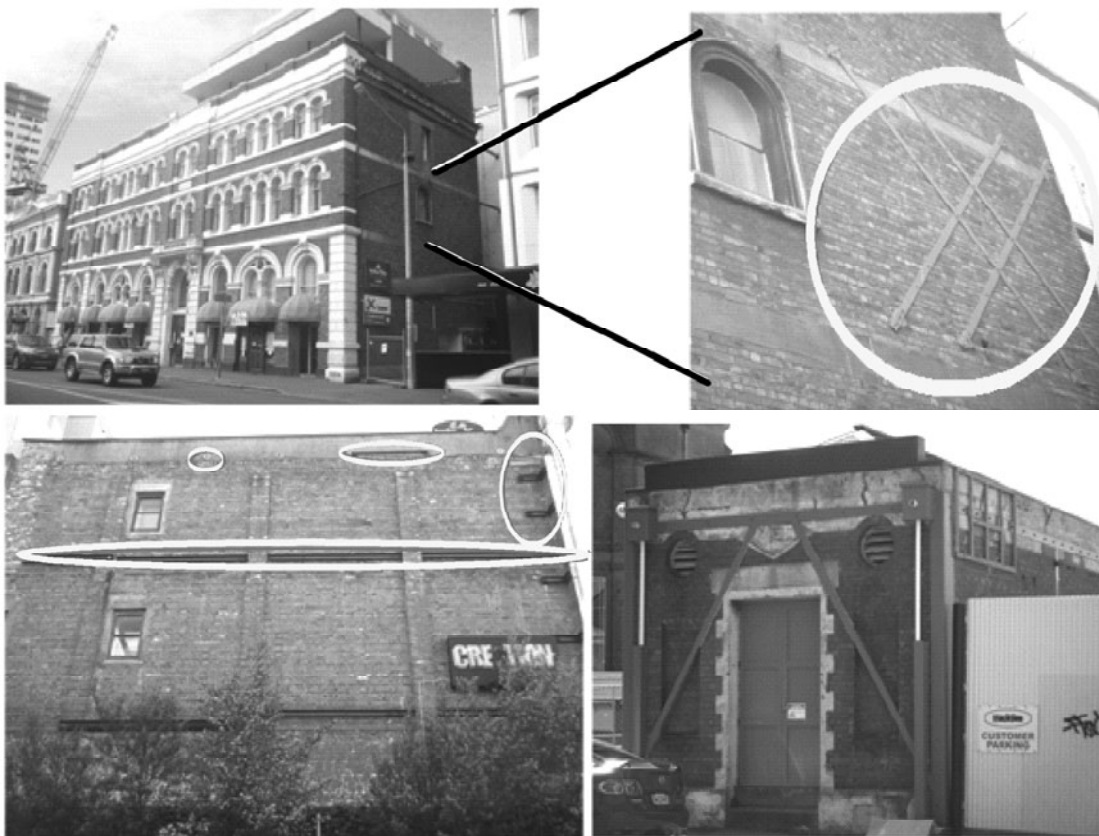
a 3-storey brick masonry building in which a side wall is retrofitted using bolted cross steel plates across the second storey, a three-storey *URM* building where steel tie beams are used to anchor a side wall with the floor and steel angles are used to tie the orthogonal return walls, and a single-storey brick masonry Power Station building heavily strengthened using a combination of steel braced frame and ties. All these buildings (especially the retrofitted walls) performed very well.

**Figure 10.** URM buildings retrofitted using different combinations of steel plates/ties/frames/angles.

damage noticeable from outside. The one-storey *URM* Powerhouse building in Madras Street, see Figure (10), which was retrofitted using steel braced frame on the front wall and a combination of steel tie beams on the side walls, was intact. The three-storey *URM* building in Gloucester Street which had steel cross plates bolted on the side walls, see Figure (10), also withstood the February earthquake with minor damage.

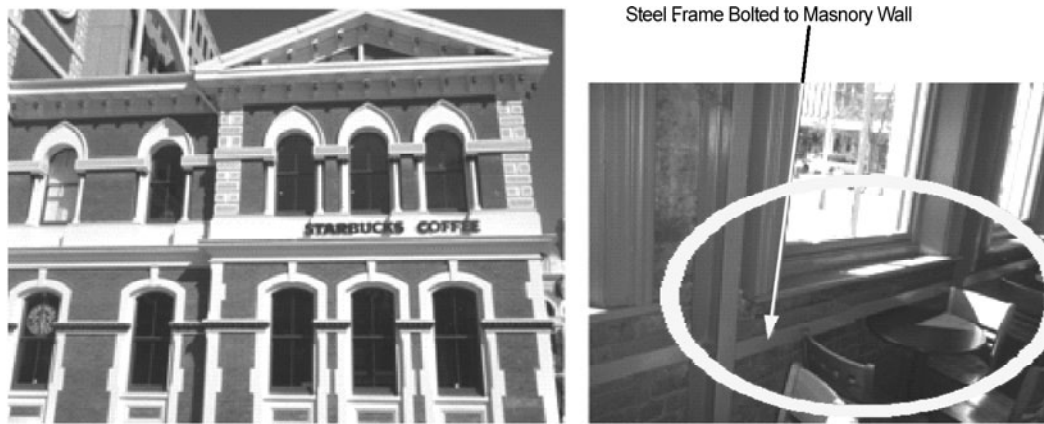
In one case, a 100-year-old *URM* building was found to be retrofitted by a steel frame inside the building (not visible from outside) bolted to the brick masonry wall, see Figure (11). The building did not suffer any noticeable damage. This building was checked again after the February earthquake, and it was found to have weathered the February earthquake also very well.

Figure 11. URM building at Cathedral Square retrofitted by steel frame bolted to the masonry wall.

As the ground shaking was more intense than what the modern buildings are designed for, even systematically retrofitted *URM* buildings suffered damage in the February earthquake. *URM* buildings which had retrofit measures other than the traditional wall anchors did well. Retrofitted by an internal steel frame, the two-storey *URM* building in Cathedral Square, see Figure (11), did not have any

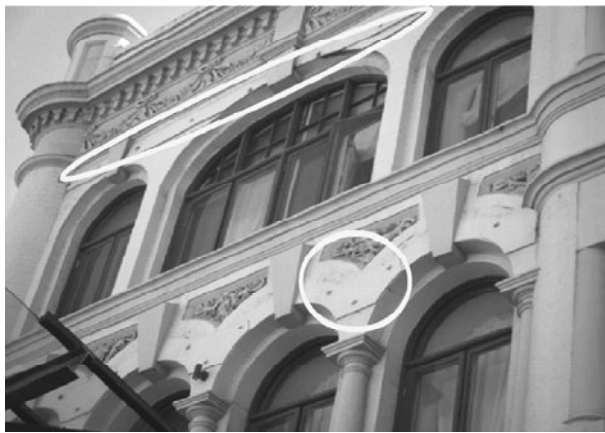
In some buildings, steel plates were bolted to the wall; mainly above the arched windows, see Figure (12). These plates seemed to have worked well because no in-plane cracks were seen in these walls. The author noticed that in other similar buildings without the plates, the walls had suffered in-plane damage in the form of diagonal cracks starting from

Figure 12. In-plane strengthening of masonry wall using bolted steel plates.

the corner of the wall to the window arches, see Figure (6). In this case, the plates seem to have effectively arrested the weak shear plane.

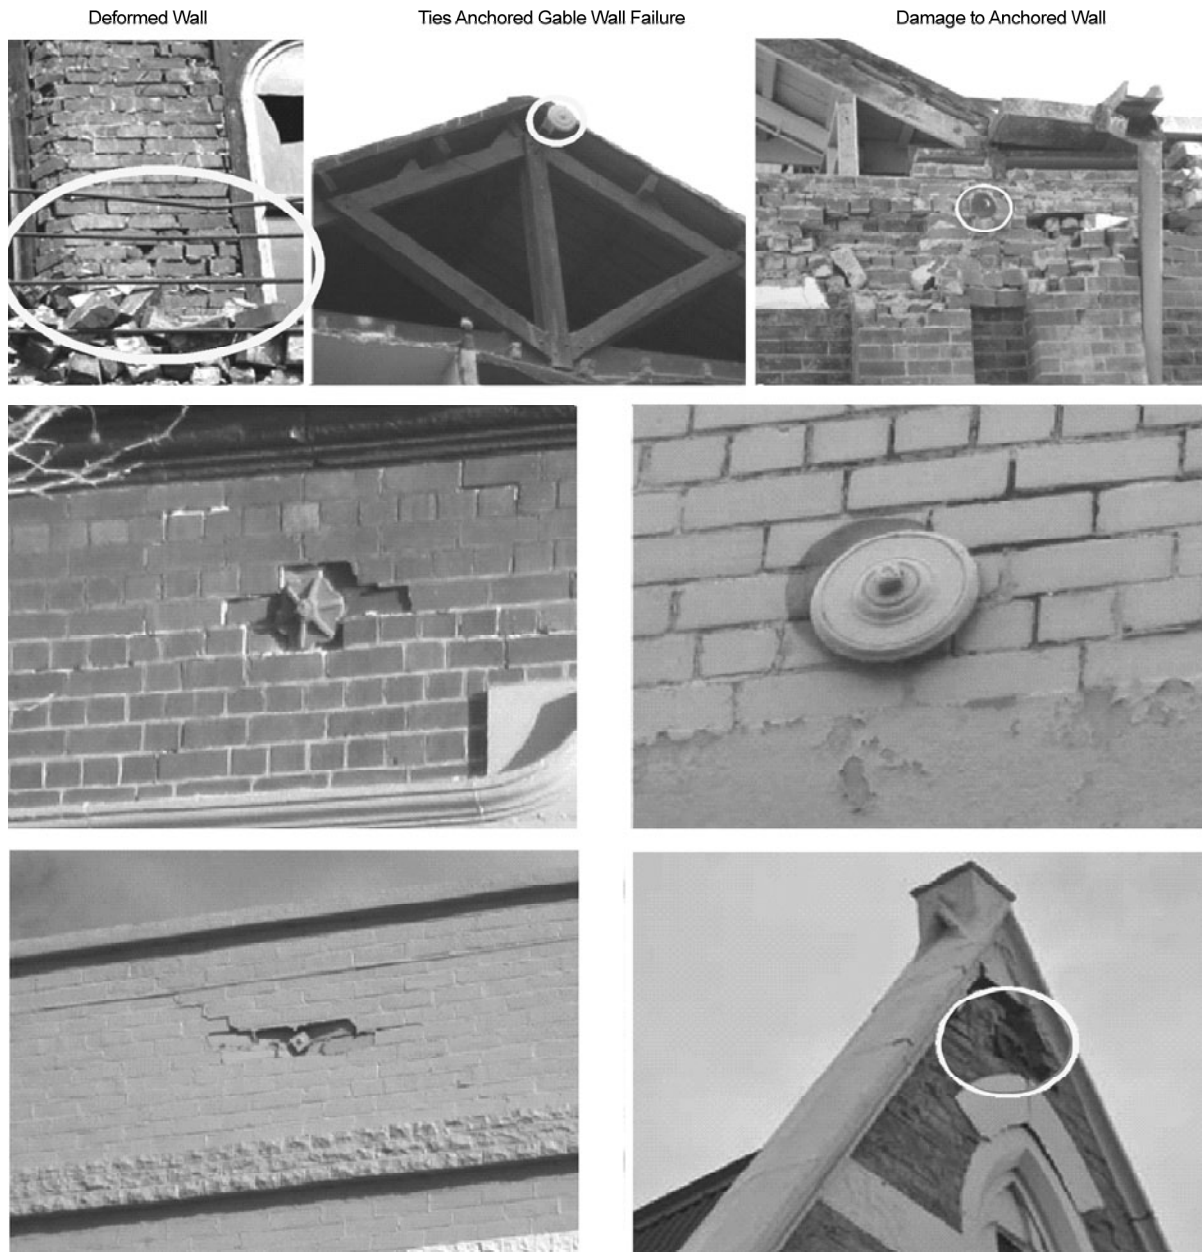
Although retrofitted structures in general performed very well in the September earthquake, some buildings which had some form of retrofitting suffered some damage. These damages could be mainly attributed to two reasons. The first is insufficient anchors between the walls and the floor/roof. As shown in Figure (13) (top row), inadequate number and size of anchors could not hold the walls (including gable ends), and could not stop them from damaging. The second type of damage observed in retrofitted URM buildings was related to the failure of anchorage. As shown in Figure (13) (middle and bottom rows), the anchor plates punched through the wall in several buildings; and in some cases the anchor plates moved. A proper design using a better estimate of the likely force could have resulted in a larger anchor plate which could have avoided these punching failures.

Figure 13. Typical damage to anchored walls observed in the September 2010 earthquake.

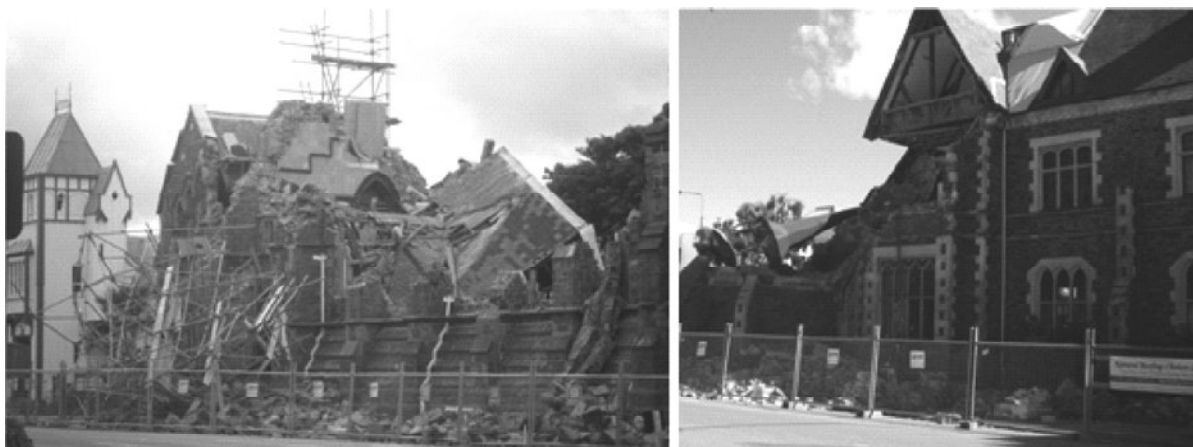
Figure 14. Collapse of URM buildings in the February 2011 earthquake.

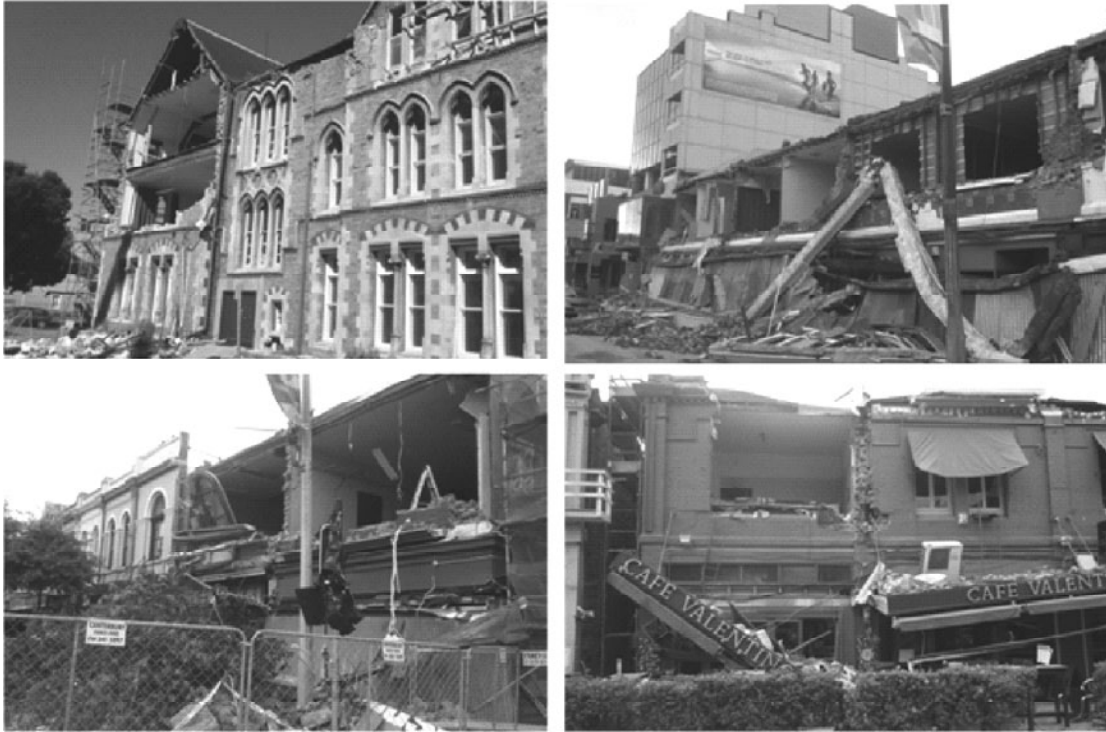
Figure 15. Out-of-plane failure of URM walls observed in the February 2011 earthquake.

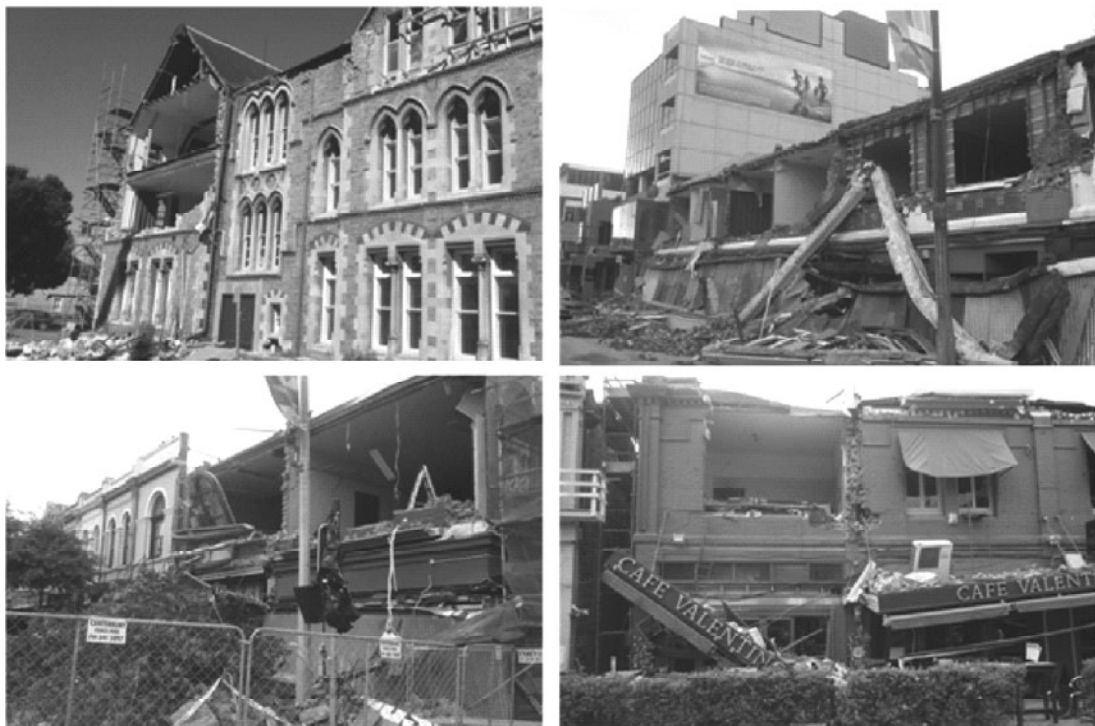
Figure 16. Failure of gable walls and parapets observed in the February 2011 earthquake.

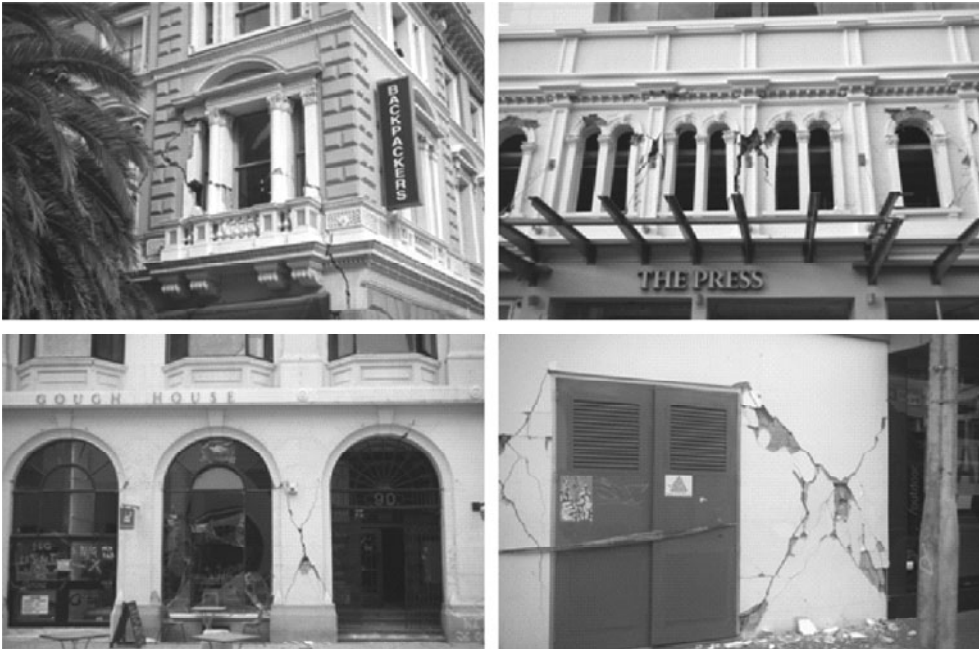
**Figure 17.** In-plane damage to walls/piers/columns/arches observed in the February 2011 earthquake.

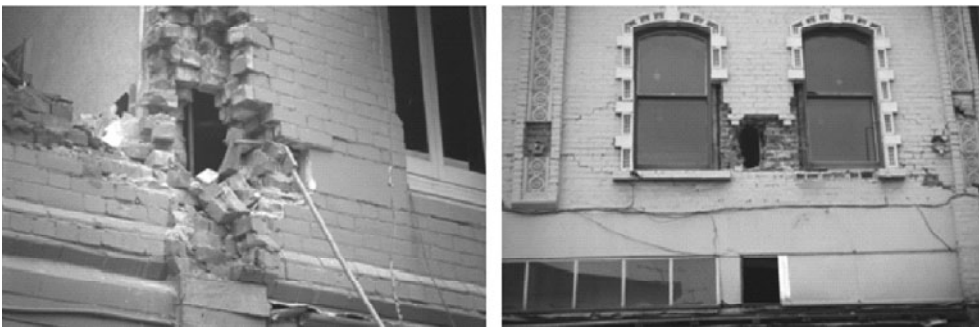
**Figure 18.** Punching failure of masonry walls due to inadequate anchorage (February 2011 earthquake).

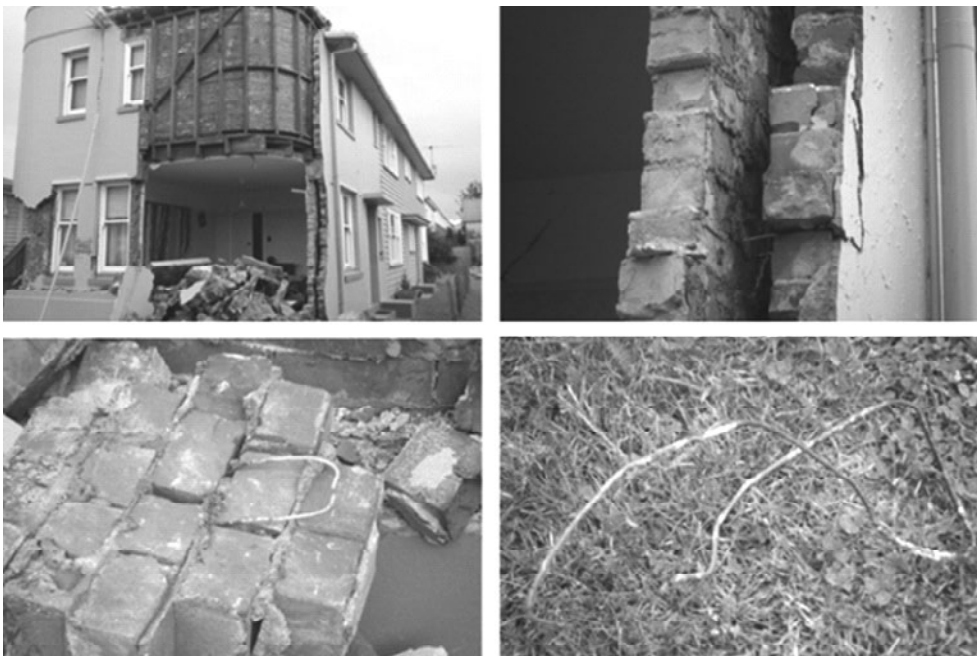
damage to in-plane masonry walls/columns/piers arches, see Figure (17); anchorage failure, see Figure (18); and cavity wall failure due to inadequate interleaf tie, see Figure (19). In most buildings, more than one form of the aforementioned damages occurred.

**Figure 19.** Failure of cavity walls due to inadequate ties (February 2011 earthquake).

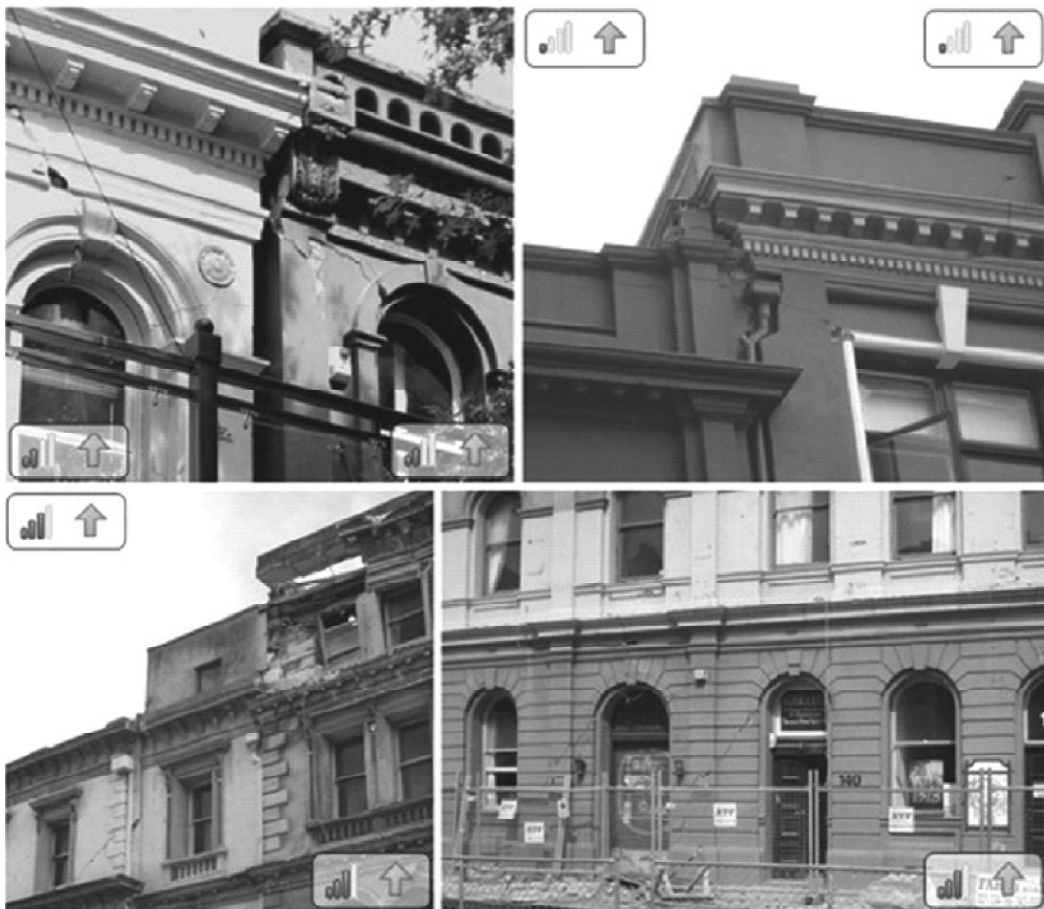
A form of building damage that was significantly more pronounced in the February earthquake compared to the September earthquake was building pounding damages [11]. During a rapid pounding survey conducted within the *CBD* after the earthquake, about 120 buildings were identified to have suffered damages of different extent due to pounding with the adjacent building. This is more than a quarter of the total buildings surveyed; pounding damage of this extent is unheard of in previous earthquakes. Some typical building pounding damages are shown in Figure (20).

Figure 20. Building pounding damage observed in the February 2011 earthquake (Photos: Greg Cole).

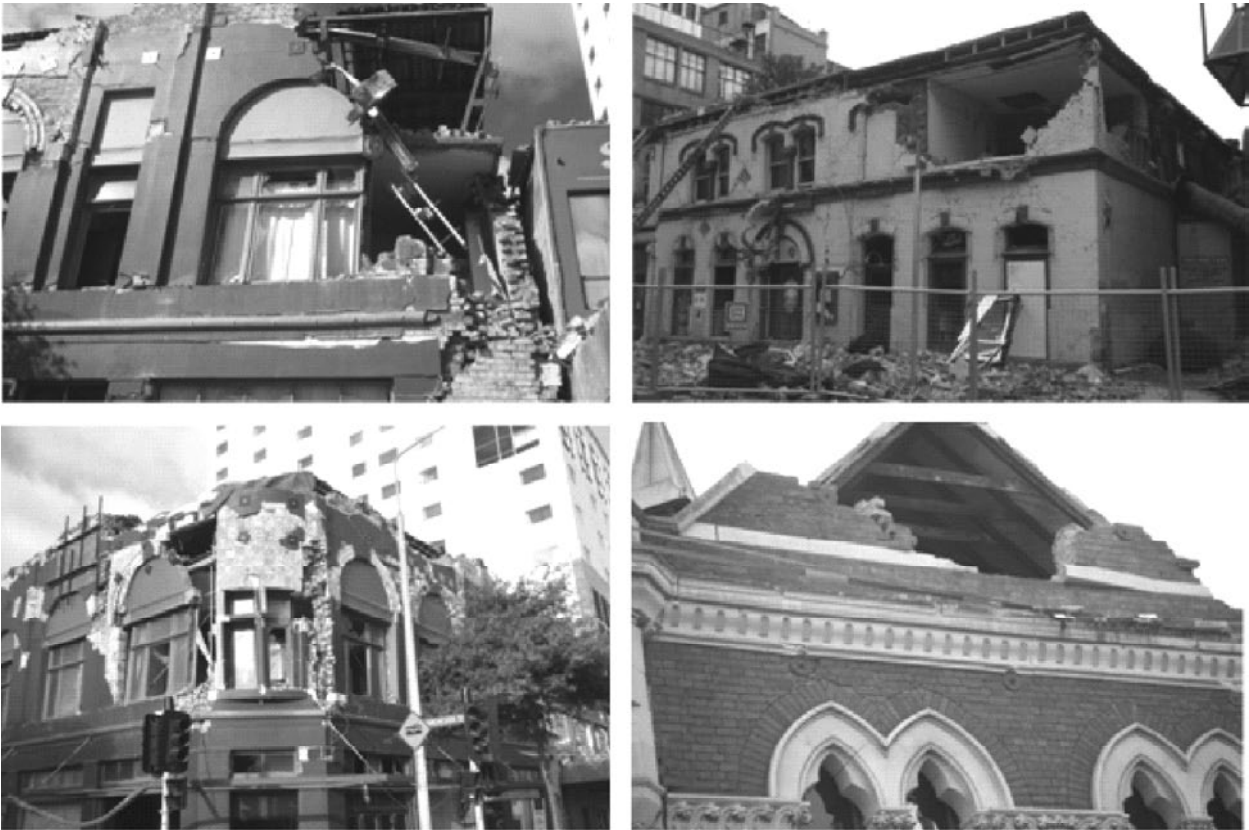
On the other hand, several buildings which had walls (in one or both directions) anchored to the floor suffered damage of different extent. One of the lessons taught by this earthquake is that we should not be fooling ourselves that so-called retrofit solutions, which tie into one or two bricks, will work. There were several *URM* buildings in Christchurch which had used some anchors to tie the wall with the floor. However, looking at the size, number and spacing of the anchors a question on its effectiveness would immediately come to the mind. Some inadequately anchored walls, which expectedly suffered damage, are shown in Figure (21). In some buildings, the anchors were of very thin size, in

**Figure 21.** Performance of inadequately anchored masonry walls in the February 2011 earthquake.

some others a number of anchors were concentrated in a small region and other parts of the wall were left unanchored; in some buildings the anchors were too far apart; in some the anchors were provided only at one level, and a number of buildings had only the side walls anchored. Obviously, in a strong shaking, these solutions will not be able to securely hold of all portions of the perimeter masonry walls, gable walls and the parapet in place. Unsurprisingly, the walls of such buildings suffered partial or complete out-of-plane collapse.

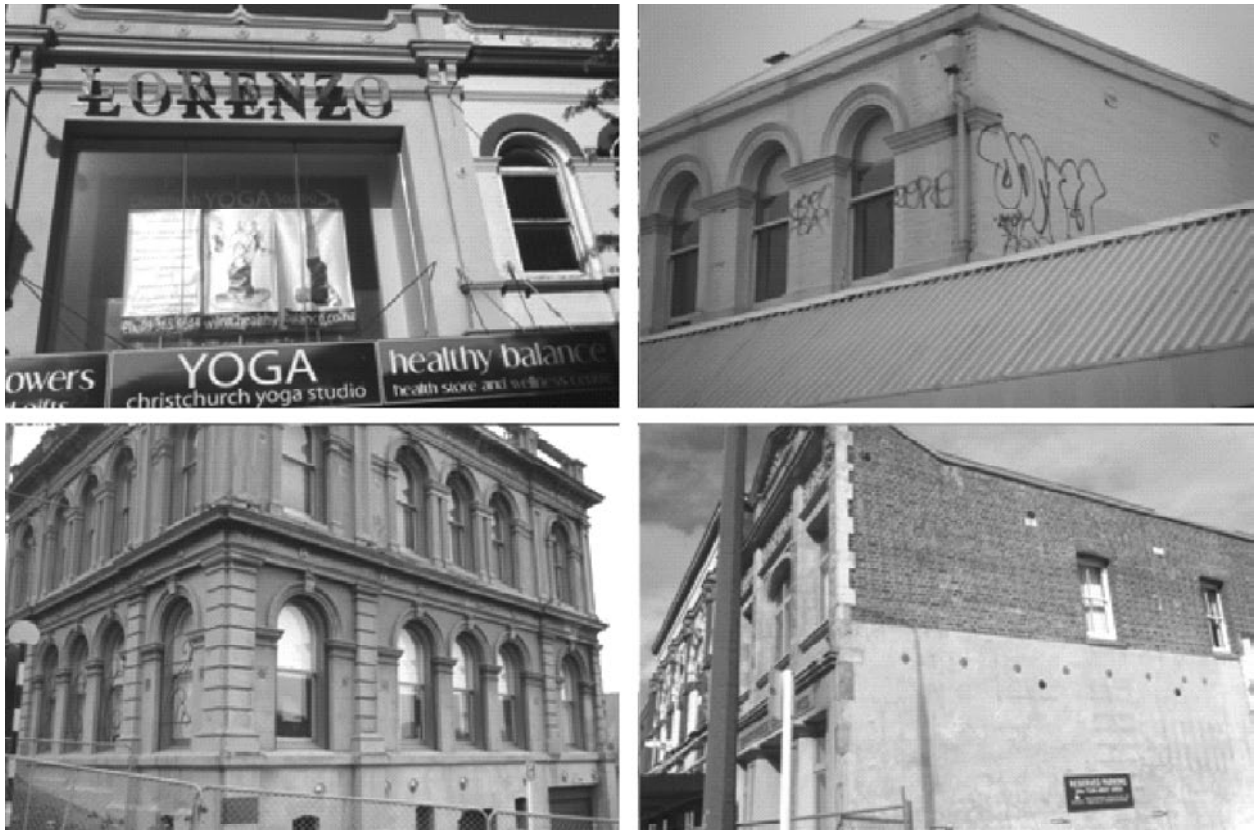
In many *URM* buildings in which the perimeter walls had an extensive grid of two-dimensional anchors, the performance was very good. Some such buildings are shown in Figure (22). In a very few buildings, the visible damage was almost non-existent despite the external walls not showing a very efficient anchorage system. The author suspects that these buildings may have some other form of retrofitting in addition to the sporadic wall anchors visible from outside.

Figure 22. Good performance of some URM buildings with anchored perimeter walls in the February 2011 earthquake.

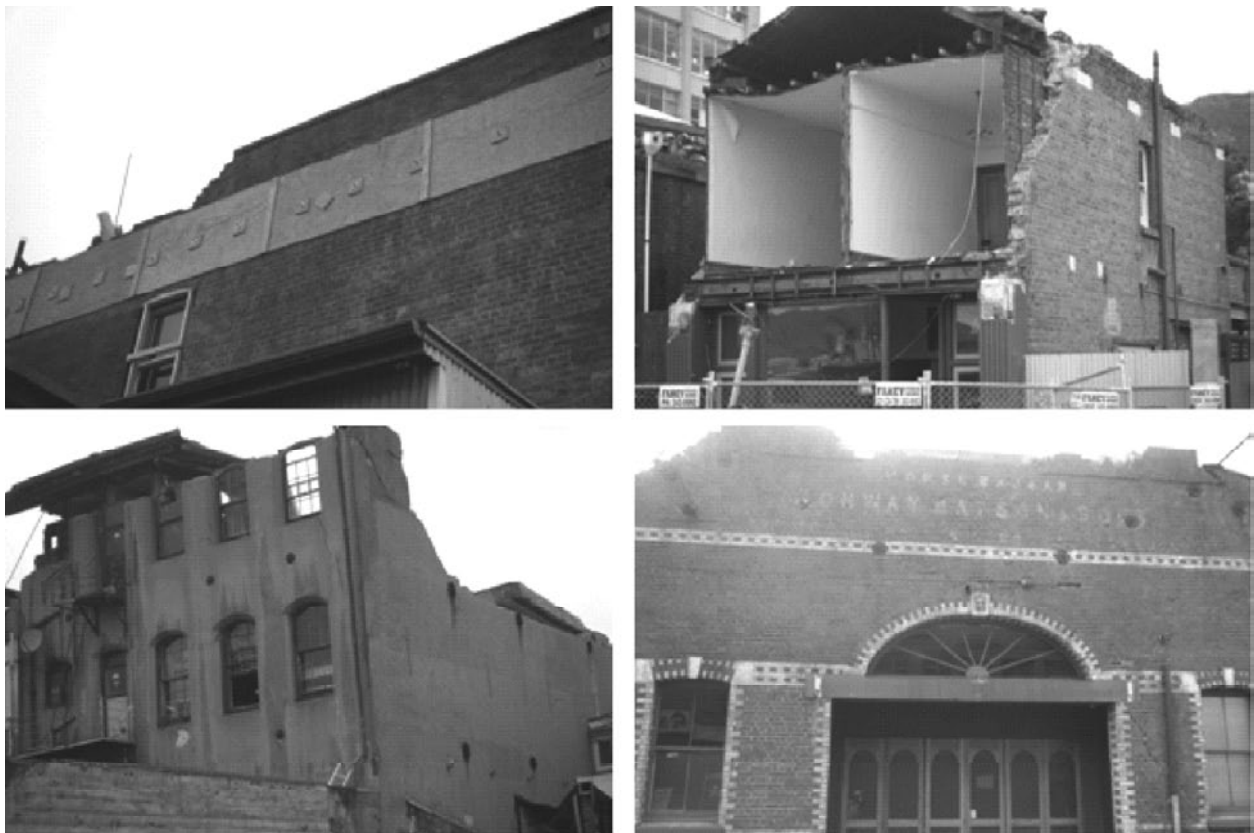
Several *URM* buildings, despite having a reasonable anchorage system, suffered significant damage. Some such cases are shown in Figure (23). In

some buildings, although the anchors seemed to be of good size and well distributed throughout the length and height of the building, parts of the perimeter walls still suffered out of plane failure. In some cases, the part of gable wall above the line of highest anchor bolts collapsed; probably, this could have been avoided by providing one or more anchors close to the apex. In some buildings, the anchors were sufficiently provided in the side walls but very few and sporadic in the front wall; which resulted in the out-of-plane failure of the front wall. As the anchor bolts are aesthetically less appealing, in deciding the retrofit system it is normally the tendency to use as few anchors/plates as possible in the front wall. The February earthquake exposed the inherent deficiency of such retrofit solutions used in several *URM* buildings in *NZ*.

Figure 23. Damage to systematically anchored masonry walls in the February 2011 earthquake.
