Preliminary Assessment of the Operational Dam's Performance in November 12, 2017 Sarpol-e Zahab Earthquake

Sarpol-e Zahab earthquake;
Tange-Hamam Dam;
Instrumentation data;
Dam settlement

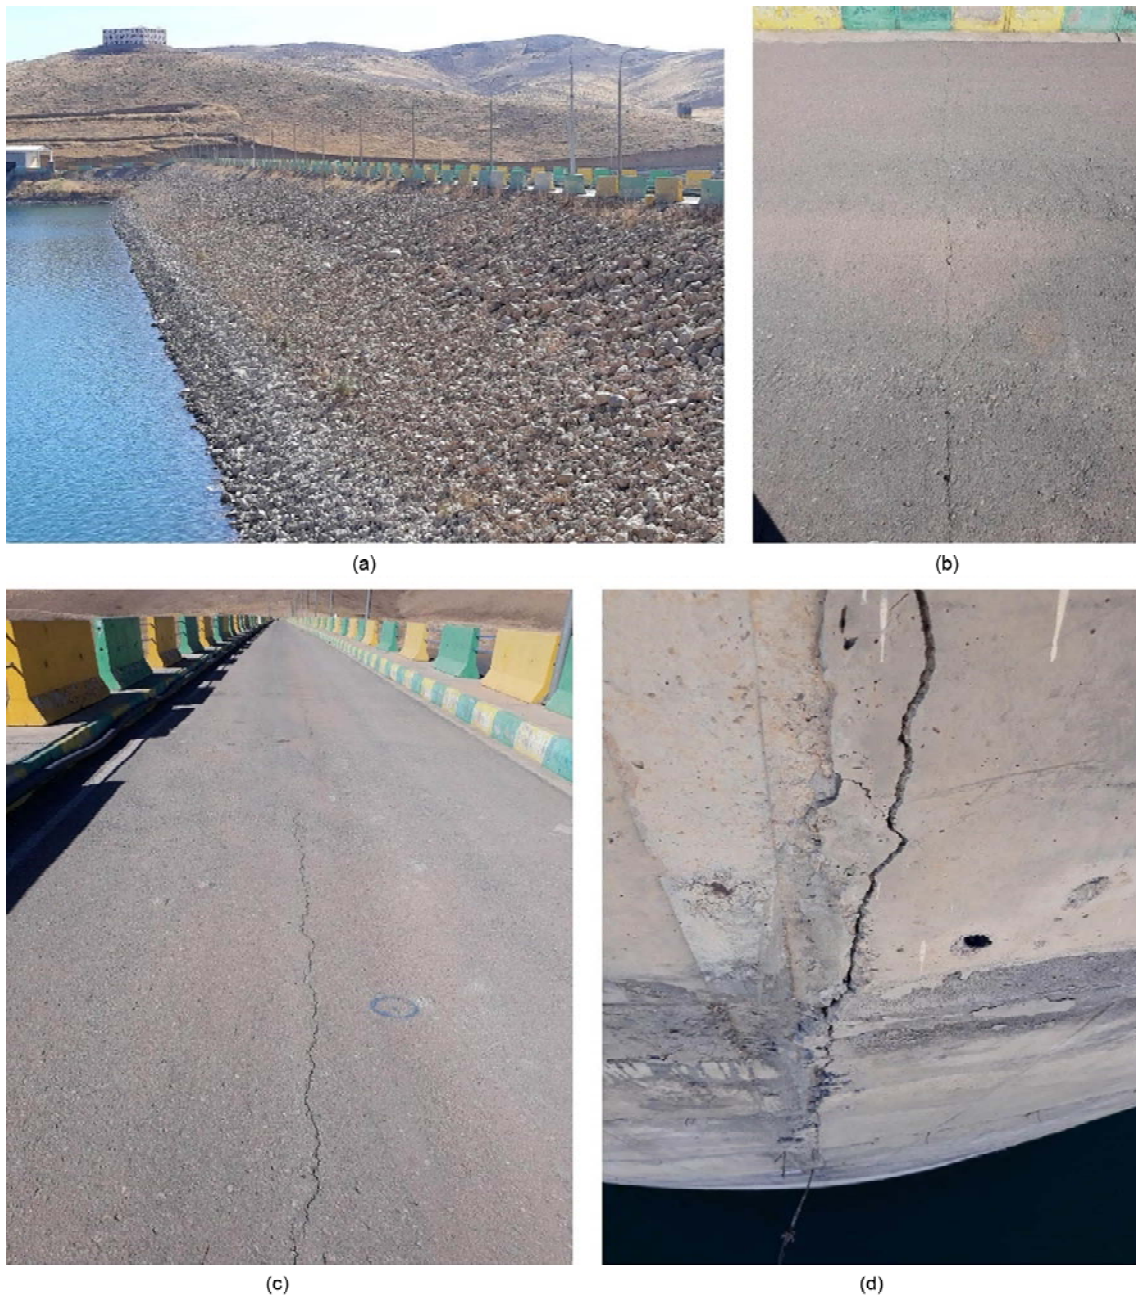
Dam, visual inspections were carried out on the site. Observations revealed the occurrence of cracks with very small openings on the crest of the dam and also an upright crack in the concrete body of the spillway's left guide wall. Figure (4) shows the images of the mentioned cracks on the crest of the dam. Initial opening of the cracks in different locations of its length has been inspected and marked by nailing for post-earthquake monitoring. Further monitoring and inspection have been placed on the agenda that shows the stagnation and lack of growth in cracks.

Figure 4. Images of observed cracks in Tange-Hamam Dam, (a) General view of the dam after the earthquake, (b) very small tiny transversal crack on the crest, (c) Longitudinal Crack on the crest, and (d) Crack and separation on the concrete at a joint place of the left wall of the spillway.

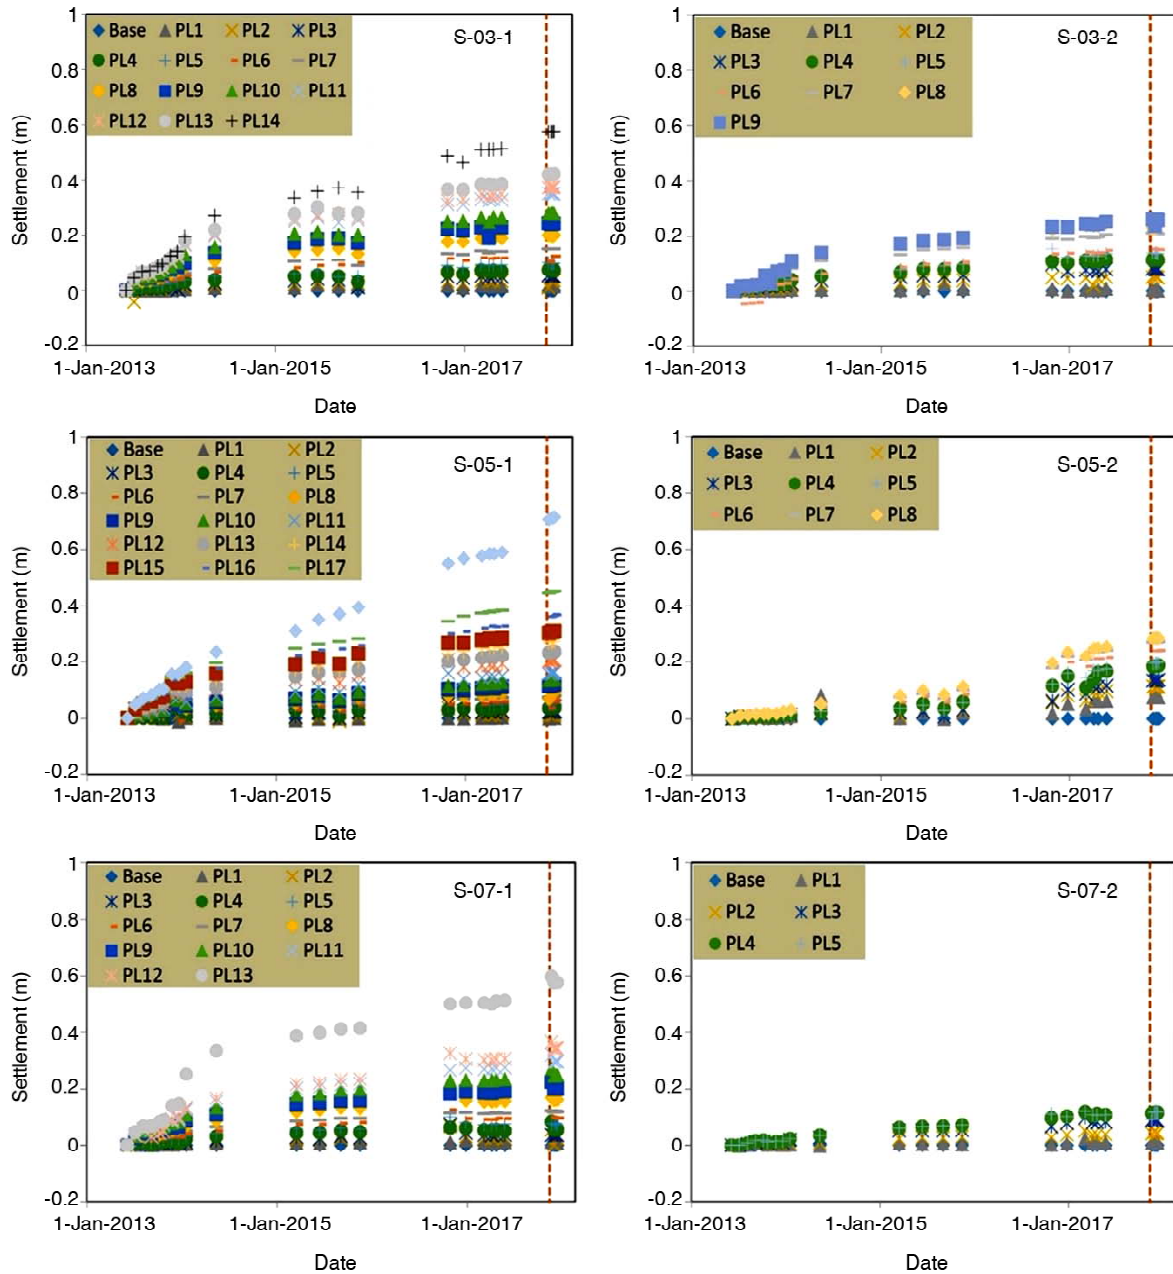
Figure (7) shows the amount of the settlement against time for every measuring plate of settlement. Plates numbering is from embankment depth to the ground surface. The graphs also show the date of the recent Sarpol-e Zahab earthquake event. As can be seen, the settlement rate in the initial period after the completion of the dam construction was significant, but gradually the settlement rate has been reduced. After about five years from the completion of the dam construction, the settlement rate was about zero and the amount of the calculated settlement in several readings before the earthquake event show approximately the same constant values. The largest amount of settlement occurred in the period between the completion of the dam and before the recent earthquake, was 58 centimeters in the middle section of the dam and in the plate located close to the crest.

After Sarpol-e Zahab earthquake occurrence, four settlement reading sessions have been performed in a week intervals. Although first reading after the earthquake is thoroughly different in comparison with earlier readings before the earthquake, the subsequent readings in the dam's body stayed relatively constant. The largest amount of settlement could be followed in the S-05-1 settlement measuring pipe, which is the only measurement that shows a small increasing trend in settlement readings and so needs to monitor its behavior in later sessions. Table (3) shows the relative settlement of the measuring plates close to the

Figure 7. Settlement of the dam's body after the completion of the construction.

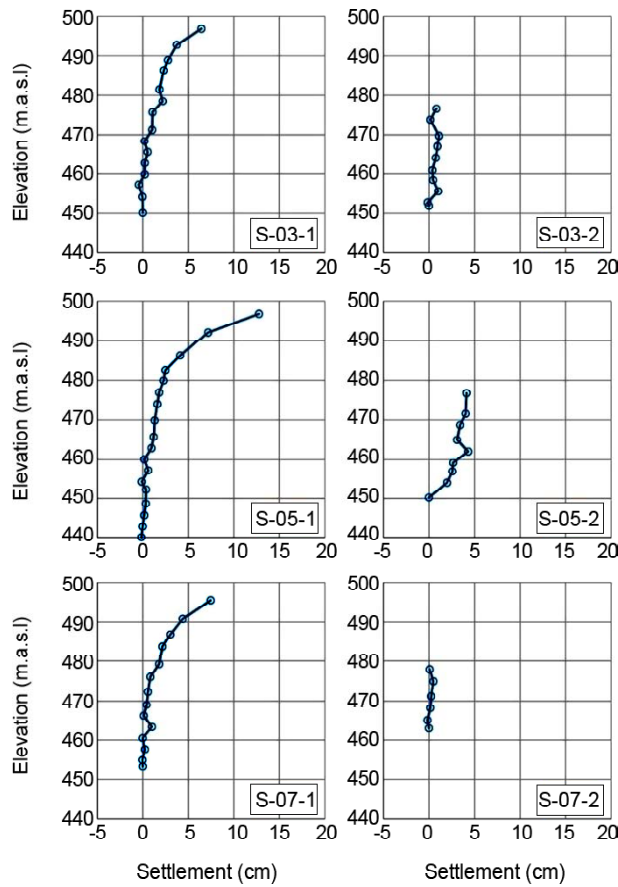
Figure (8) contains the earthquake-related settlement values in terms of the level of the monitoring point. As it can be seen, the settlement in lower third of the dam, especially in the core

gauges is negligible and the highest amount of settlement occurs in upper third of the dam body in a way that at S-05-1, about 3 cm of total 13 cm occurred in the bottom two-thirds of the dam body and 10 cm occurred in upper third part. There is also a similar situation in S-03-1 and S-07-1 so that among the total settlement of 6 and 7 cm, respectively, less than 2 cm occurred in bottom two-thirds and the rest is related to the upper third part. The settlement gauges located on the sides of the shell, downstream of the dam, has negligible quantities and just the settlement gauge, which located in the middle section shows near 4 cm settlement close to the surface. At this point, unlike

Figure 8. Earthquake-related settlement in different levels of the dam's body.

other gauges of the central core, settlement distribution in the body height is more uniform.

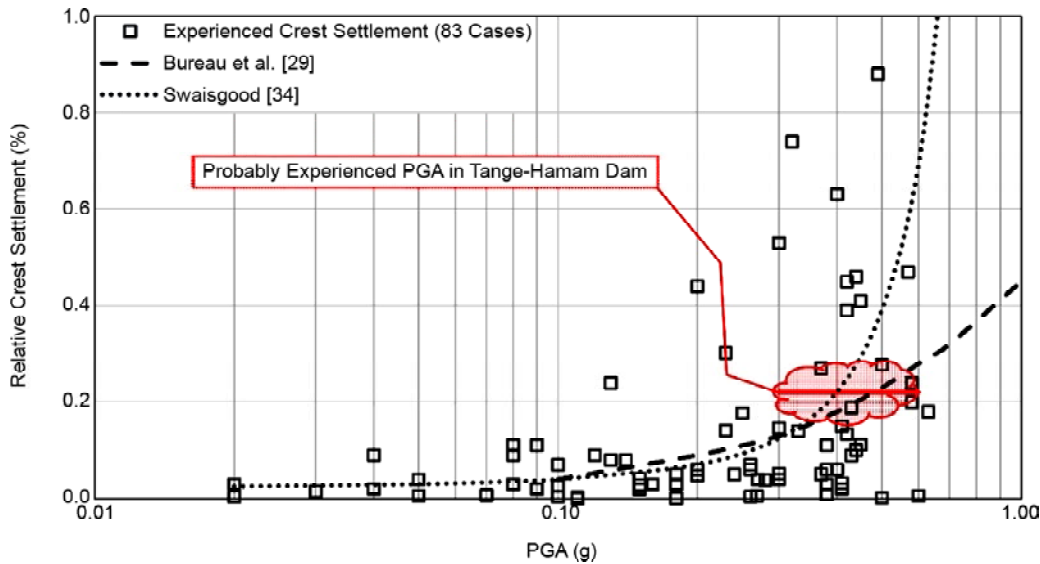
Figure 10. Comparison of settlement in Tange-Hamam Dam with world data and empirical relationships for an earthquake with $M=7.3$.

Considering the peak ground acceleration of at least 0.3-0.6 g as the incident acceleration in the Tange-Hamam Dam site during the recent earthquake, the measured amount of earthquake-related settlement has been assessed and compared to the predicted values. The considered acceleration would not be unrealistic according to the acceleration of 0.68 g, which was recorded in Sarpol-e Zahab city [33] during the earthquake. Figure (10) shows the values of the earthquake-related settlement experienced in 83 embankment dams caused by 39 earthquakes since 1920 [34]. Besides, in the figure the earthquake-related settlement of Tange-Hamam Dam along with the predicted values of settlement, based on the empirical relationships of Bureau et al. [29], and Swaisgood [28] for an earthquake with the magnitude of 7.3, have been presented. As can be seen, if the peak ground acceleration in the Tange-Hamam Dam site considered as 0.3-0.6 g, the amounts of settlement occurred in the dam is in the range of the predicted values by experimental relationships, and it can be concluded that the Tange-Hamam Dam performance

was acceptable in total.

Particularly, the data which has been showed in Figure (10), contains 36 cases of dams which have experienced the PGA of 0.3 g to 0.6 g as it is expected for Tange-Hamam Dam that about half of them have been faced moderate to major damages during the earthquakes. Among them, The Upper San Fernando earth core rockfill dam, during February 9, 1971, ($M_w = 6.6$) earthquake, experienced the highest amount of settlement, which was 2.11 percent of the dam height due to a 0.55 g PGA. This dam showed a 1.02 percent settlement once more due to 0.42 g PGA of January 17, 1994 earthquake that was noticeable. Besides, Austrian Dam in California, which showed a 1.51 percent settlement due to a 0.57 g PGA during October 17, 1989 ($M_w = 7.1$) earthquake was another case that is worth to note. The Upper San-Fernando dam and Austrian dam constructions are finished in 1920 and 1950, respectively. When the modern construction rules were not still considered in the building of the dams. In conclusion, commitment to modern construction standards, resulted acceptable performance of Tange-Hamam dam during Sarpol-e Zahab ($M_w = 7.3$) earthquake.
