Sarpol-e Zahab Earthquake Damages to Roadway Bridges

ABSTRACT

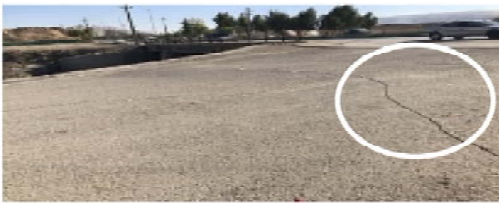
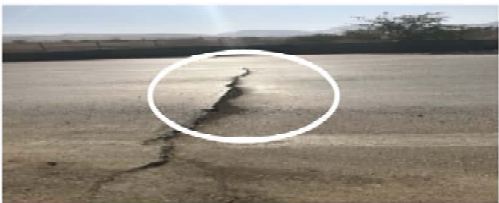
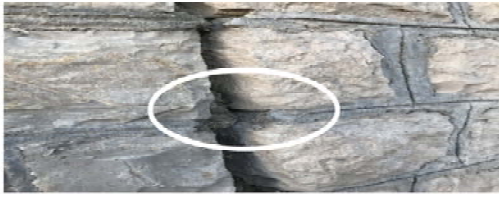
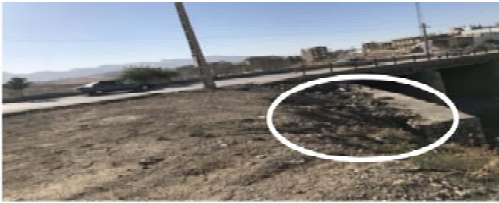
Table 5. Bridge A4B2-13.

Structure Type: Multi Span Simple Concrete Girder	River Intersection: Yes			
Latitude: 34.463518	Longitude: 45.856203			
Material and Structural Specifications				
Deck	Superstructure		Bent	Substructure
	Type: Girder	Width: 8m		Type: Wall
	Material: Concrete	Span Length: 32m		Material: Masonry
	No. of Spans: 3	Span Length : 10m	Abutment	Type: Closed
				Material: Masonry
Damage Comments				
- Damage to the Deck and Large Crack on It (a, c)		Deck: 1		
- Subsidence of the Soil of Abutment (b)		Abutment: 2		
- Separation of Wing Wall (d)		PGA: 0.53g

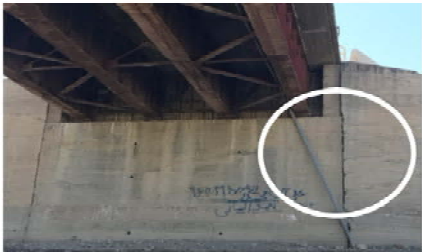
Table 6. Bridge A5B1-17.

Location: Sarpol-e Zahab to Ghasr-e Shirin		 		
Structure Type: Single Span Steel Girder	River Intersection: Yes			
Latitude: 34.775154	Longitude: 45.782817			
Material and Structural Specifications				
Deck	Superstructure		Bent	Substructure
	Type: Girder	Width: 10m		Type: No Column
	Material: Steel	Bridge Length: 30m		
No. of Spans: 1	Span Length: 30m	Abutment	Type: Closed Material: Concrete	
Damage Comments				
- Damage to the Deck and Sidewalk (d)		Deck: 0		PGA: 0.48g
- Damage to the Abutment (a, b)		Abutment: 2		
- Rupture of Soil (c)		Damage level

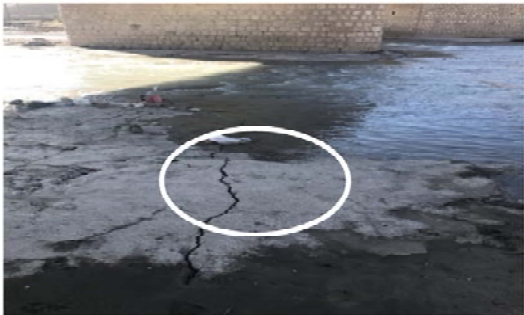
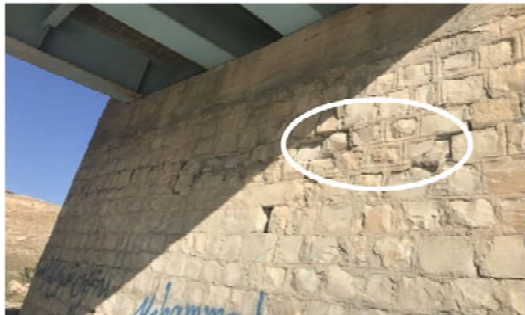
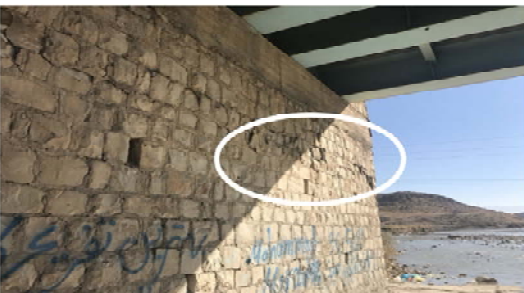
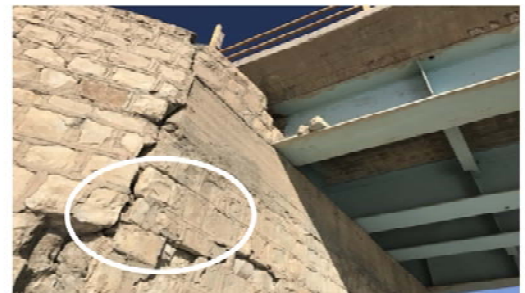
Table 7. Bridge A6B2-27.

Structure Type: Multi Span Steel Girder	River Intersection: Yes			
Latitude: 34.840319	Longitude: 45.901841			
Material and Structural Specifications				
Deck	Superstructure		Substructure	
	Type: Ggirder	Width: 7m	Bent	Type: Wall
	Material: Steel	Span Length : 32m		Material: Masonry
No. of Spans: 2	Span Length : 16m	Abutment	Type: Closed Material: Masonry	
Damage Comments				
- Fault Offset (a)		Damage Level	Deck : 0	PGA: 0.29 g
- Damage and Separation of Abutment (b, c, d)			Abutment : 2
