# Performance of Lifeline Systems in Bam Earthquake of 26 December 2003

**Masoud Moghtaderi-Zadeh<sup>1</sup>, Farrokh Nadim<sup>2</sup>, and Mohammad Javad Bolourchi<sup>3</sup>**

**ABSTRACT:** *At 5:26 am local time, Friday, December 26, 2003, an earthquake with moment magnitude 6.5 hit the city of Bam in southeast Iran. The earthquake caused more than 26,000 deaths, 30,000 injuries, and left 70,000 homeless. It caused extensive damage to residential and commercial buildings and emergency response facilities. In contrast to the inflicted human loss and suffering and extended building damage, lifeline systems, although damaged, performed much better. Transportation systems, i.e., roads, bridges, railways, and the airport, although slightly to moderately damaged, were generally operational soon after the earthquake to support emergency response and recovery effort. There were several breaks in the water distribution systems and minor damage to deep wells. However, the traditional qanat systems, which bring water from foothills tens of kilometers away via underground tunnels, were mostly damaged. The Bam area is served via connection to countrywide electric grid system. There was

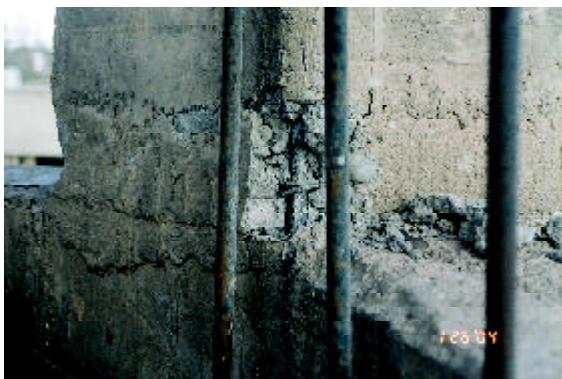
There was report of damage to a number deep wells and also several pipeline breaks throughout the city. Due to collapse of the buildings and breakage of connecting pipes, at users ends, water had to be brought by tanker trucks to the tents and shelters and other users after the earthquake. Overall the storage tanks performed well. Figures (1) shows an elevated concrete water tank, located near the old section of the city close to the earthquake rupture where the damage was high. The tank experienced severe stress and deformation at the column-beam connections.

Figure 1. Elevated concrete water tank located in near the old section of the city where the damage was high. The tank experienced severe stress and deformation at the column-beam connections.

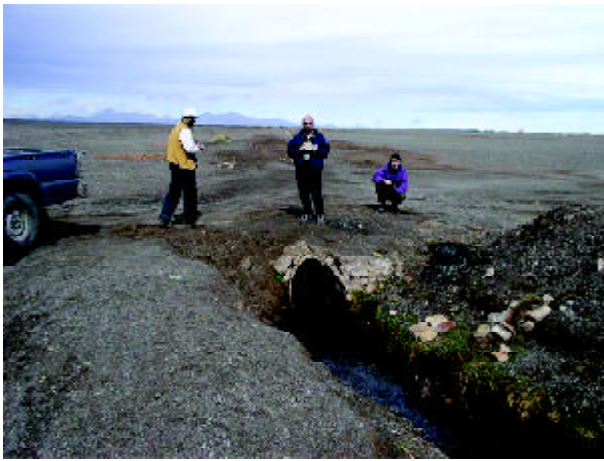
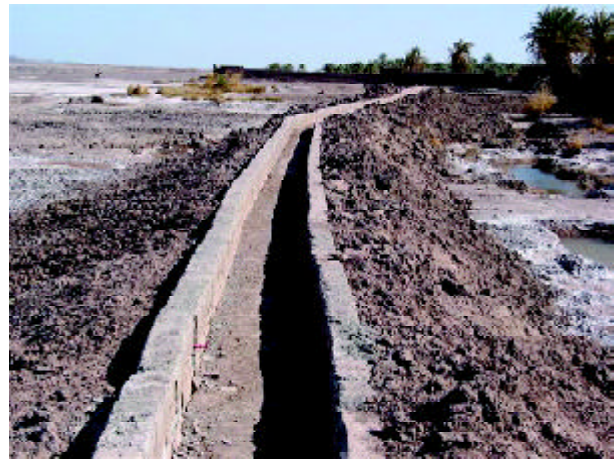
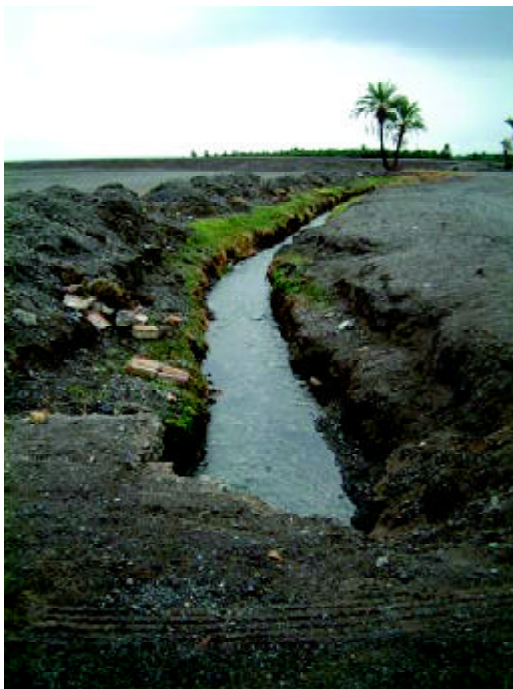
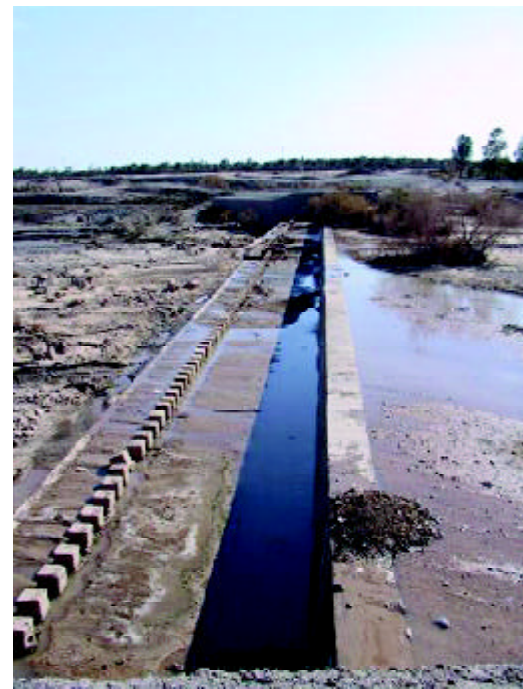
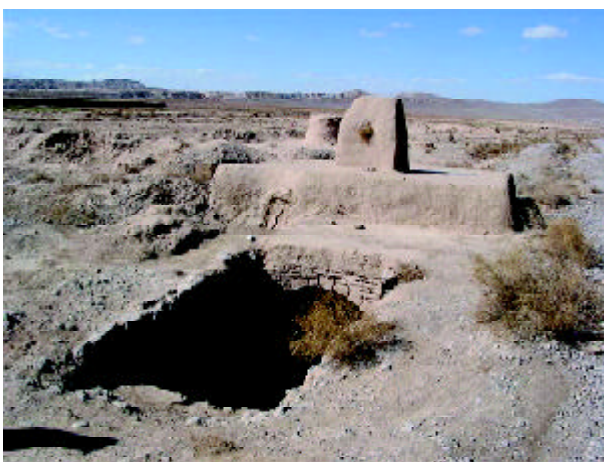
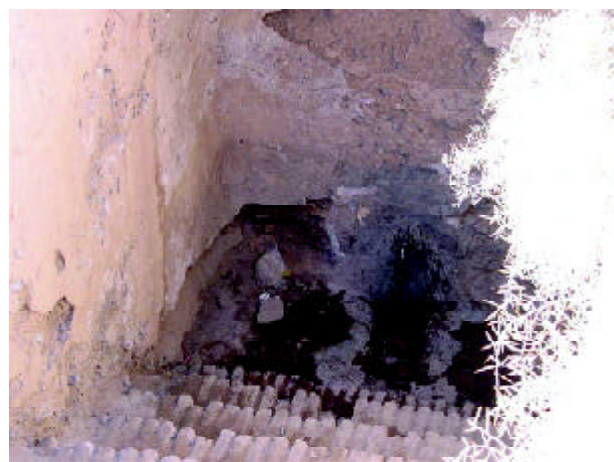
More than 55 chains of qanats had various levels of damage mostly to their wells and underground tunnels closer to the city and the quake epicenter. The damage was in the form of failure of the underground tunnel walls and wells, blocking the water to reach the ground

**Figure 5.** Once the qanat chain arrives at its destination, the underground tunnel reaches the ground surface (top and middle left pictures). From there the water is distributed via man-made channels and brought to farms and date palm gardens. Damage to the channels is noted in the middle and lower right pictures. The qanat water sometime is stored in traditional underground reservoirs (bottom two pictures).

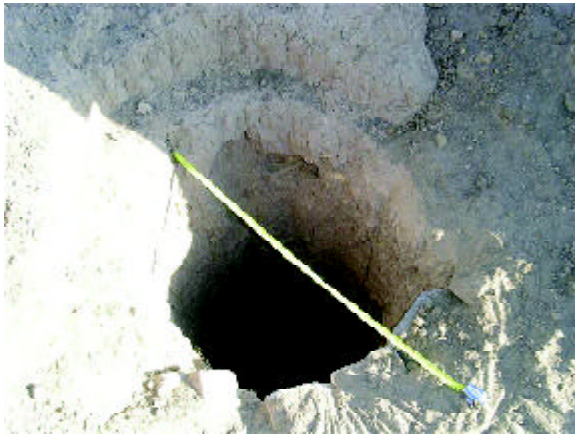
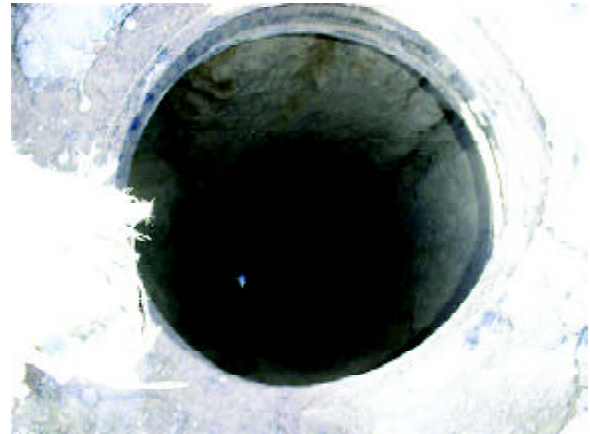
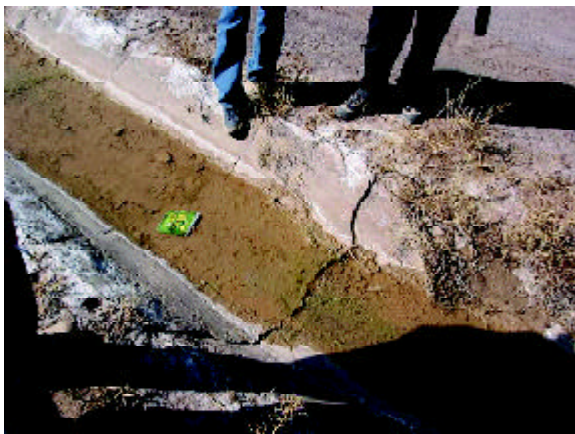
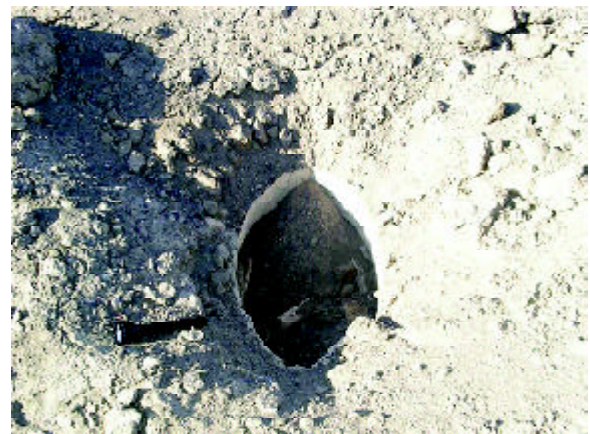
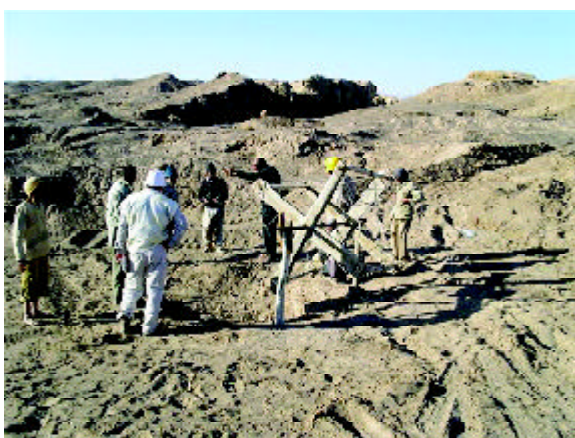
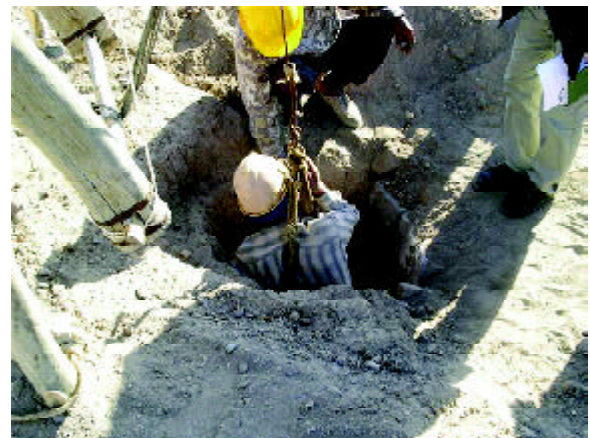
surface. One should note that the wells as well as the underground tunnels are not reinforced and are basically vertical and horizontal holes in the ground. Even without earthquakes the wells and the tunnels need regular maintenance to remove the fallen soil from the well walls and tunnels. At the time of the

team visit a number of qanat builders from other parts of Iran had come to Bam area to clean and reconstruct the damaged qanats, see Figure (6). In addition to damage to qanat chains, the distribution surfaces channels were damaged or closed off due to collapsed garden walls or other constructions.

**Figure 6.** The vertical wells, also used as access wells, are usually large enough for one person to be able to climb down (about 90cm across). Note the use of old tire at the entrance of one well. Damage to the qanat systems included underground tunnel collapse and closure (not shown), access well failure, which in turn causes the closure of the underground tunnel, damage to the channels. At the time of our visit a number of qanat builders had been brought from other parts of country to repair the very important qanats.

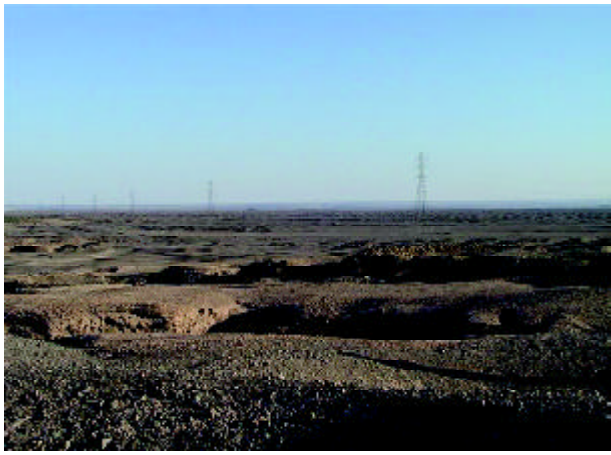
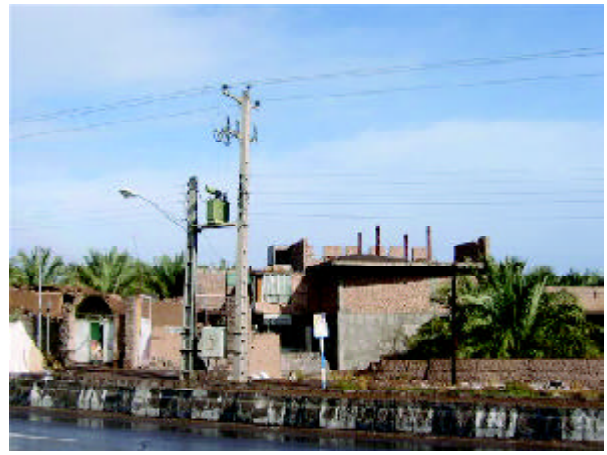
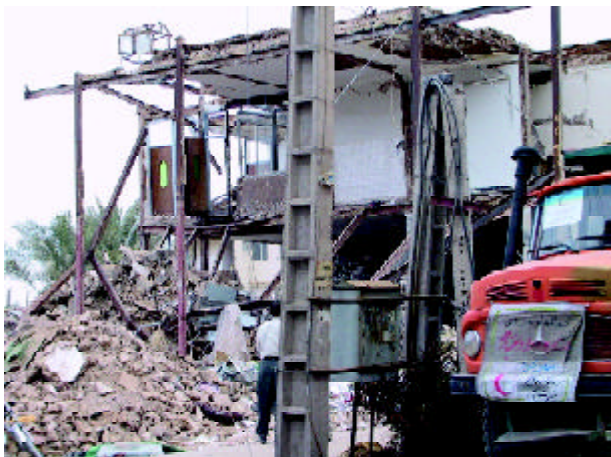
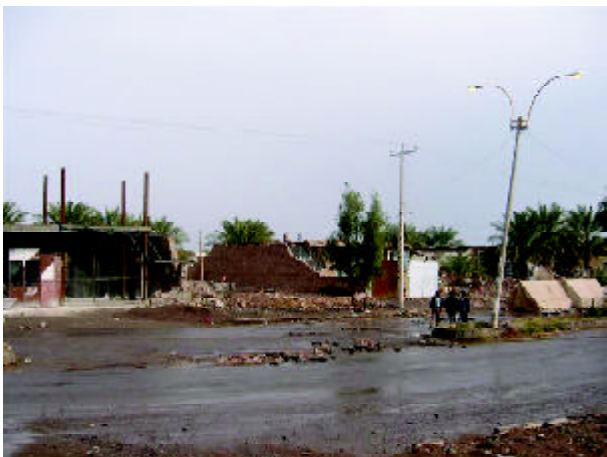
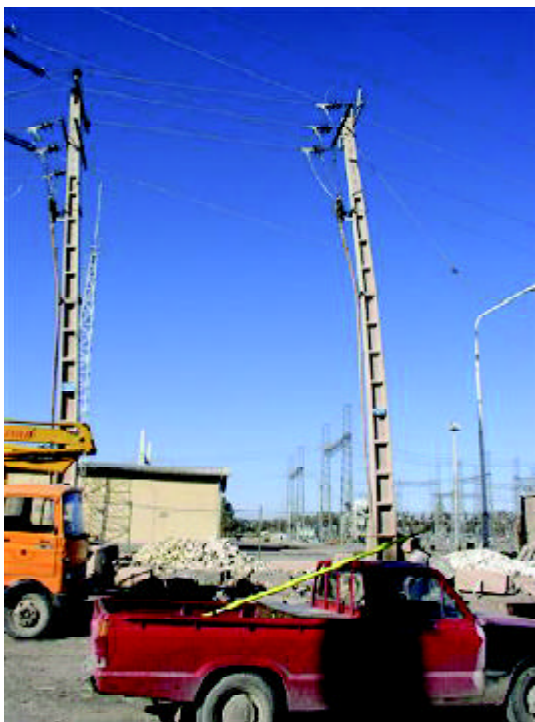
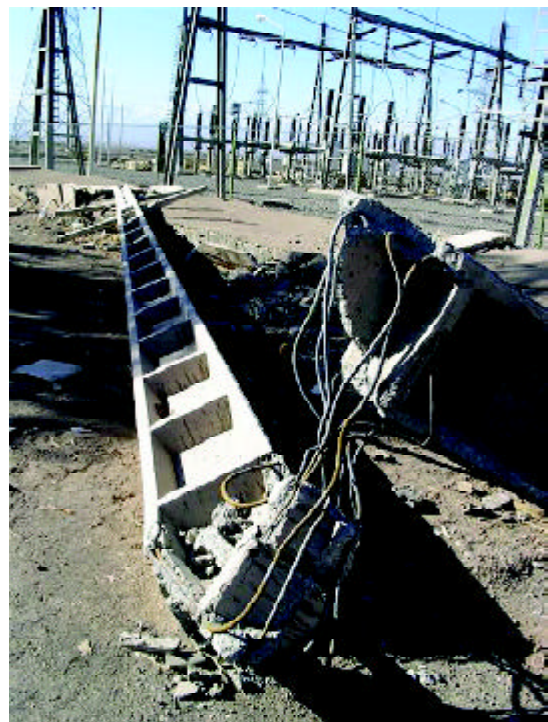
There was no damage to main 230kV transmission lines. There was however damage to concrete poles in the distribution system and streetlights. Part of the damage to the concrete poles was due to collapse of adjacent walls and buildings. We observed series of poles to be out of plumb. Damage to transformers on distribution poles was reported [8], see Figure (8).

**Figure 7.** Damage to transmission line towers was not observed. Concrete and wooden poles are used to bring electricity from substations to users. Pole top transformers convert the electricity to 220V. Many distribution poles were damaged. A large number of distribution poles and street light poles were out of plumb after the earthquake.

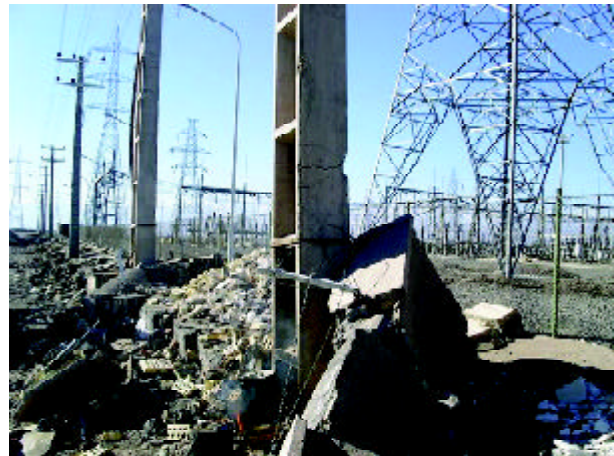
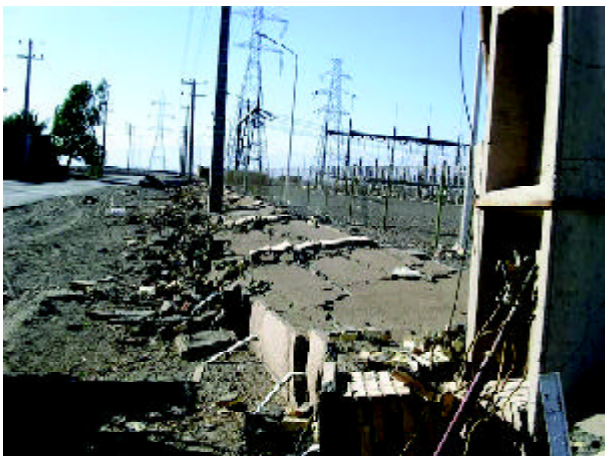
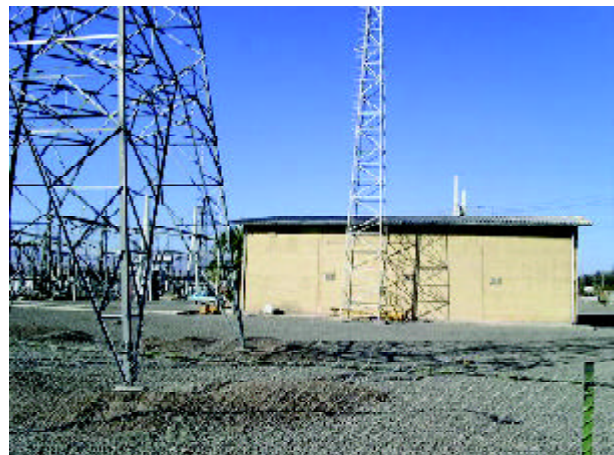
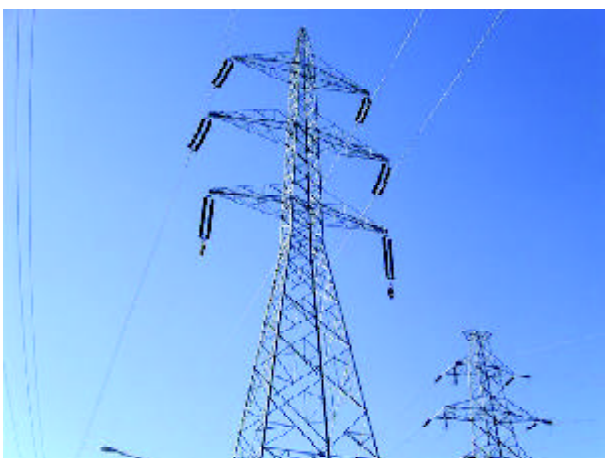
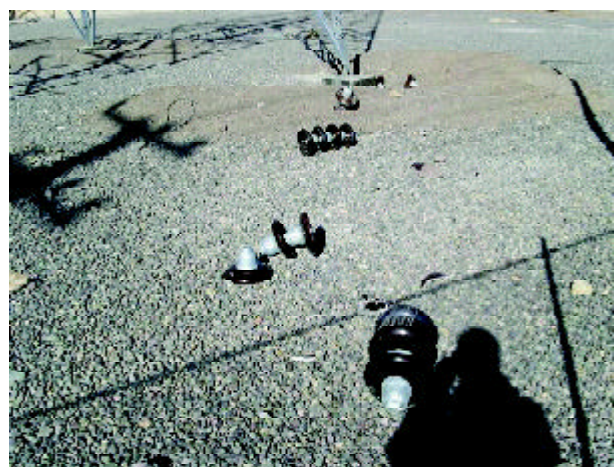
The 230kV substation in Bam experienced some damage. There was some damage to porcelain insulators and bushings at this substation. The wall around the substation collapsed. The office/control building in the substation structurally performed well, see Figures (8) and (9). This substation was about 5km distance from epicenter. At the time of our visit (one month after the earthquake), electricity had been restored throughout the city, even in the area where there was severe to complete building destruction.

**Figure 8.** The 230kV substation experienced minor damage. The wall surrounding the facility collapsed. In the process it hit the concrete poles and caused their failure. A number of porcelain insulators were broken. The office/control room did not seem to have been damaged structurally.

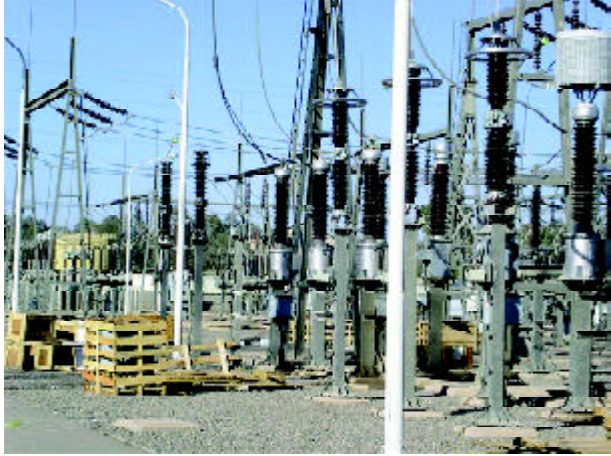
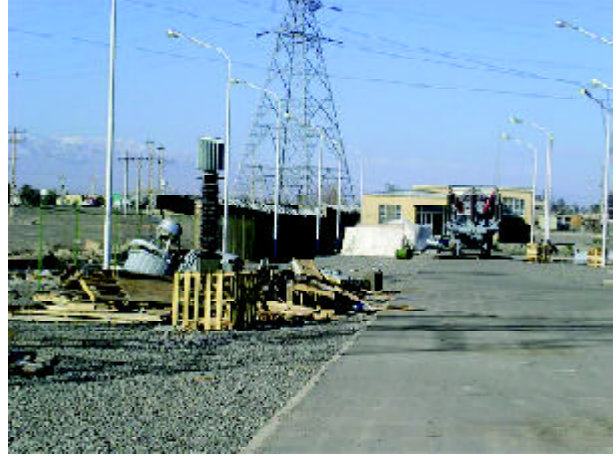
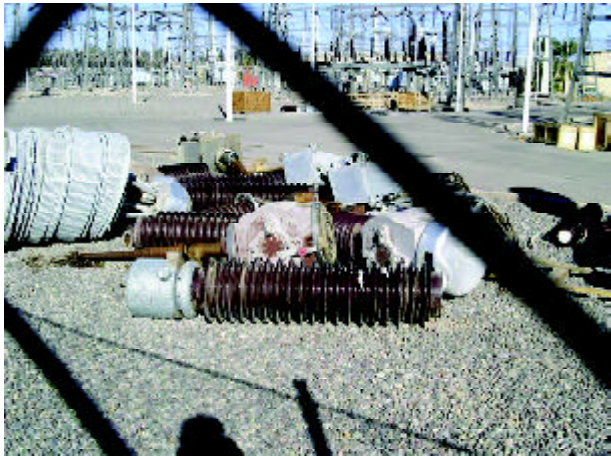
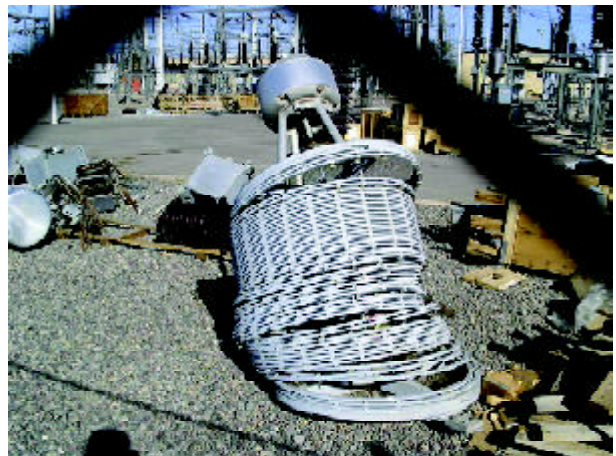
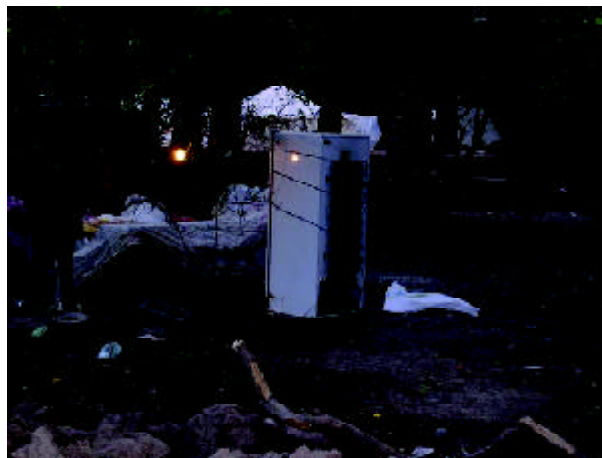
**Figure 9.** Damage to various electric equipments in the 230kV substation is observed in the above pictures. At the time of our visit (one month after earthquake) the electricity was available throughout the city, even though most of the users' buildings had been severely damaged to use the electricity.

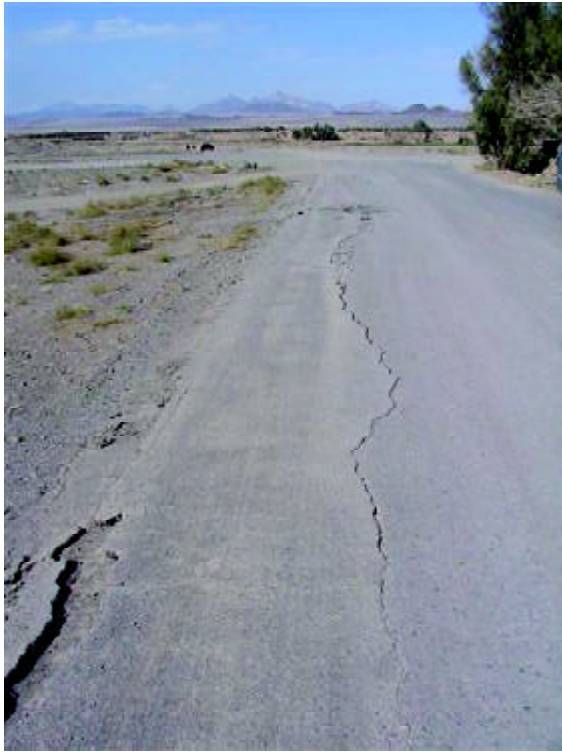
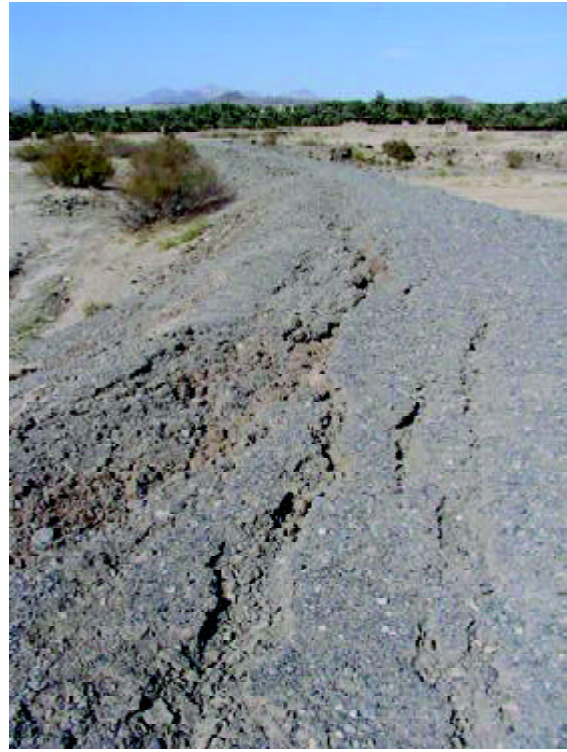
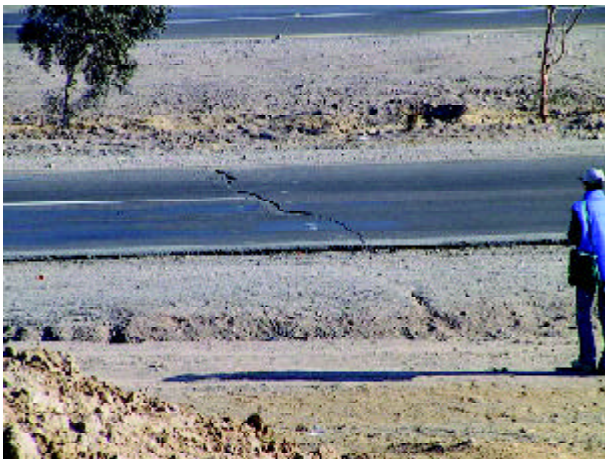
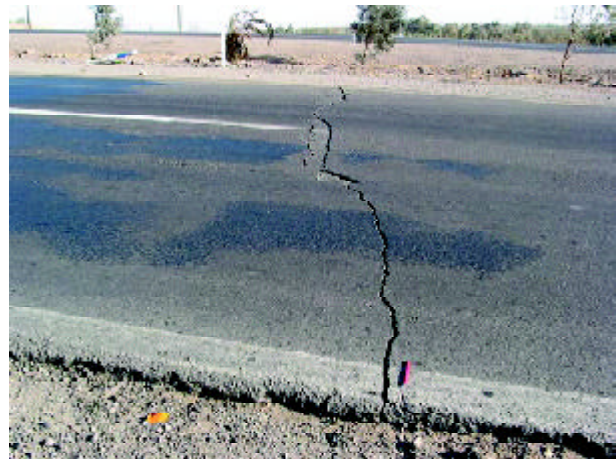
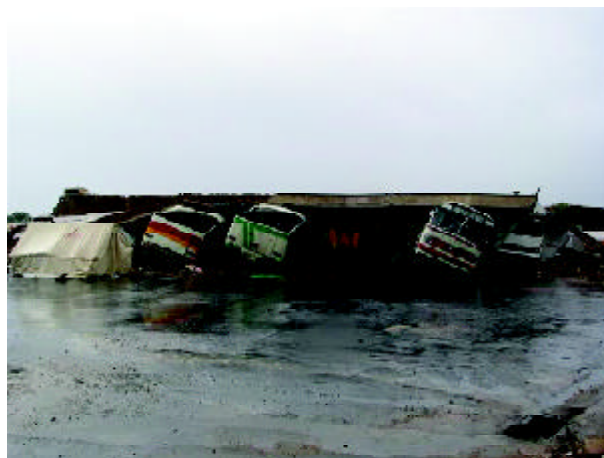
There is a main two-way highway-connecting city of Bam to Kerman on the northwest and Zahedan and Iranshahr on east and southeast of Bam. This road crosses the Bam fault scarp. Very minor damage to road embankments and surface cracks in the main highway close to Bam fault scarp were observed. For the most part, roads and streets were usable immediately after the earthquake, see Figure (10).

Cross-country bus lines are the main mode of transportation for masses in Iran especially outside the major cities. The last picture of Figure (10) shows the roof of a bus terminal building collapsed onto several busses.

**Figure 10.** There were minor damage to roads and highways. There were some damage to road embankment and surface cracks cracks in the main highway close to Bam fault scarp. For the most part roads and streets were usable immediately after the quake. The roof of bus terminal building collapsed onto several busses.

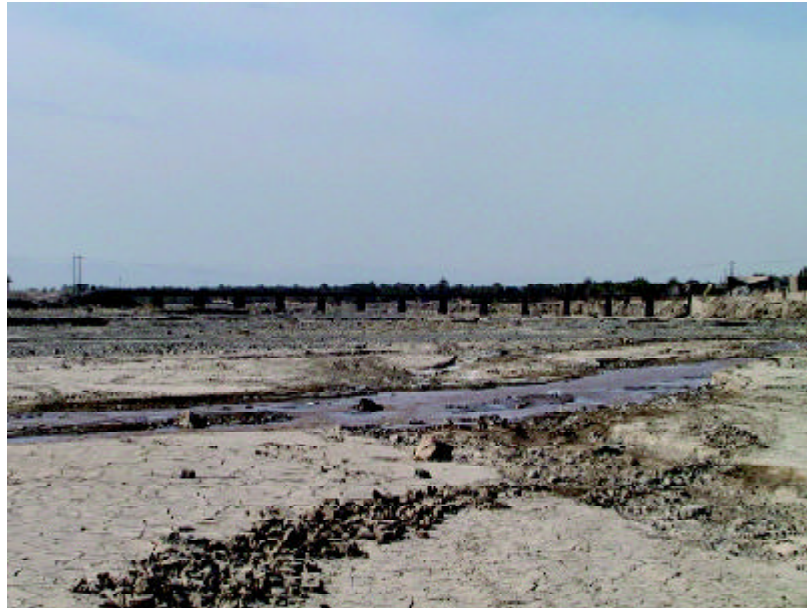
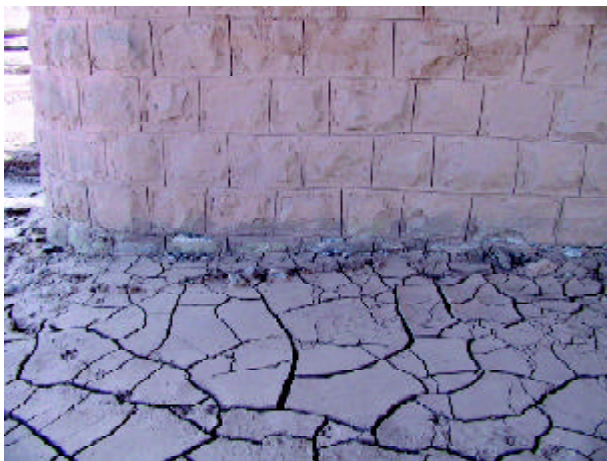
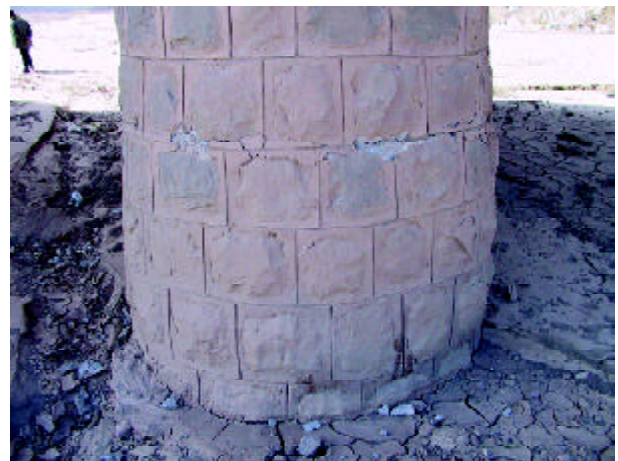
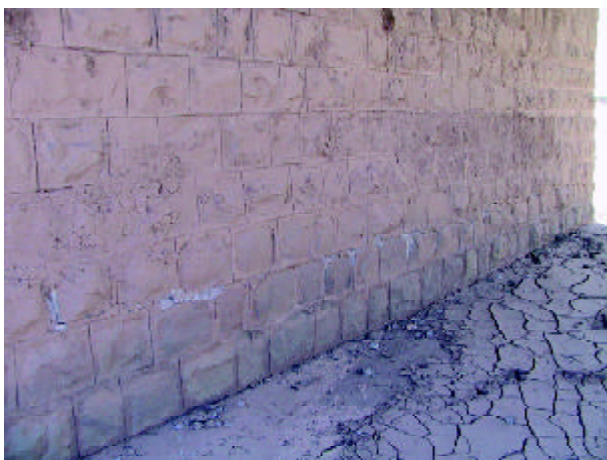
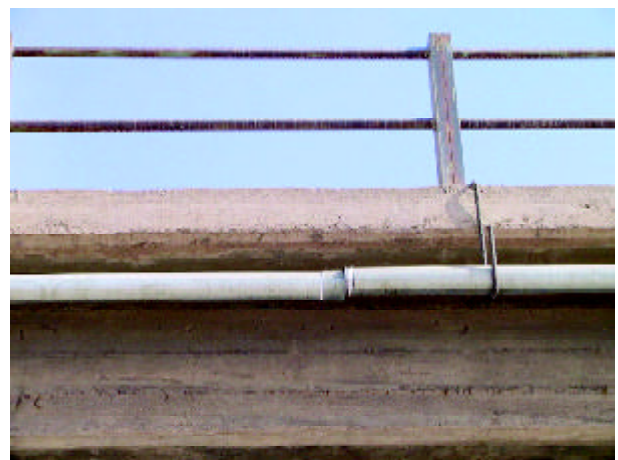
The bridges over a Bam river, called Posht-e-rud, performed relatively well. Figure (11) shows one of the main bridges over the river. There are signs of vertical movement in the base of the support walls/columns. Damage to the pipeline on the side of the bridge is observed. All of the three main bridges were

**Figure 11.** A bridge over the Posht-e-rud performed relatively well. There are signs of vertical movement in the base of the support walls/columns. Damage to pipelines is observed.

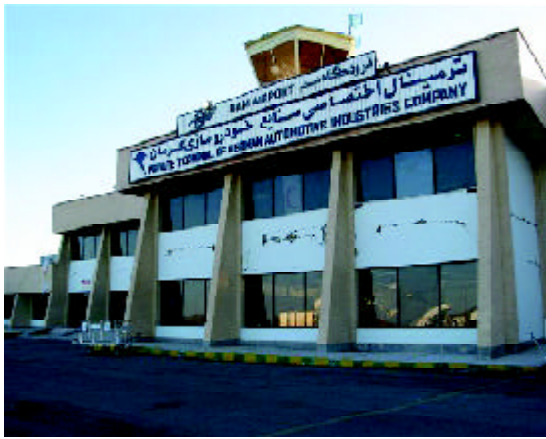
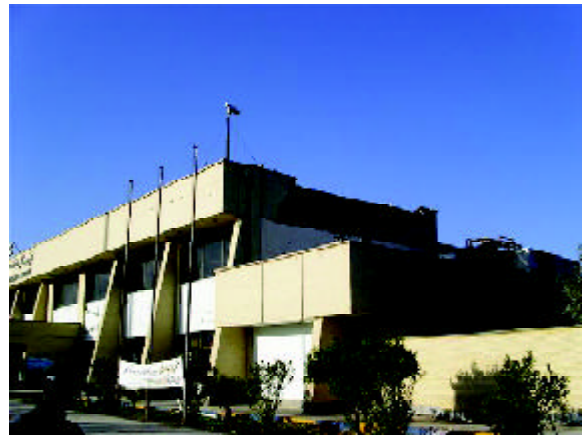
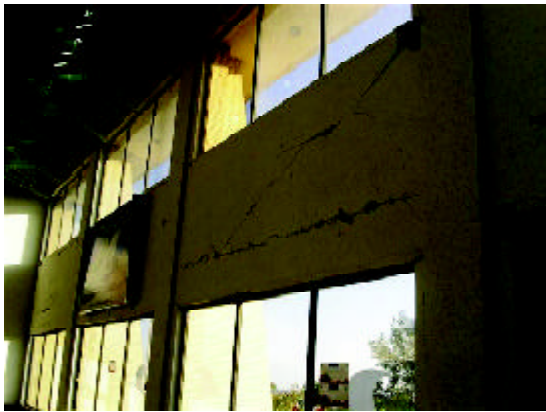
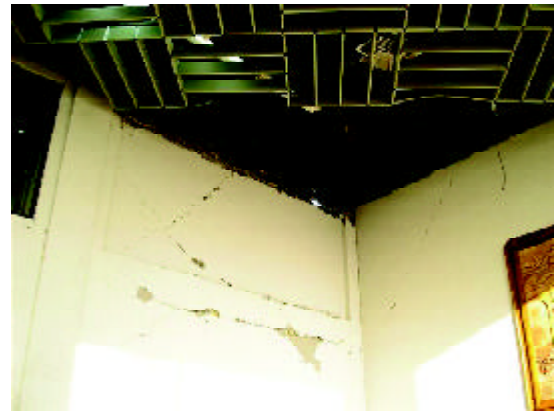
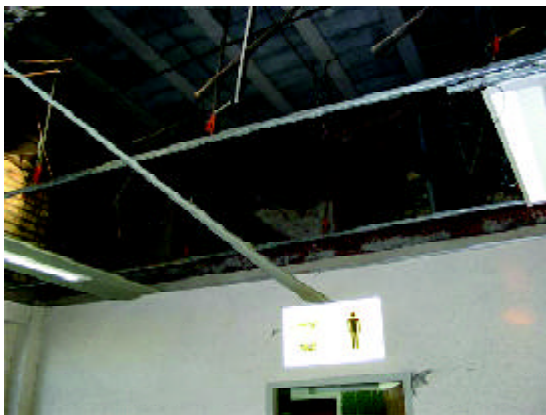
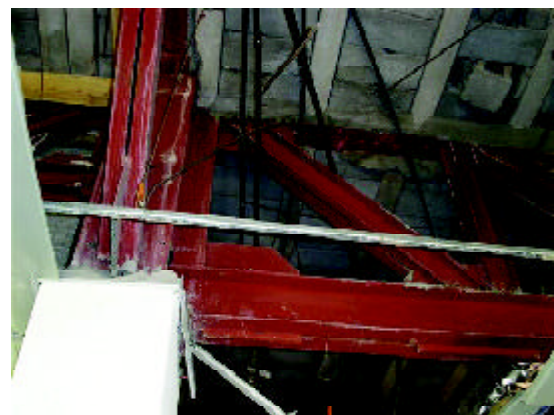
The main terminal building at the Bam airport had moderate damage, but the runway was operational immediately after the earthquake, see Figures (12). The steel frame terminal building was moderately damaged, but it withstood the quake. The masonry infill walls were damaged. The false ceilings were severely damaged. There was moderate damage to stairway to the second floor. There was nonstructural damage to airport control tower (broken windows). The airport runway had little damage and came to be extremely useful for emergency response and recovery effort. Hundreds of flights from inside of Iran and around the world landed in this airport immediately after the earthquake to bring search and rescue teams and equipment as well as much needed medical, food, blankets, tents and other supplies.

**Figure 12.** The engineered steel frame terminal building at Bam airport was moderately damaged. The masonry infill walls were damaged. The false ceilings were severely damaged. The airport runway had little damage.

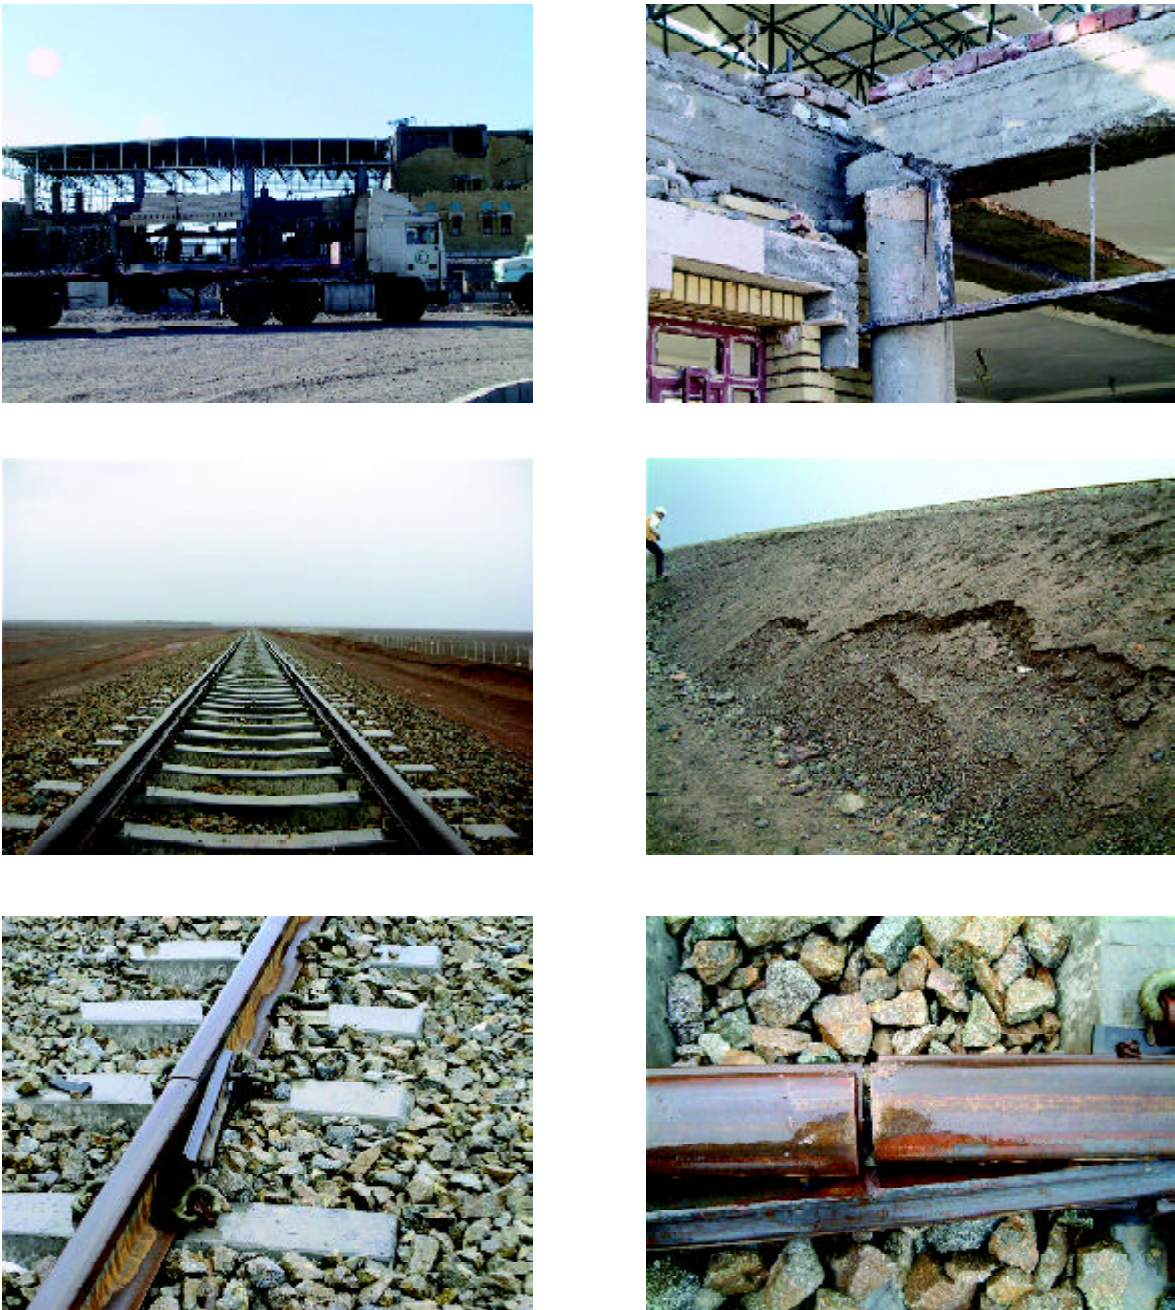
The construction of railroad to Bam had just been completed but the railroad had not been used prior to the quake. The passenger terminal located some 25km south of the city was under construction and had some damage. There was no damage to the rail tracks. There was light damage to embankment. The railroad was extremely useful for bringing supplies and help to Bam immediately after the earthquake, see Figure (13).

**Figure 13.** The passenger terminal was under construction and had minor damage. There was no damage to rail tracks. There was light damage to embankment.

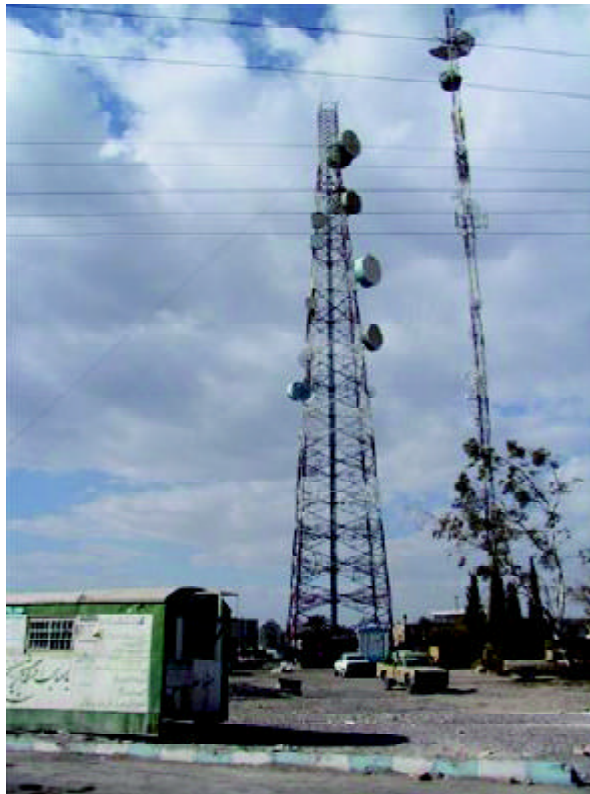
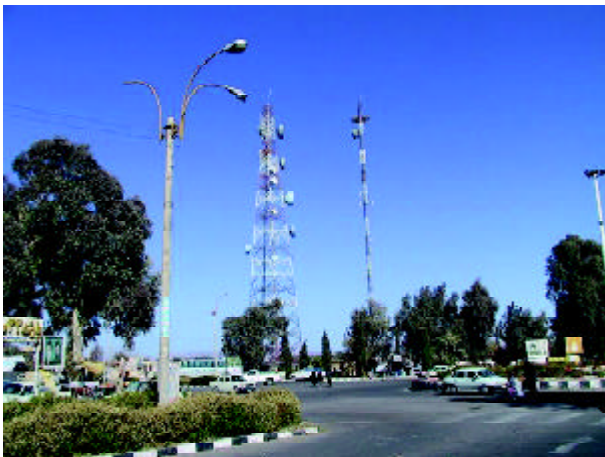
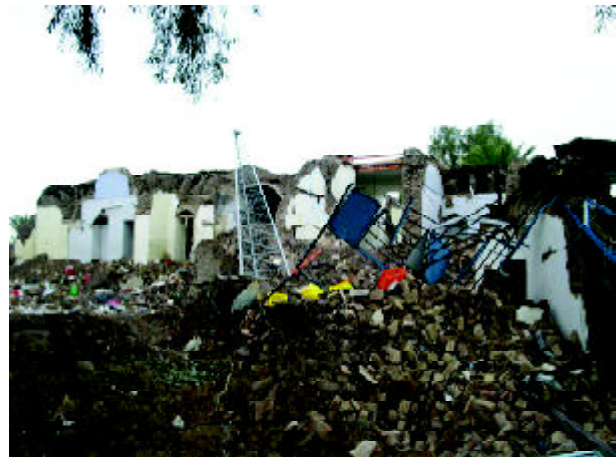
equipment. The main telecom towers mostly survived the quake. Some communication towers located on the roofs of the collapsed buildings were also damaged, see Figure (15).

**Figures 15.** The main telecom towers mostly survived the quake. Some communication towers located on roof of the collapsed buildings were also damaged.
