# On the Nonstructural Elements and Their Behavior in the Bam Earthquake of 26 December 2003

*Mahmood Hosseini*

Structural Engineering Research Center, International Institute of Earthquake Engineering and Seismology (IIEES), Tehran, Iran, email: hosseini@iiees.ac.ir

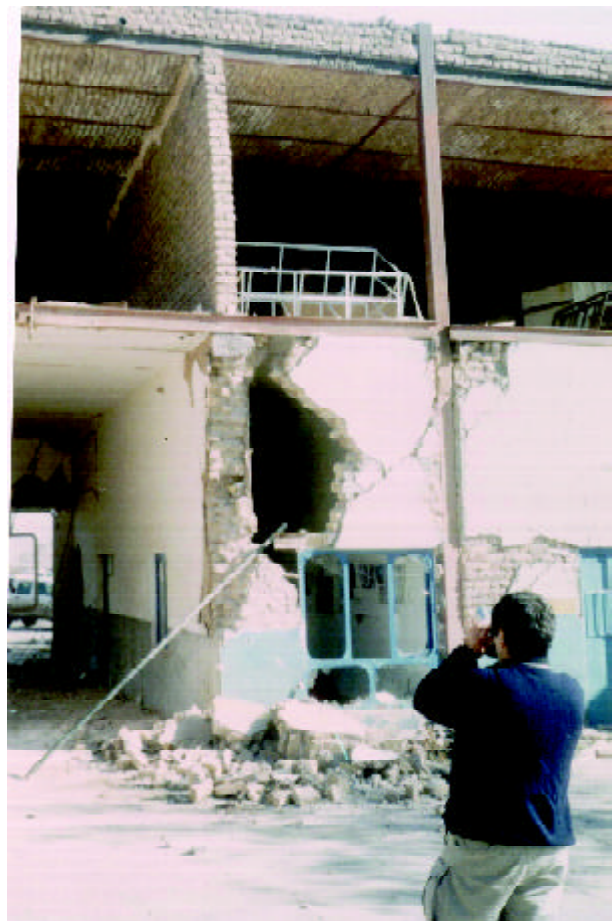
Several cases of damage to external wall masonry were observed, of which some samples are shown in Figures (1) to (4). It is seen in Figure (1), which is related to the recently constructed Emdad Khodro building located beside the Kerman-Zahedan road, that the external walls in the second story and a part of it in the first story of the building have fallen out. This building had a serious case of pounding as it is shown in the next pictures. The broken glasses of the window in the first story are also visible in the picture. Note that there is no sign of the interlocking between the remained wall in the second floor with the one formerly perpendicular to that, which is now fallen

**Figure 1.** Collapse of the external walls made of brick masonry in Emdad Khodro building (Photo by M. Hosseini).

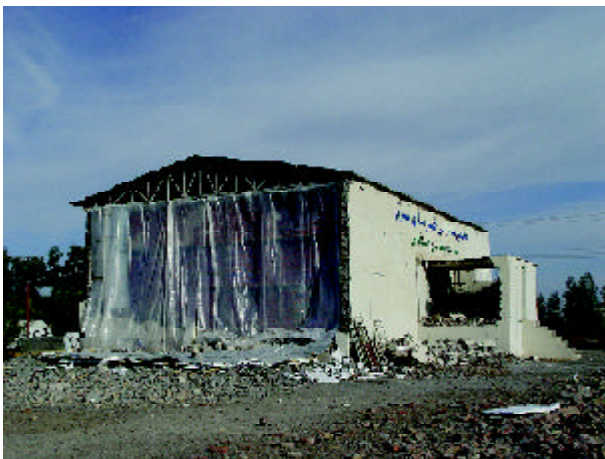
Another case of damage to the external walls is shown in Figure (2), which is related to Khormaye Shargh (East Date) export company. The complete collapse of the end wall of the refrigerating hall is seen in the figure. It is also seen that one wall of the motor house beside the hall has collapsed. A close up of this fallen wall is shown in Figure (3). Examination of the building showed that there was not any internal stabilizing column or external buttress in that end wall. In the case of the motor house wall just its inherent weakness and little integrity with other walls can be

**Figure 2.** Complete collapse of the external wall of the refrigeration saloon of Khormaye Shargh (east date) export company made of concrete block masonry (Photo by M. Hosseini).

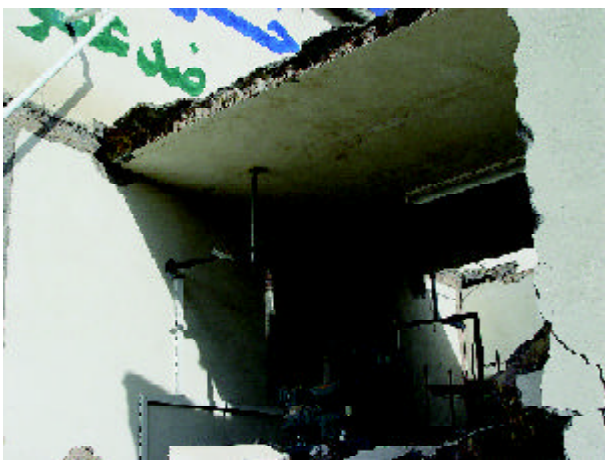
**Figure 3.** Complete failure of the external wall with partial collapse of the ceiling in the motor house of Khormaye Shargh export company (Photo by M. Hosseini).

the main cause of collapse.

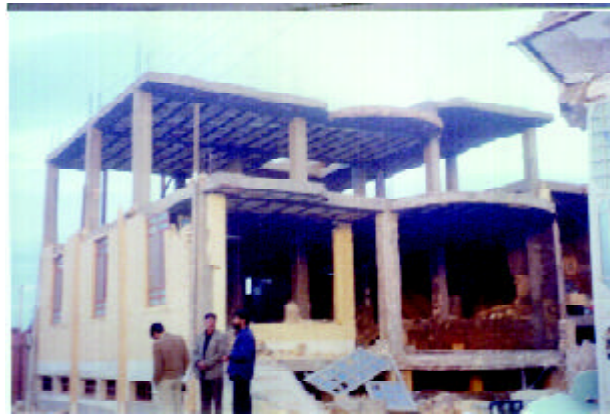
Other samples of the external walls failure are shown in Figures (4) and (5). The little integrity of these walls and their weak connections with the structures are believed to be the main causes of failure in these cases.

**Figure 4.** Collapse of external walls in an under construction R/C building, whose skeleton remained intact after the quake - Note to the fallen out window as well (Photo by M. Hosseini).

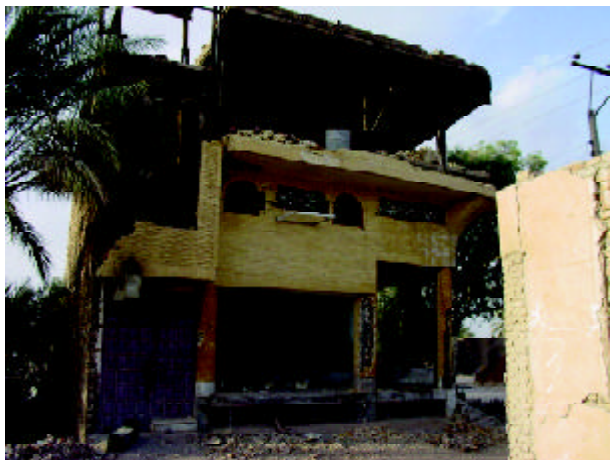
**Figure 5.** Collapse of the external wall masonry in the second and third stories of a 3 story steel structure building - the roof parapet has fallen as well (Photo by M. Hosseini).

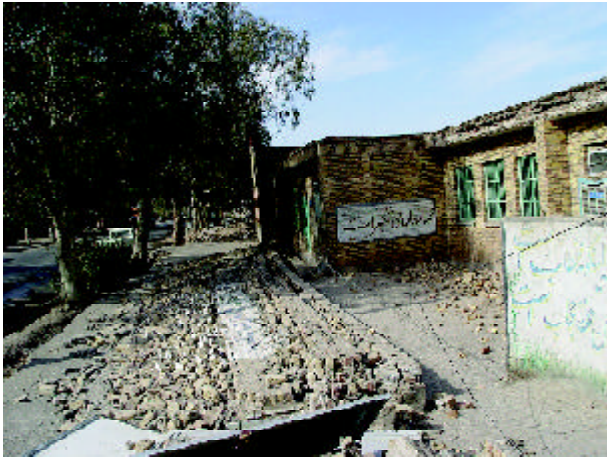
The main reason behind the collapse of these yard walls, as it can be seen in Figures 6 and 7, is in addition to their inherent weakness, the lack of, or the long distance between buttresses [loghaaz-haa].

**Figure 6.** Topped brick wall - Note to the fallen parapets as well (Photo by M. Hosseini).

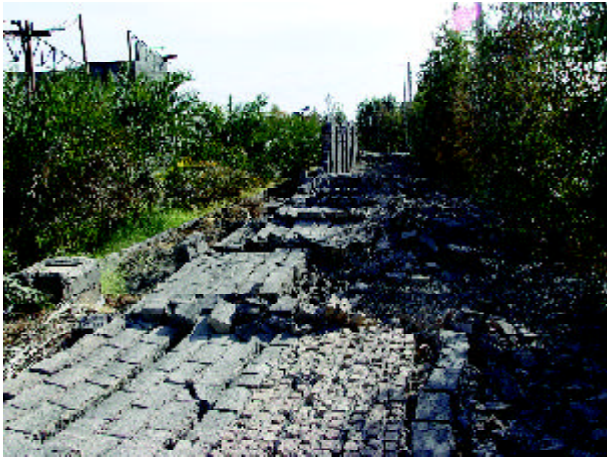
**Figure 7.** Topped concrete block (partially brick) wall (Photo by M. Hosseini).

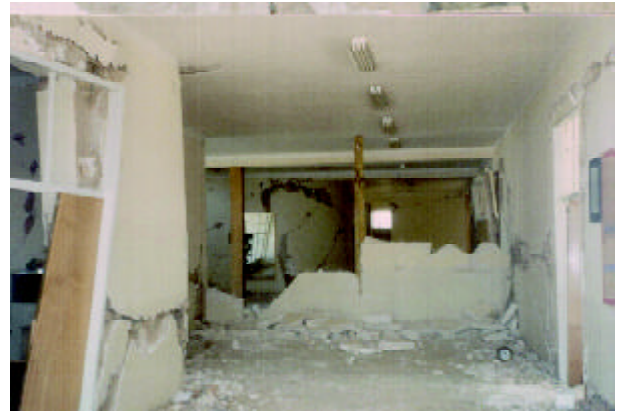
**Figure 8.** Severely damaged interior wall made of gypsum panels (Photo by M. Hosseini).

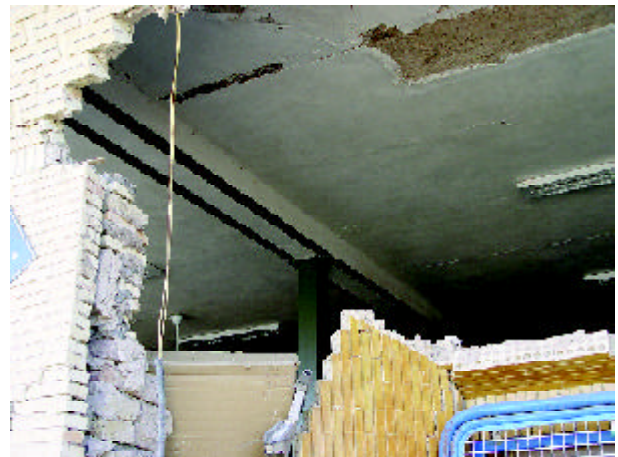
**Figure 9.** Severely damaged interior partition (Photo by M. Hosseini).

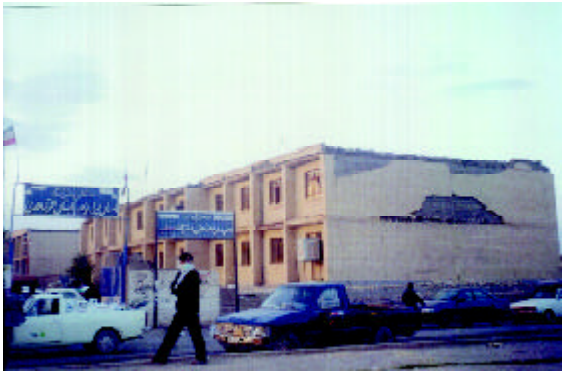
**Figure 10.** Damage to the so called 3cm brick facade in the second story of the Hijab girls' mid school (Photo by M. Hosseini)

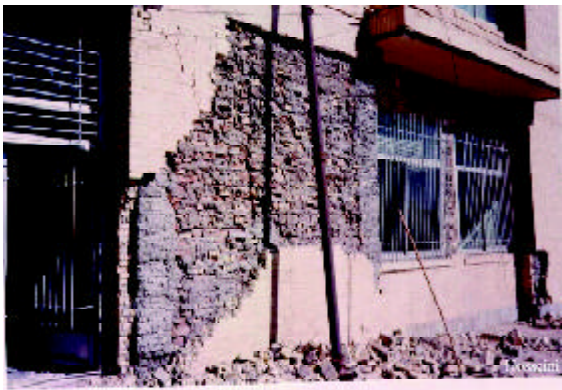
It is noticeable in Figures (11) and (12) that the window glasses have remained intact while the brick facades have gotten severely damaged. It is also notable that the parapet of the logistic building of (formerly) Azadi Hotel (presently Iran Parsian Hotel) has not fallen, which can be because of its little height. It should be noted as well that the Iran Parsian Hotel is located far from the causative fault of the earthquake comparing with the Hijab intermediate school or the city electric substation. However, this building suffered extensive nonstructural damages.

**Figure 11.** Damage to the so called 3-cm brick facade in the first story of the office building of the city electric substation (Photo by M. Hosseini).

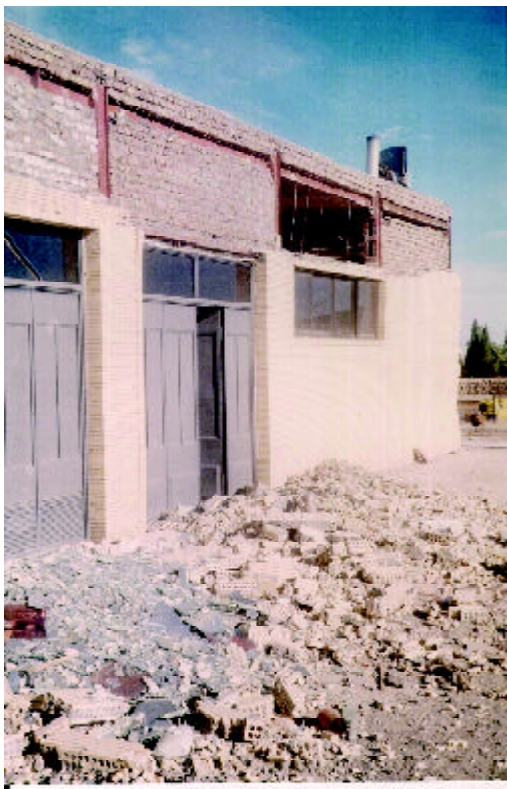
**Figure 12.** Damage to the brick facade in the top part of the walls in the logistic building of Azadi Hotel (Photo by M. Hosseini).

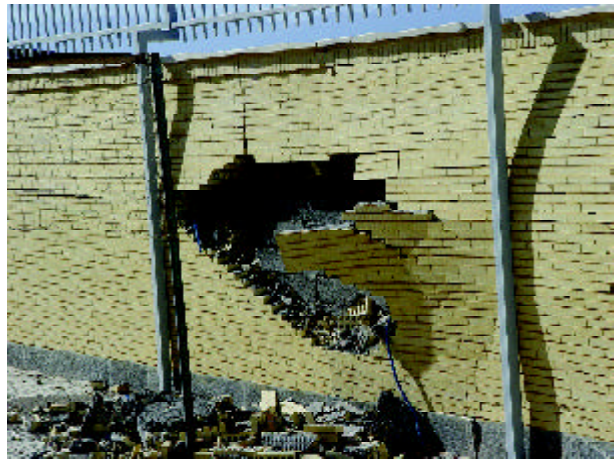
An interesting point, which is visible in Figure (13), is the lack of cohesion between the main wall masonry and the brick façade. The very clean surface of the concrete block masonry of the wall in this figure shows clearly this lack of cohesion. In the special case shown in this figure it seems the vertical box profiles of the top fence have prevented the façade from the complete collapse. Other interesting point is the detachment of the group of bricks with the used mortar behind them, which are stuck together and made a big piece of debris. It is obvious that falling of such a big piece from a high elevation can be very harmful to the subjected people. Nevertheless, this type of integrity between the bricks and the mortar can help their retrofit as described in section 5 of this paper.

**Figure 13.** Damage to the brick facade in a yard wall (Photo by Mahmood Hosseini).

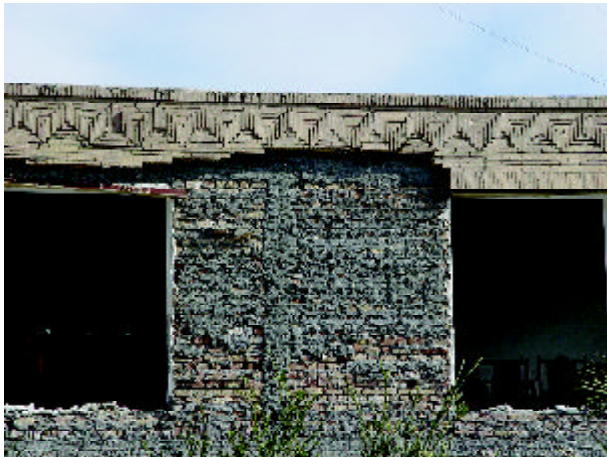
**Figure 14.** Failure of the brick facade in the external wall of a residential building - note to the popped out windows as well (Photo by M. Hosseini).

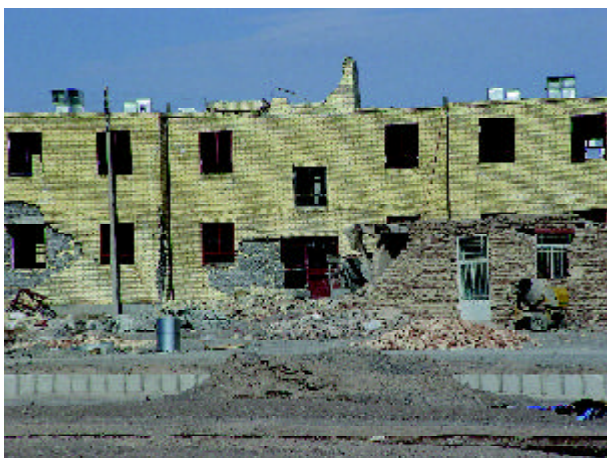
**Figure 15.** Damage to the brick facade in lower part of the two story residential buildings - Note to the collapsed penthouse as well (Photo by M. Hosseini).

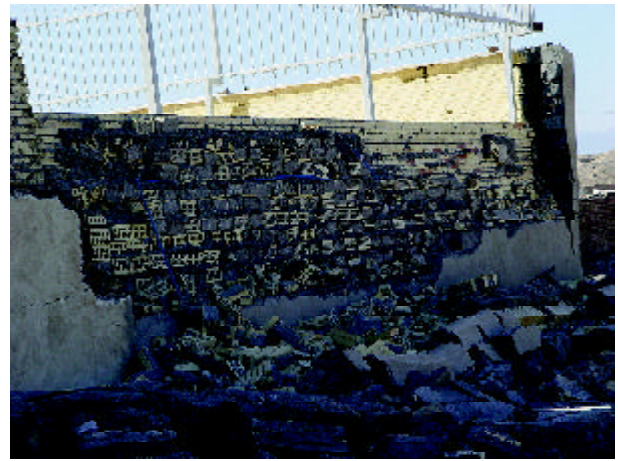
**Figure 16.** Damage to the plastered brick and block facade in a yard wall (Photo by M. Hosseini).

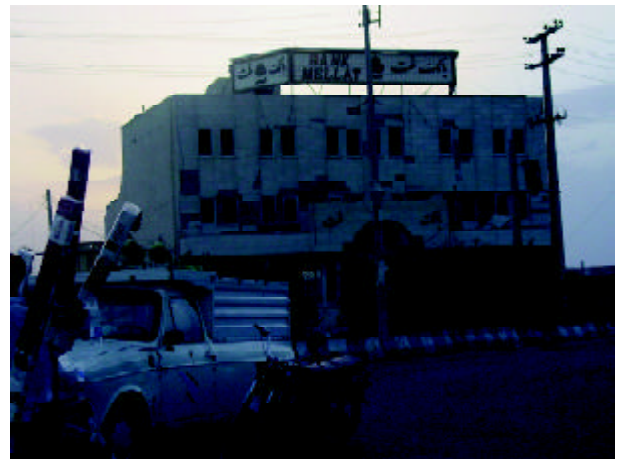
The sample of damaged stone façade is shown in Figure (17). The scattered locations of the detached tiles of the façade on the elevation of the building

**Figure 17.** Damage to the stone tiles facade in Ban k Mellat building (Photo by M. Hosseini).

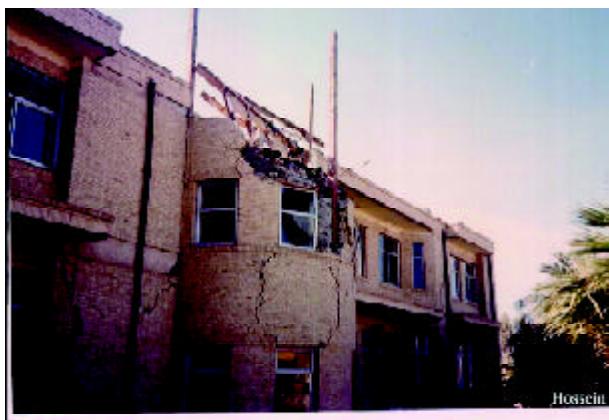
**Figure 18.** Severely damaged staircase roof in the office building of the city electric substation-Note to the broken glasses as well (Photo by M. Hosseini).

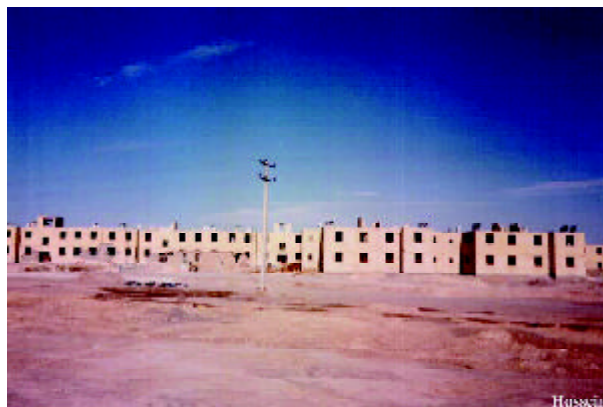
**Figure 21.** Severely damaged or totally collapse penthouses in the residential complex two story buildings (Photo by M. Hosseini).

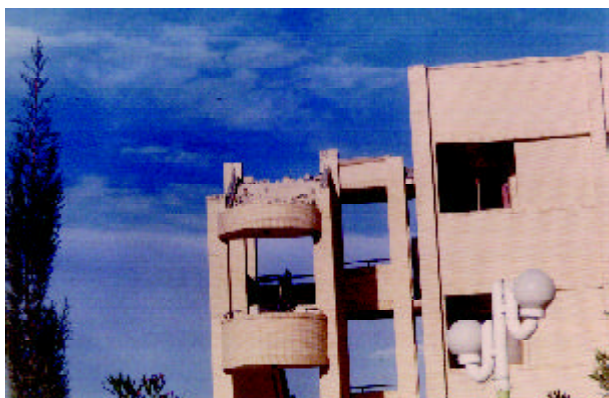
**Figure 19.** Damage to the staircase roof in the three story building of Azadi Hotel (Photo by M. Hosseini).

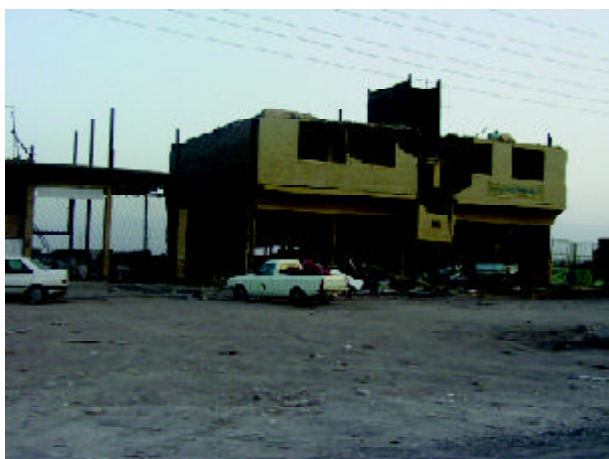
**Figure 20.** Severely damaged staircase in a commercial building (Photo by M. Hosseini).

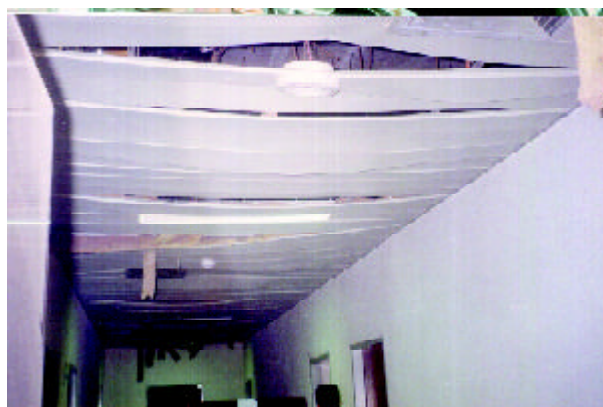
The most important building in which this kind of nonstructural damage was observed was the Bam Airport Terminal. It can be realized in Figures (22) and (23) that although the false ceiling parts seem not to be heavy, because of their high length, on the one hand, and the strong vertical component of the ground motion, on the other, they have suffered from a kind of buckling instability, resulted in their falling down.

**Figure 22.** The deformed parts of the false ceiling in the Bam Airport Terminal Building (Photo by Mahmood Hosseini).

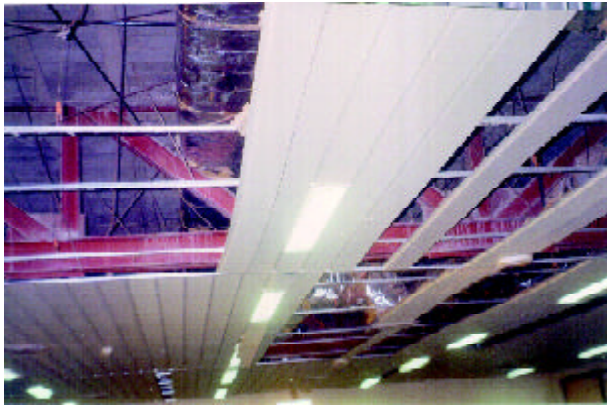
**Figure 23.** The false ceiling of the Bam Terminal Building, of which some part have fallen down because of instability (Photo by M. Hosseini)

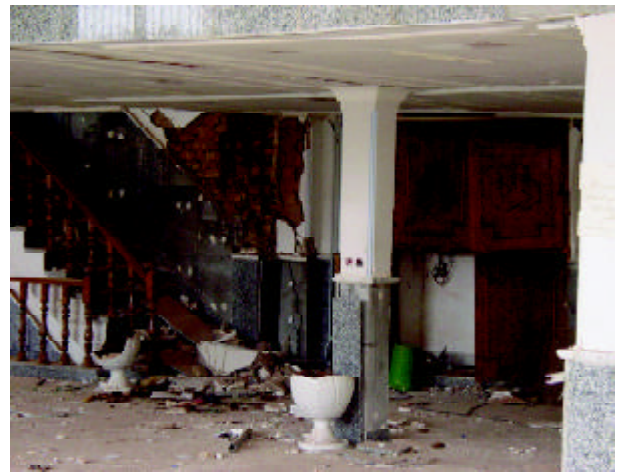
**Figure 25.** Severely damaged gypsum layer finishing of the interior wall of the Bank Refah Karekaran building (Photo by M. Hosseini).

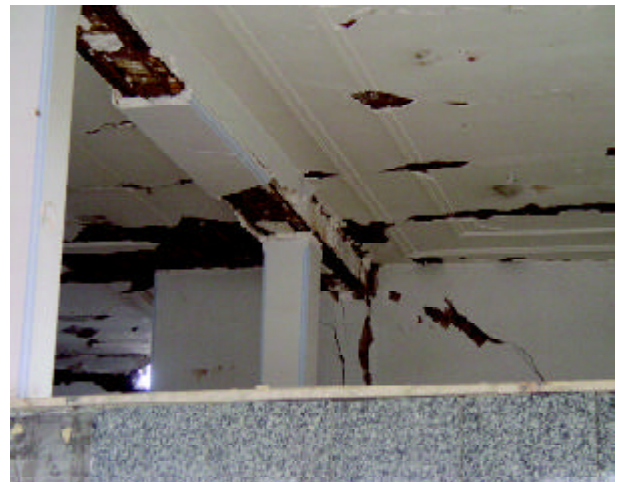
**Figure 26.** Severely damaged gypsum layer finishing of the ceiling of the Bank Refah Karekaran building (Photo by M. Hosseini).

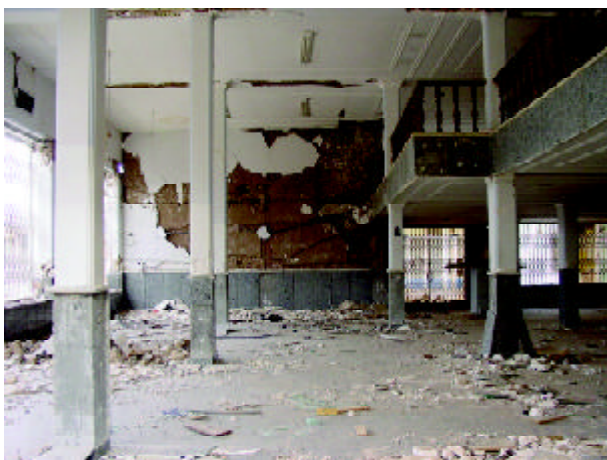
**Figure 24.** Severely damaged gypsum layer finishing of the interior wall of the Bank Refah Karekaran building (Photo by M. Hosseini).

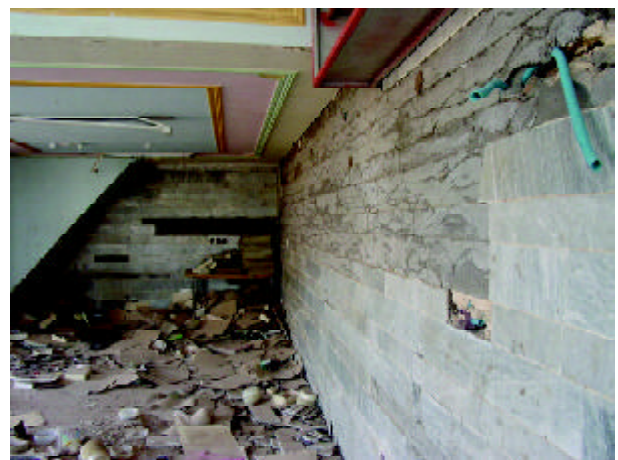
**Figure 27.** Severely damaged stone tile finishing of the interior wall of the Bank Refah Karekaran building (Photo by M. Hosseini).

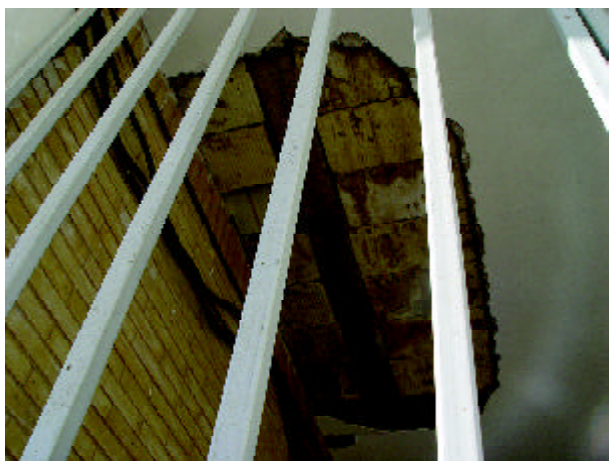
**Figure 28.** A big part of gypsum veneer of the ceiling has separated and fallen (Photo by M. Hosseini).

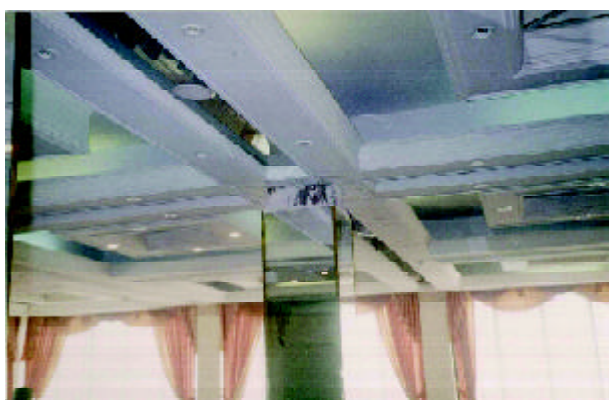
Figures (29) and (30) show the damages to the interior veneers in the Azadi (Iran Parsian) hotel. The veneers of the upper part of almost all of columns in the lobby were damaged as shown in Figure (29). There were also some damages to the ceramic tile veneers in the bathrooms of the hotel as shown in Figure (30). An interesting point is that just a small part of the column veneer as shown in Figure (29) was damaged, while the lower part which is covered

**Figure 29.** A sample of damages to the veneers of the columns tops in Azadi (Iran Parsian) hotel (Photo by M. Hosseini)

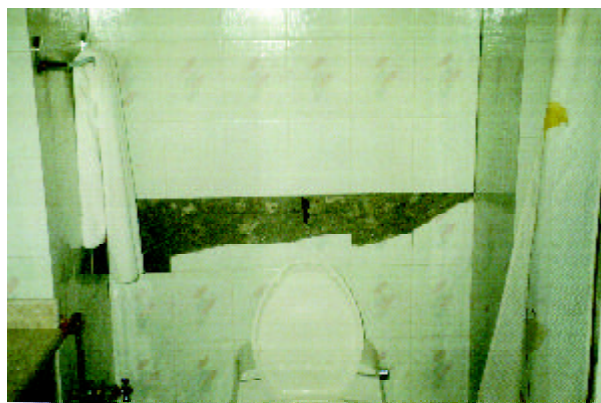
**Figure 30.** A sample damages to the ceramic tile interior veneers in the bath rooms of Azadi (Iran Parsian) hotel (Photo by M. Hosseini).

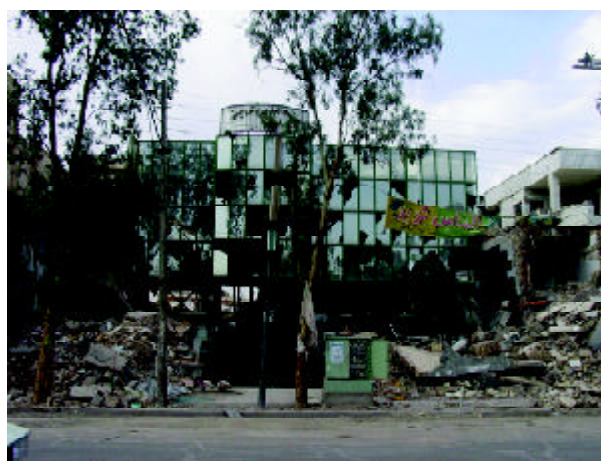
**Figure 31.** Damage to the glass facade of trade and tourism building (Photo by M. Hosseini).

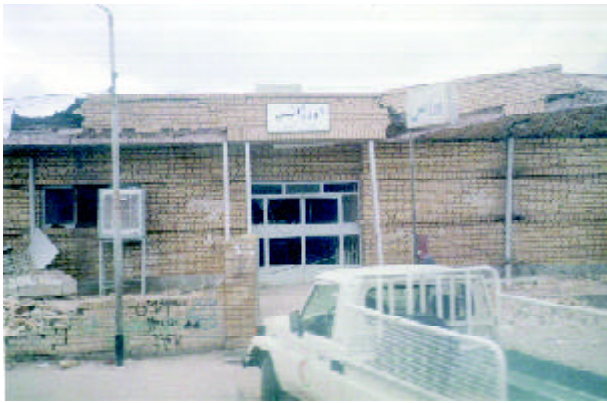
**Figure 32.** Damage to the glasses of widows in the Emergency Section of the city hospital (Photo by M. Hosseini).

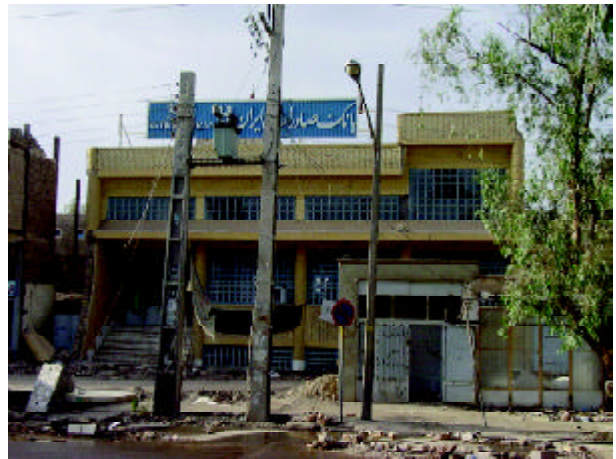
**Figure 35.** Damage to the glasses of widows in Bank Saderat Iran building (Iran Import Bank) (Photo by M. Hosseini).

Figure (34) shows the broken window glasses of a building, while no crack can be seen on the veneer of the walls. The same case is seen in Figures (35) and (36). This shows that the window glass is more vulnerable than the brittle facades. Nevertheless, in

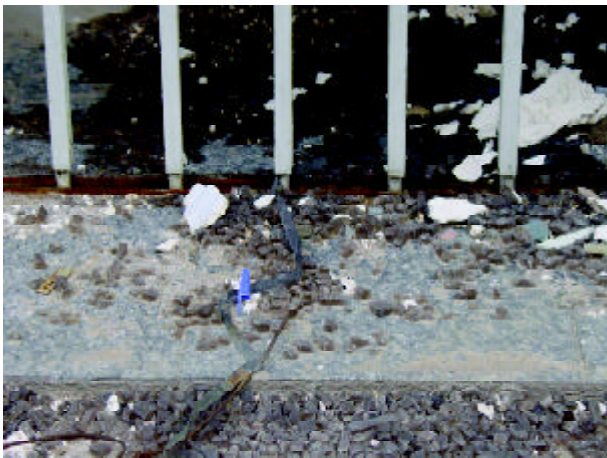
**Figure 33.** Splashed Parts of the broken thick glass door of Bank Refah Karekaran building (Photo by M. Hosseini).

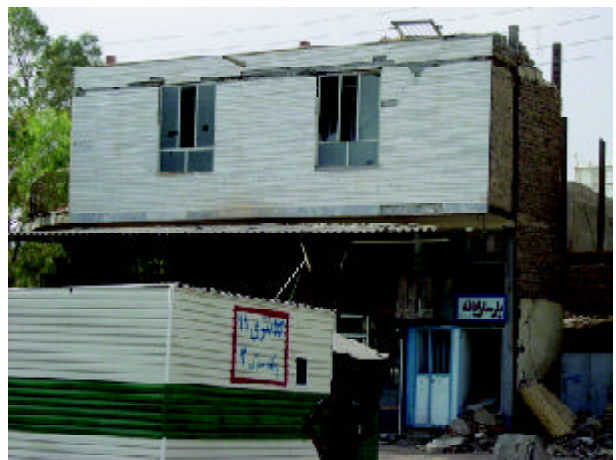
**Figure 36.** Damage to the glasses of widows in the second story of a residential building - Note to that horizontal damage line in the façade at the level of roof (Photo by M. Hosseini).

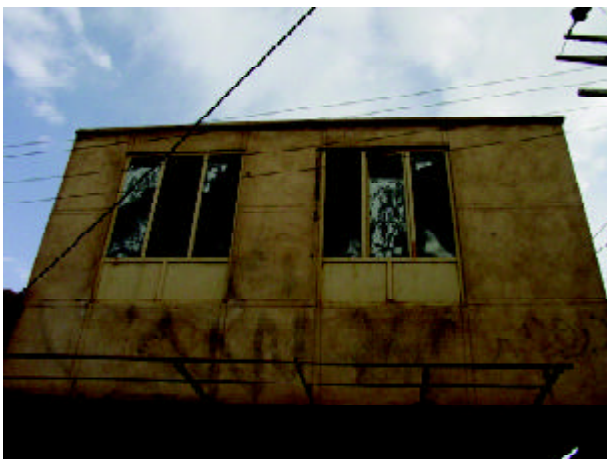
**Figure 34.** Damage to the glasses of widows in the second story of a residential building (Photo by M. Hosseini).

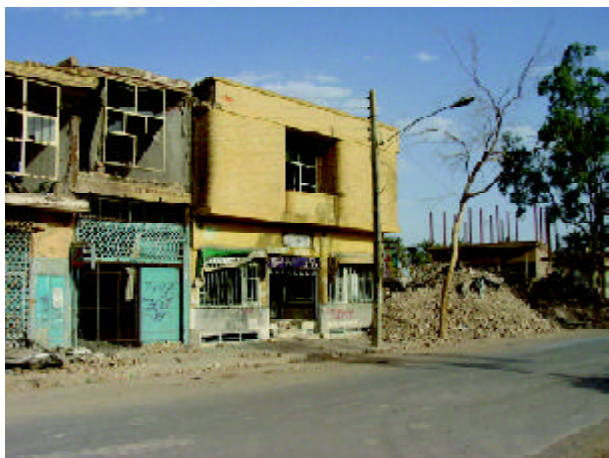
**Figure 37.** Damage to the glasses of widows in the second story of a residential building (Photo by M. Hosseini).

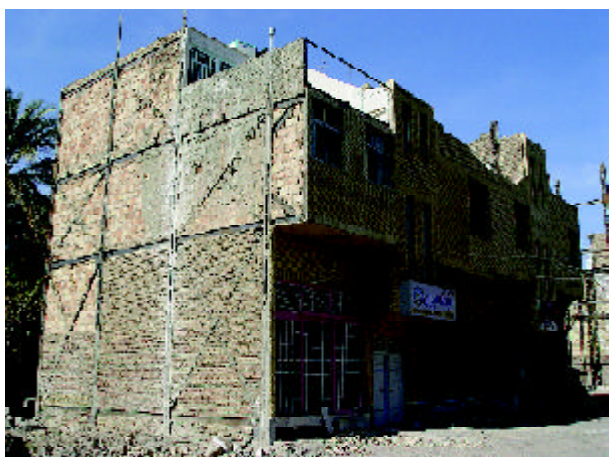
**Figure 38.** Collapse of parapets in the Iran Insurance Company building (Photo by M. Hosseini).

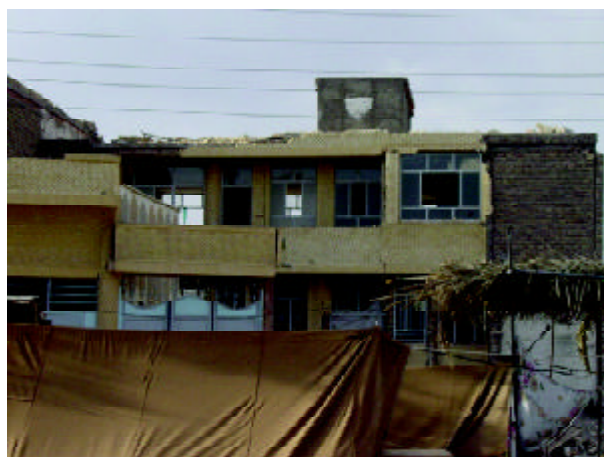
**Figure 40.** Complete collapse of parapets in a two story building (Photo by M. Hosseini).

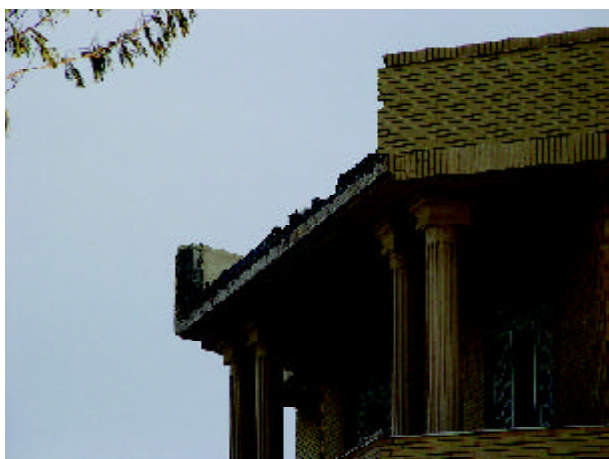
**Figure 39.** Partial collapse of parapets in a two story building (Photo by M. Hosseini).

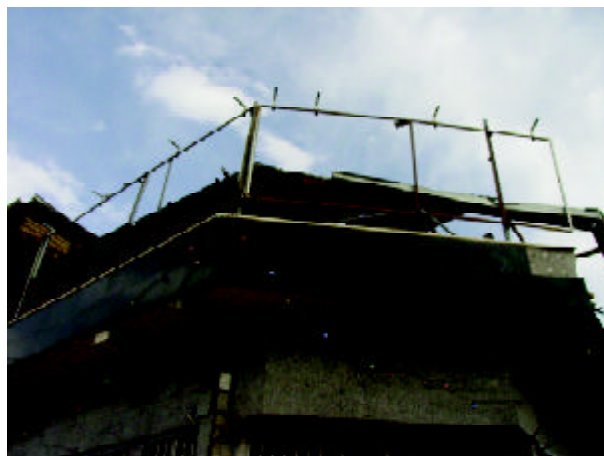
Figure (41) shows the collapsed tablets and bill board of a commercial building. Regarding the relatively low weight of the bill boards it can be claimed that the connection between the boards and their frames have not been strong enough to resist the earthquake shock. A part of the stone façade of the parapet has also failed, which is basically because of the failure of the whole parapet from that point to right (not completely shown in the picture). This again confirms the directivity effect of the earthquake.

**Figure 41.** Collapse of tablets and bill boards in a commercial building (Photo by M. Hosseini).

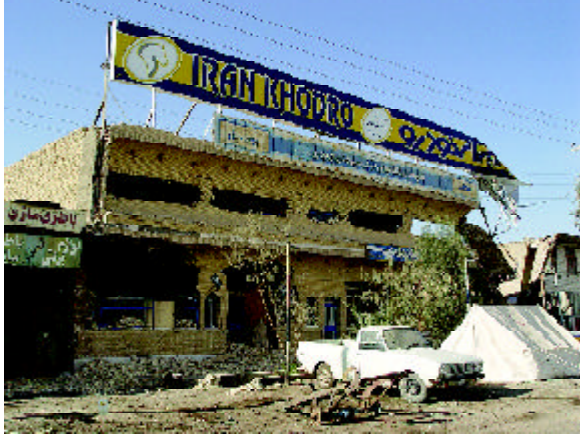
An almost newly observed phenomenon in this earthquake was the popping out of the windows and some door frames. Some samples of these cases are shown in Figures (42) to (44). This phenomenon can

Figure 42. The windows in Iran Khodro building popped out of walls (Photo by Mahmood Hosseini).

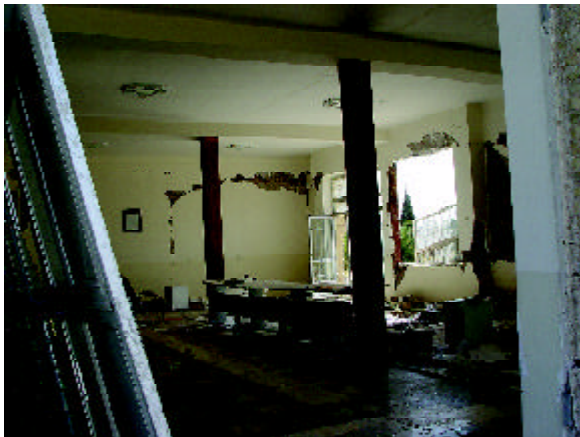
Figure 43. A popped out window in the electric substation office building (Photo by M. Hosseini).

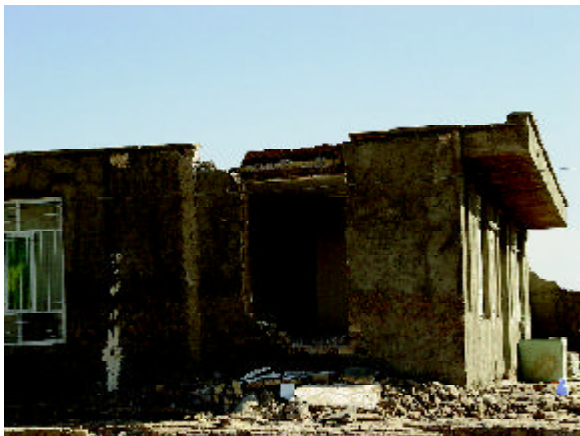
Figure 44. A popped out window in a one story residential building (Photo by M. Hosseini).

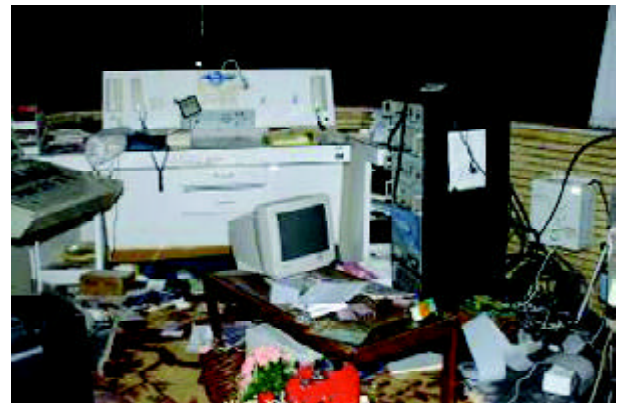
The cases of damage to mechanical and electrical facilities of building were not observed so much in this earthquake. Nevertheless, the observed cases had very adverse consequences. For example, the failure of these facilities in the Bam Airport Terminal and particularly its control tower resulted in the interruption of the airport operation for several hours. It could be understood from Figure (45) that some of electrical

Figure 45. The failure of mechanical and electrical facilities and interior equipment of the Bam airport control tower (Photo Source: [http://www.irna.ir/melli/bam/photo\\_index6.htm](http://www.irna.ir/melli/bam/photo_index6.htm))

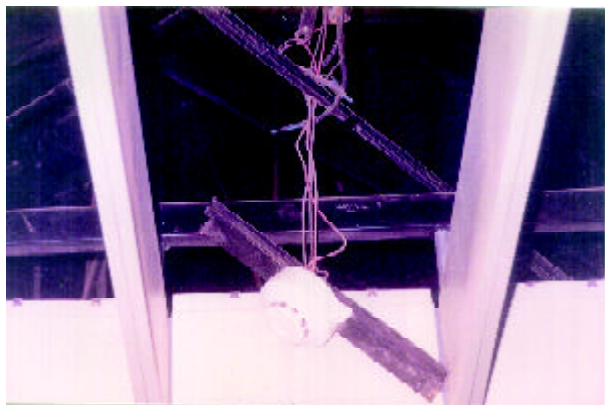
**Figure 46.** The failed smoke detector of the Bam airport (Photo by M. Hosseini).

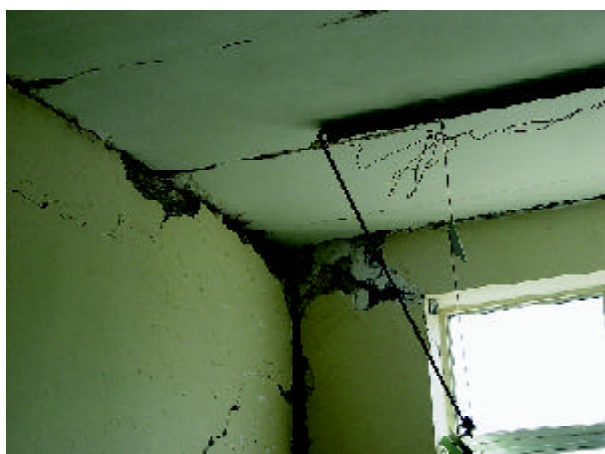
**Figure 47.** The failed light fixtures in the office building of the city electric power substation. (Photo by M. Hosseini).

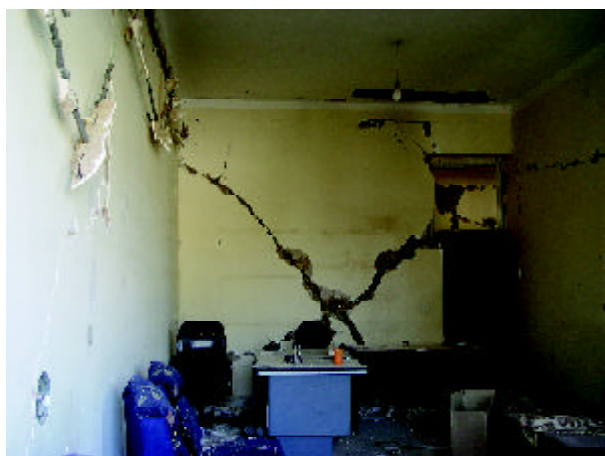
this kind of failure seems to be the potential weak lines in the finishing due to the presence of the wire protection tubes, which are in fact some mainly hollow spaces. The partial failure of the ceiling in Figure (48) is also notable. This has been in fact an

**Figure 48.** The pulled out protective tubes of electric wires in the office building of the city electric power substation (Photo by M. Hosseini).

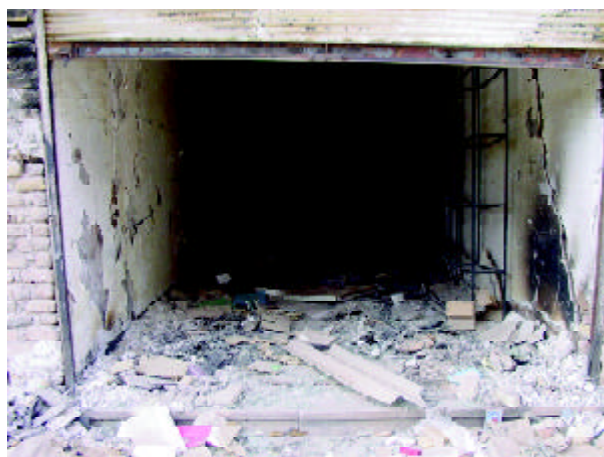
As in many of the past earthquake this event had also some cases of post earthquake fires, which were mainly due to the damage to the electrical facilities. Figure (49) shows a partially burnt shop, which caught fire because the failure of its electrical facilities. The fire caused of the deformation of the broken glass pieces as shown in Figure (50).

**Figure 49.** A partially burnt shop which got in fire because the failure of its electrical facilities (Photo by M. Hosseini).

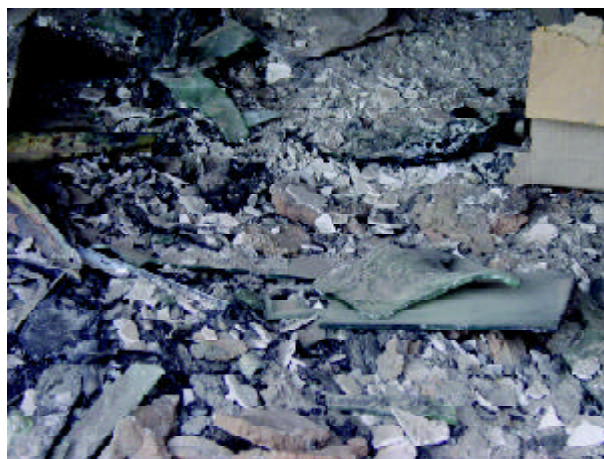
**Figure 50.** The deformed pieces of glass due to the fire occurred in the shop shown in Figure (49) (Photo by M. Hosseini)

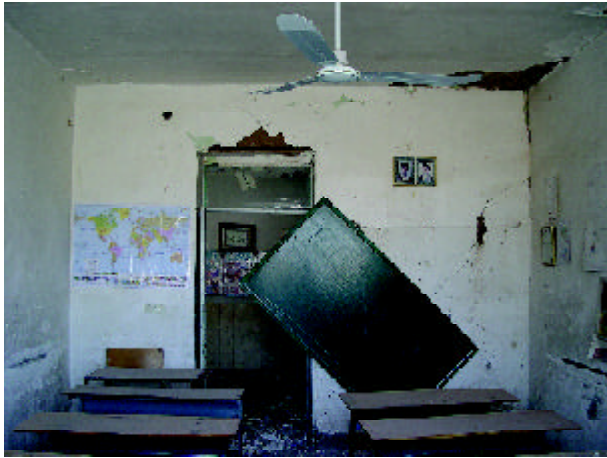
hook), still, because of the inherent weakness of the wall finishing and even the wall masonry, it would have detached from the wall because of notching phe-

**Figure 51.** The semi-fallen blackboard due to the weak connection (Photo by M. Hosseini).

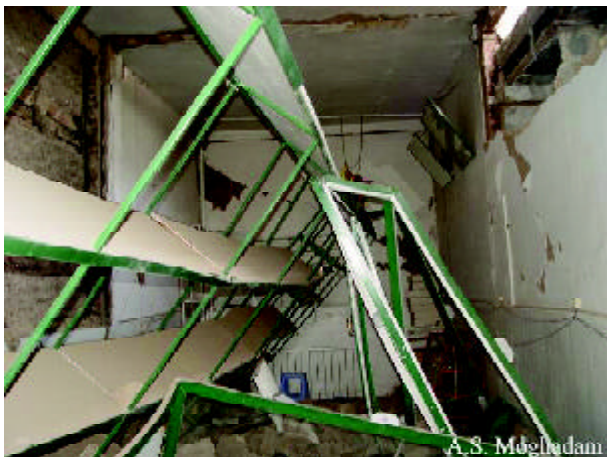
**Figure 52.** The toppled shelves of a shop board due to their weak connection (Photo by A.S. Moghadam).

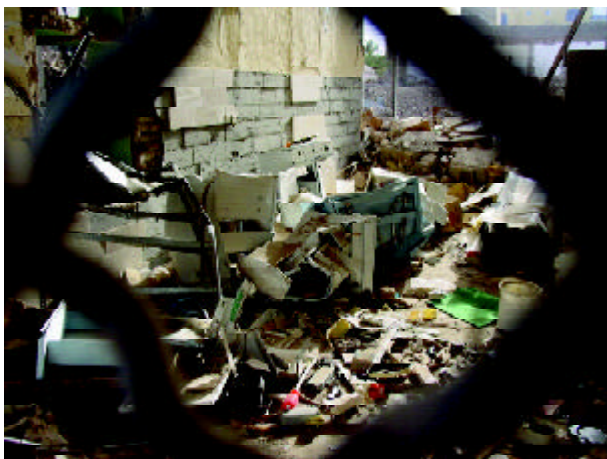
**Figure 53.** The entirely messed interior equipments of a shop (Photo by M. Hosseini)
