# Performance of Steel Structures and Associated Lessons to be Learned from November 12, 2017, Sarpol-e Zahab - Ezgeleh Earthquake ( $M_w$ 7.3)

Sarpol-e Zahab - Ezgeleh Earthquake; Steel structures; Failure types; Seismic code

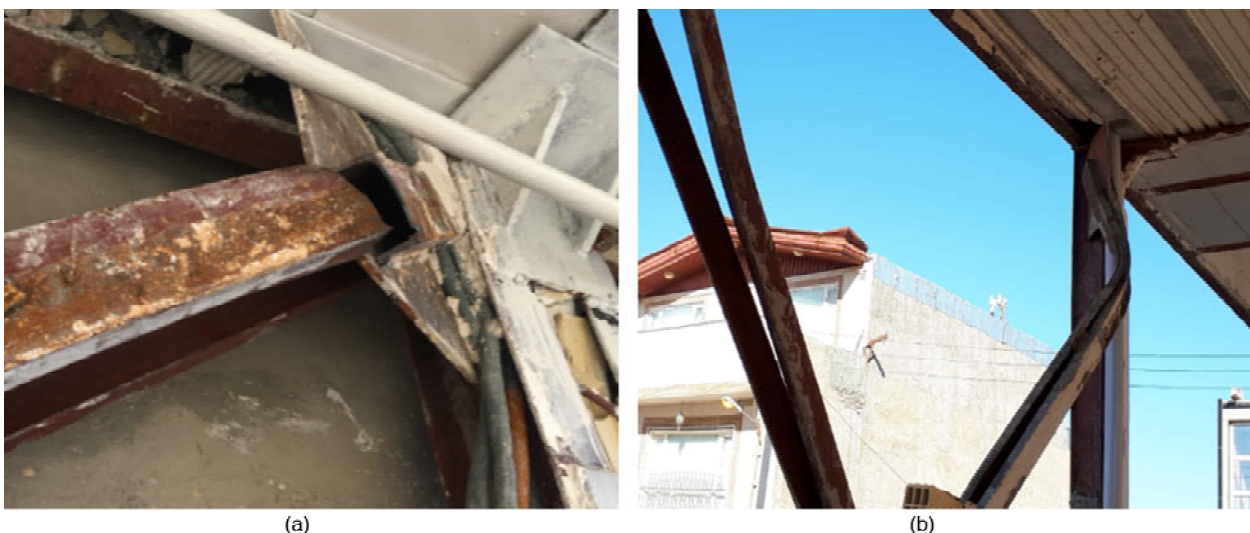
well as a significant number of brittle failure of the welded brace connections. The investigation demonstrated that the capacity of the welds was well below the actual strength of the bracing members and the forces that likely developed in these members during the shaking. In many cases, bracing members experienced significant inelastic out-of-plane buckling not only because of the axial seismic loads, but also because of premature failure and excessive out-of-plane rotations of gusset plates as shown in Figure (4).

**Figure 4.** Premature buckling of brace members due to the excessive out-of-plane deformation in gusset plates.

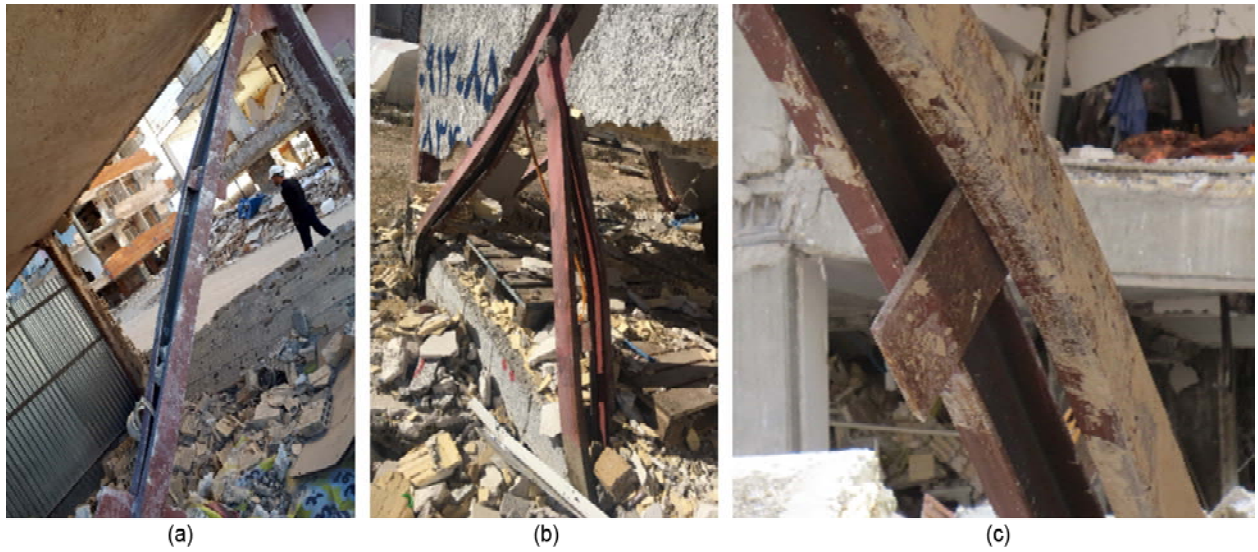
A widespread failure mode, observed in braced frames, was the early buckling of built-up brace members with double channel section, due to the lack of connector plates or brace-to-connector welding as shown in Figure (5). According to AISC-360 [3], the longitudinal spacing of connectors, connecting components of built-up compression members must be such that the slenderness ratio of individual shapes does not exceed three-fourths of the slenderness ratio of the governing slenderness ratio of the built-up member. By ignoring the connector plates, the buckling response of built-up brace member, would be governed by single channel section characteristics with global buckling capacity, much lower than that of a double channel section.

**Figure 5.** Lack of connector plates or brace-to-connection plate welding in brace members with double channel section.

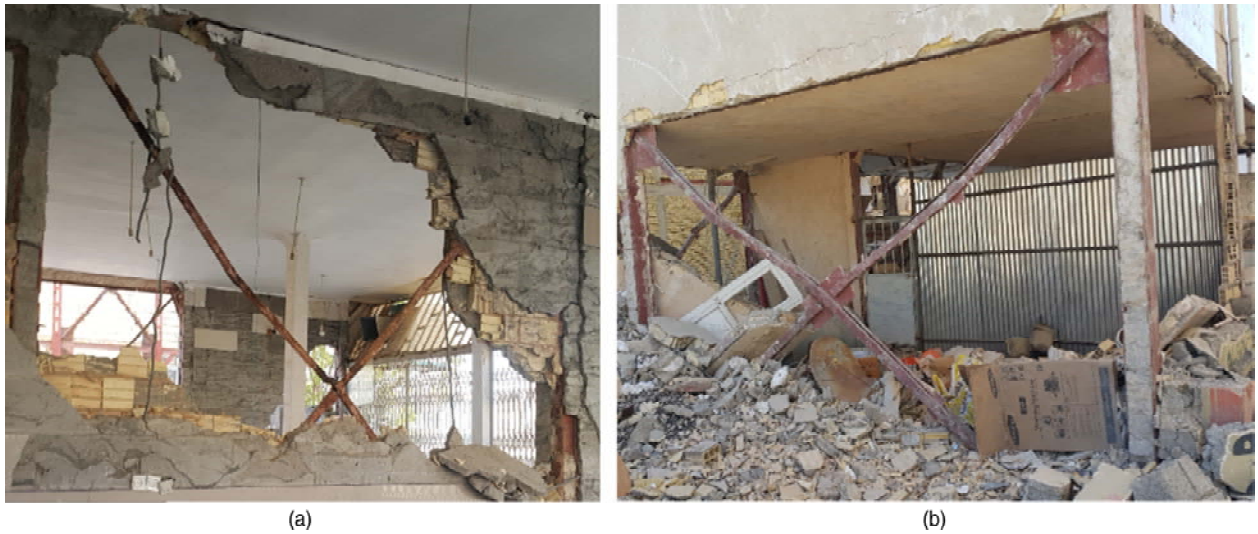
As well as ignoring connector plates in brace elements, implementation of slender brace members and improper brace splices as shown in Figures (6) and (7), caused premature buckling and fracture of brace members.

**Figure 6.** Overall buckling of slender brace members.

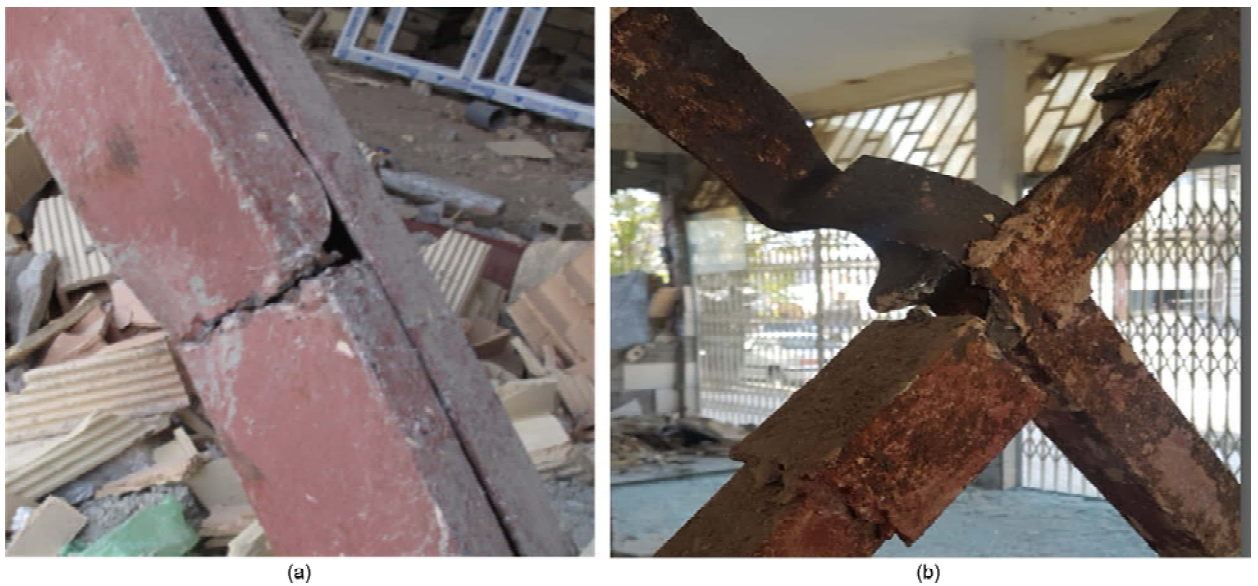
**Figure 7.** Inappropriate brace splices.

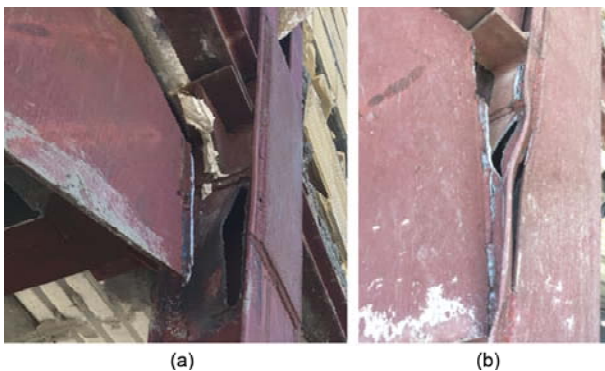
**Figure 8.** Premature failure of brace connection due to the direct welding of gusset plate to columns web led to column web rupture.

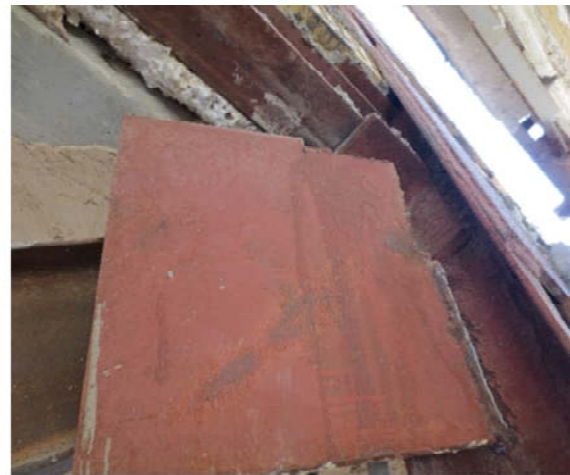
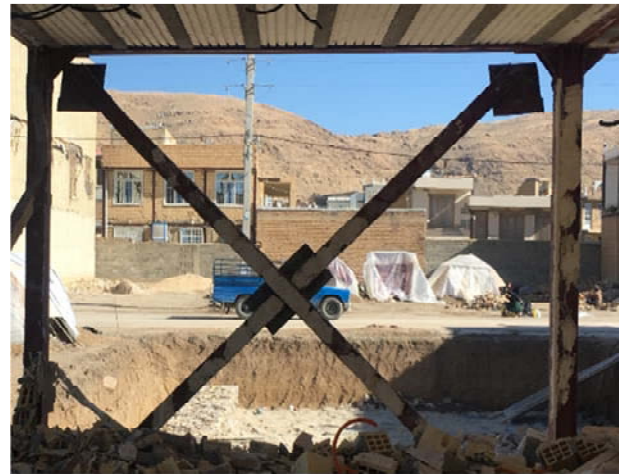
**Figure 9.** Ignoring gusset-to-beam welding.

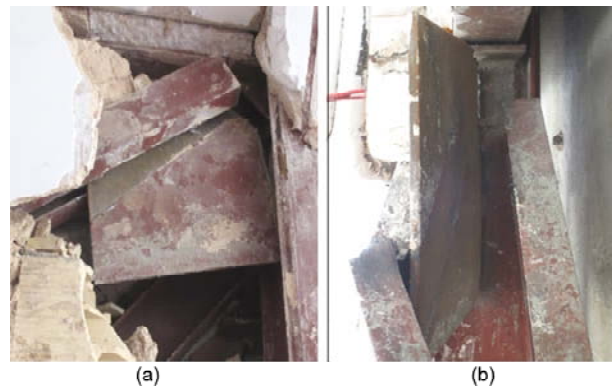
quality of brace-to-gusset plate welding as shown in Figures (10) and (11).

**Figure 10.** Ignoring brace-to-gusset plate welding.

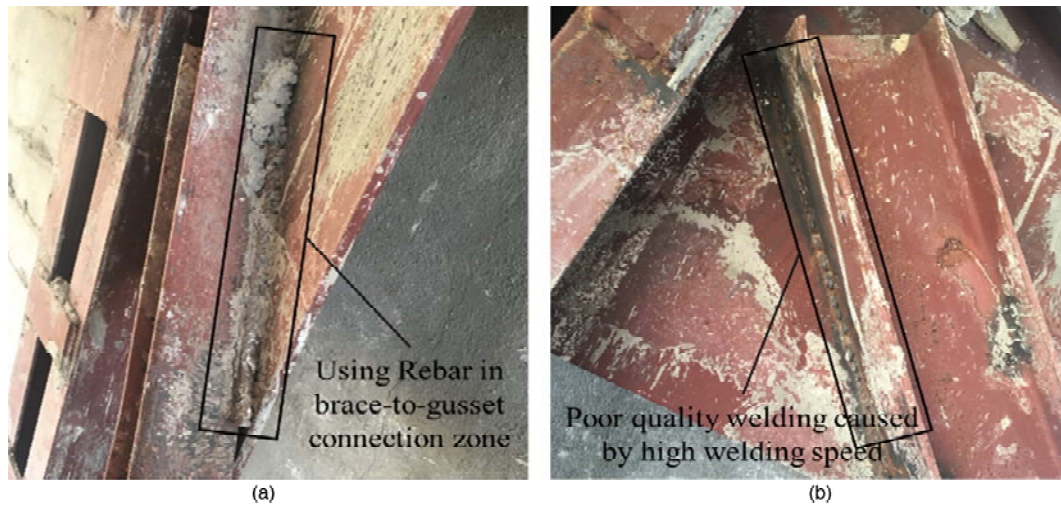
Figure 11. Poor quality of welding in brace connections.

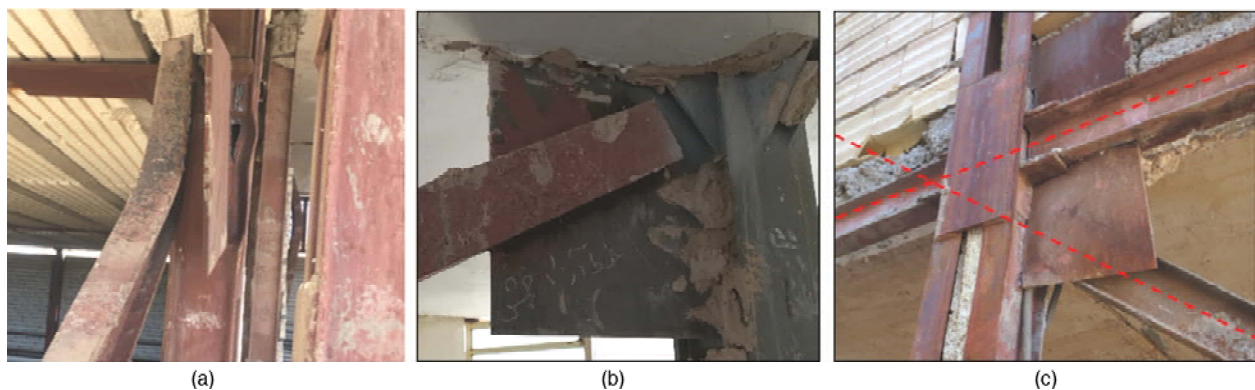
Finally, out-of-plane eccentricity in the connection, lack of consideration for a fold line in gusset plates and bending deformation caused by brace in-plane eccentricity can be considered as other widespread construction errors as shown in Figure (12).

Figure 12. Inappropriate geometrical detailing of gusset plate. (a) Out-of-plane eccentricity in the brace connection. (b) Ignoring fold line in gusset plate, necessary to accommodate significant rotations corresponding to out-of-plane buckling of brace. (c) In-plane eccentricity of brace to beam-column joint.

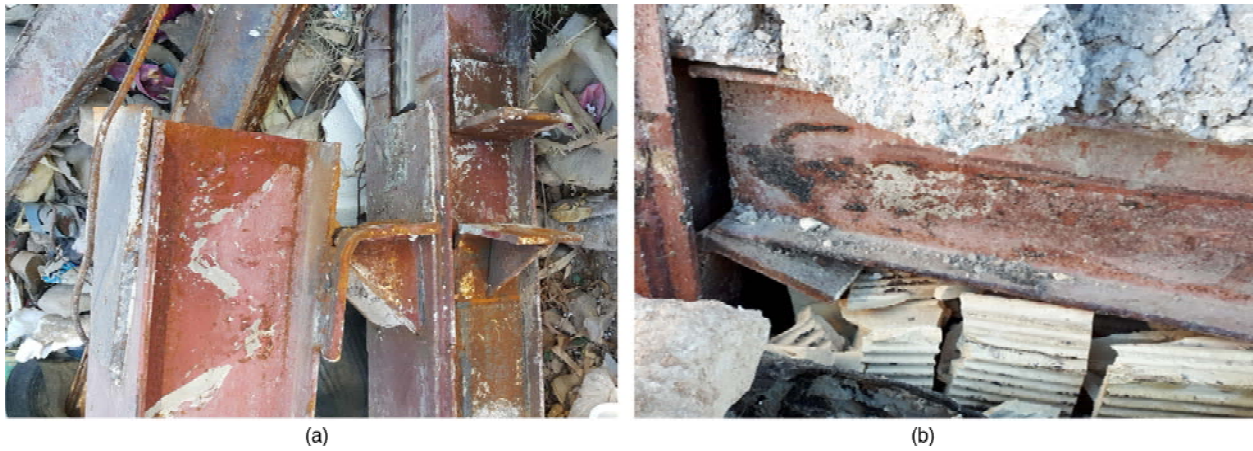
**Figure 15.** Common Brittle failure modes in moment connections. (a) Weld failure at the flange plate-to-column. (b) Weld failure at the flange plate-to-beam.

According to the observations, weld failure at the flange plate-to-column (Figure 15a) and flange plate-to-beam (Figure 15b) regions were the dominant failure mode in collapsed WFP connections.

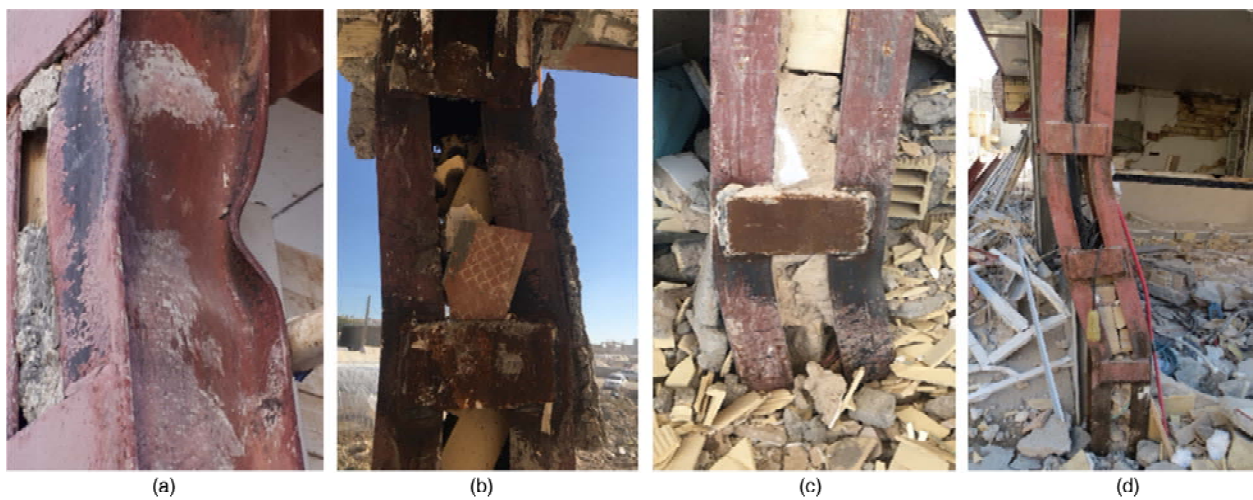
**Figure 16.** Formation of plastic hinges at the column ends.

As a result of incapability of moment connections to transfer moment and shear forces corresponding to the formation of plastic hinges at the beam ends and weak column / strong beams, all inelastic responses in moment frame were concentrated at the column ends. Formation of plastic hinges and local buckling at the column ends (Figure 16) led to the occurrence of widespread soft story mechanisms in damaged buildings.

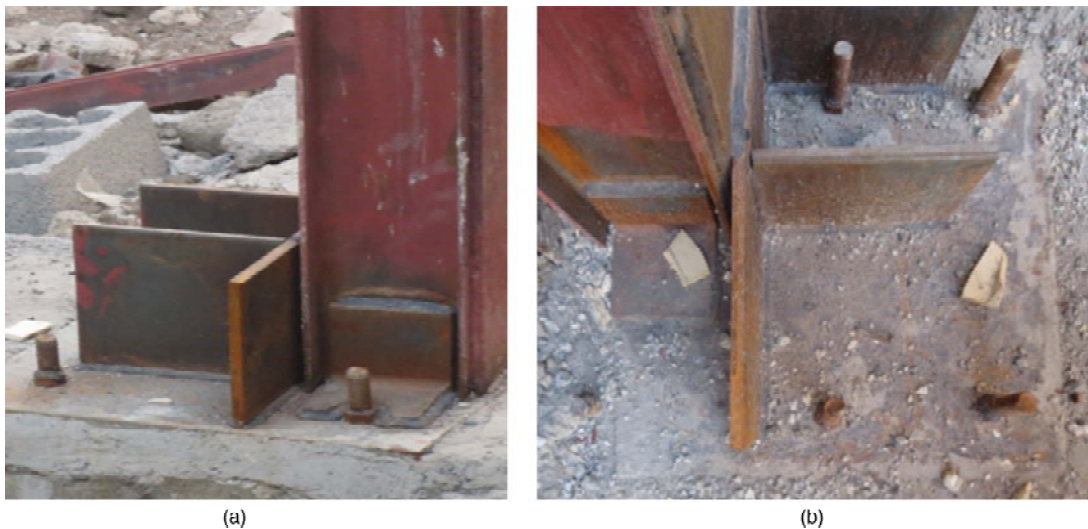
practice in earthquake affected areas are shown in Figure (17). Asymmetric alignment of column in base plate especially in the side base plates, insufficient and improper bolt layout in base plate, lack base plate stiffeners and etc. are obvious according to Figure (17).

**Figure 17.** Common base plate construction practice in earthquake affected areas.

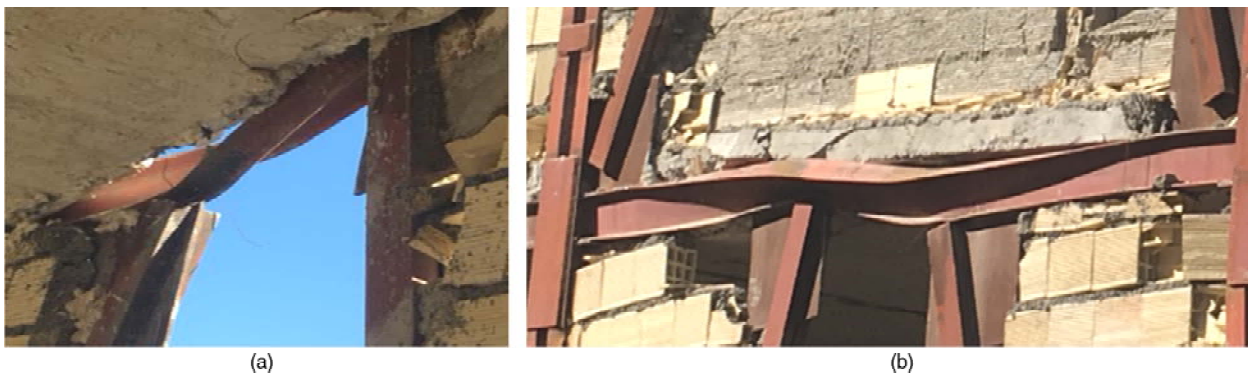
**Figure 18.** Lateral-torsional buckling of link member due to the lack of lateral bracing of link member.

as diagonal braces, columns, and portions of the beam outside of the link remain essentially elastic under the forces that can be developed by fully yielded links. In contrast with CBFs, beam elements in EBFs are subjected to significant shear and bending actions and it is necessary to provide lateral bracing for link members to avoid lateral and lateral-torsional buckling especially at the ends of the link member to ensure stable cyclic behavior. Full-depth stiffeners at the ends of link member and intermediate web stiffeners are also required in link members to transfer the link shear forces to the reacting elements, restrain the link web against buckling and to delay the onset of inelastic shear buckling of the web. Although EBF with proper seismic detailing can provide a satisfying amount ductility, elastic stiffness and dissipation capacity, a significant number of damaged structures with inappropriate eccentrically braced frames, observed during the site visits. As shown in Figure (18), lack of lateral bracing and stiffeners in link members

caused premature out-of-plane buckling of link member in early earthquake excitations for significant number of steel structures with EBF.

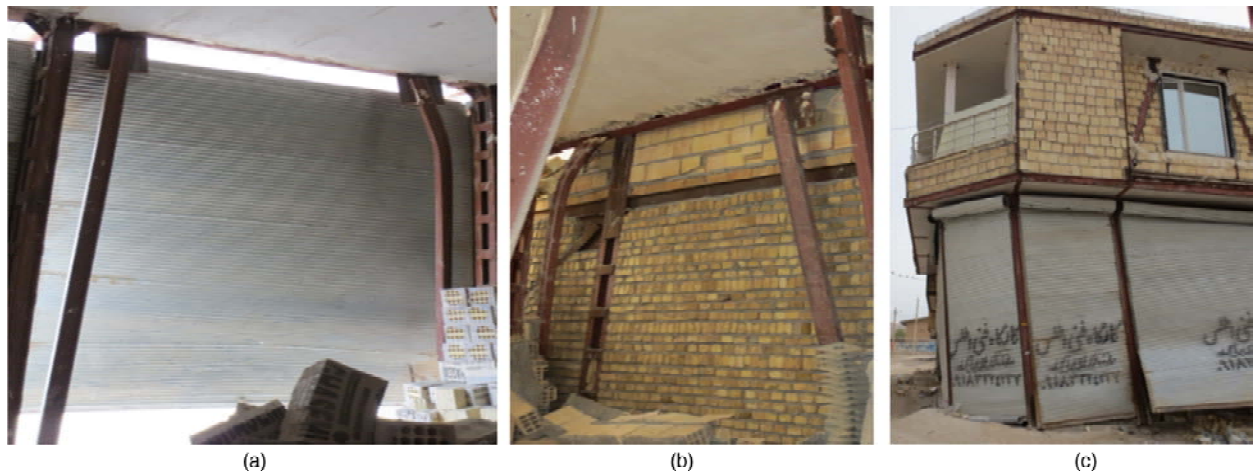
Figure (20) shows the case study of a 2-story residential building in Sarpol-e Zahab city with eccentrically braced frame system in both direction. The semi-rigid beam-to-column connections like samples shown in Figure (15), in one direction and

unstiffened Seat angle connection in orthogonal direction are implemented. As it is evident in Figure (20), due to the excessive eccentricity ratio implemented in the eccentrically braced bays

( $e/L > 5$ ), the presence of EBFs showed little effect on the lateral stiffness of building. Removing the infills as well as the higher ceiling in the first story of building, intensified the lateral instability of building and formation of soft story mechanism. It is evident that, the corrugated steel panels, prevented the structural collapse through their in plane stiffness as shown in Figure (20c).

Figure 20. Case study: A 2-story eccentrically braced frame building with excessive eccentricity ratio.

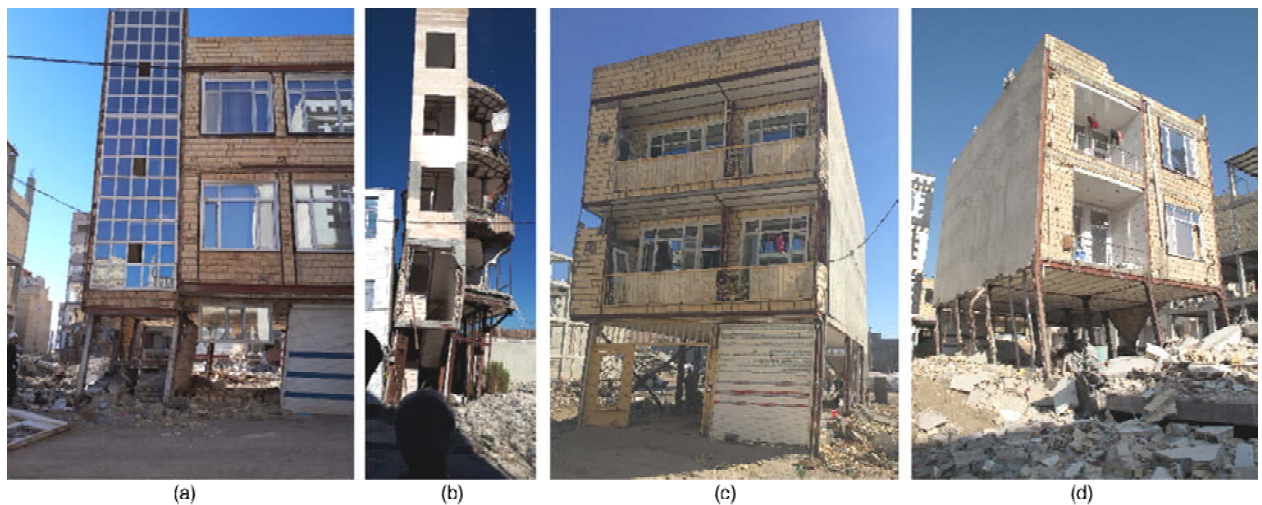
The soft story phenomenon was widely observed among damaged buildings with different LFRS in earthquake affected areas as shown in Figure (21). In moment resisting frames, incapability of implemented moment connections to transfer moment and shear actions corresponding to developing of plastic hinges at the beam ends and strong beam/weak columns are the most important causes for

Figure 21. Soft story phenomenon.

the formation of soft story mechanism; while in CBFs, premature failure of brace connections and buckling of braces in early seismic excitations are the most common soft story causes. Finally, in EBFs, the implementation of large eccentricity ratio (Figure 20), as well as the lack of lateral bracing and stiffeners for link member, are the most important and widespread soft story causes. The Iranian seismic code, has not provided any mandatory regulations to avoid "soft story" for structures with three stories or less while, according to observations, low-rise steel buildings, are also vulnerable to soft story damages.

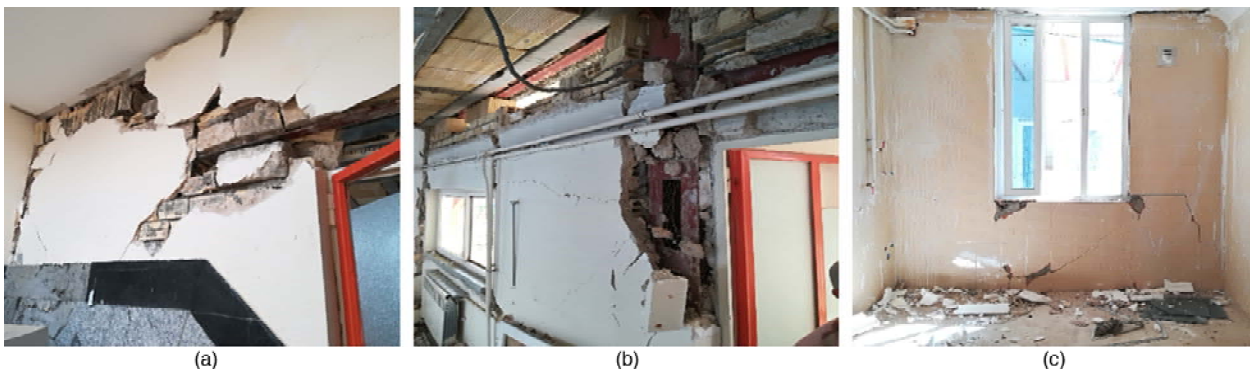
Figure 22. In-plane failure of infill walls.

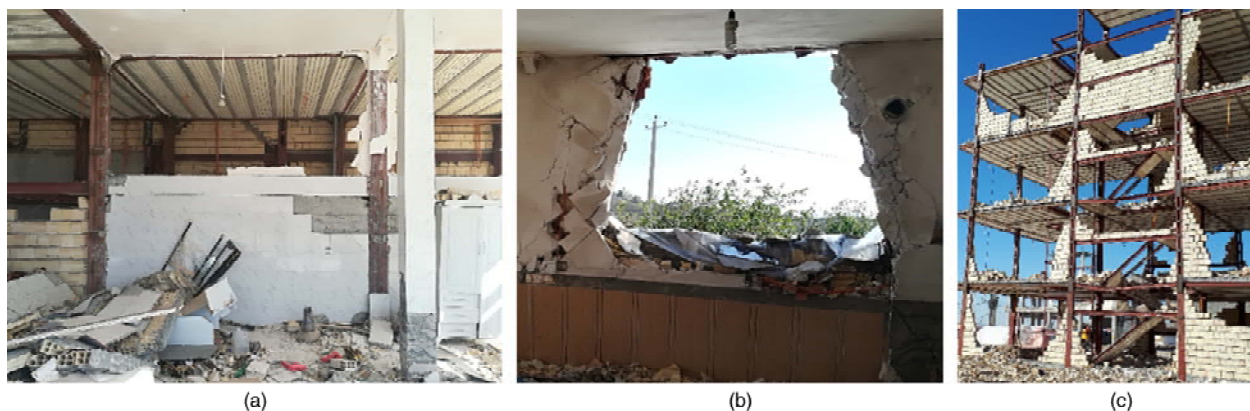
Figure 23. Out-of-plane failure of infill walls.

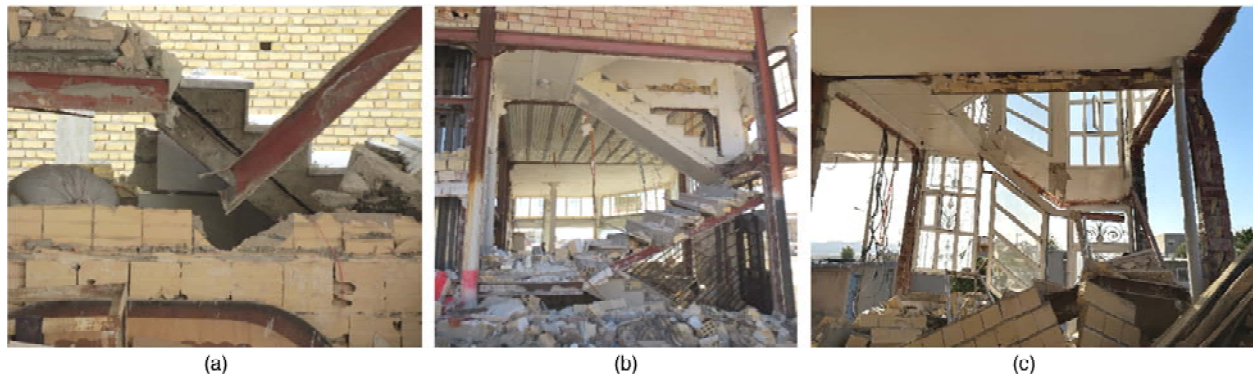
Figure 24. Failure of staircase.
