Earthquake Building Damage Detection Using VHR Satellite Data (Case Study: Two Villages Near Sarpol-e Zahab)

Babak Mansouri^{1*}, Shakiba Mousavi², and Kambod Amini-Hosseini¹

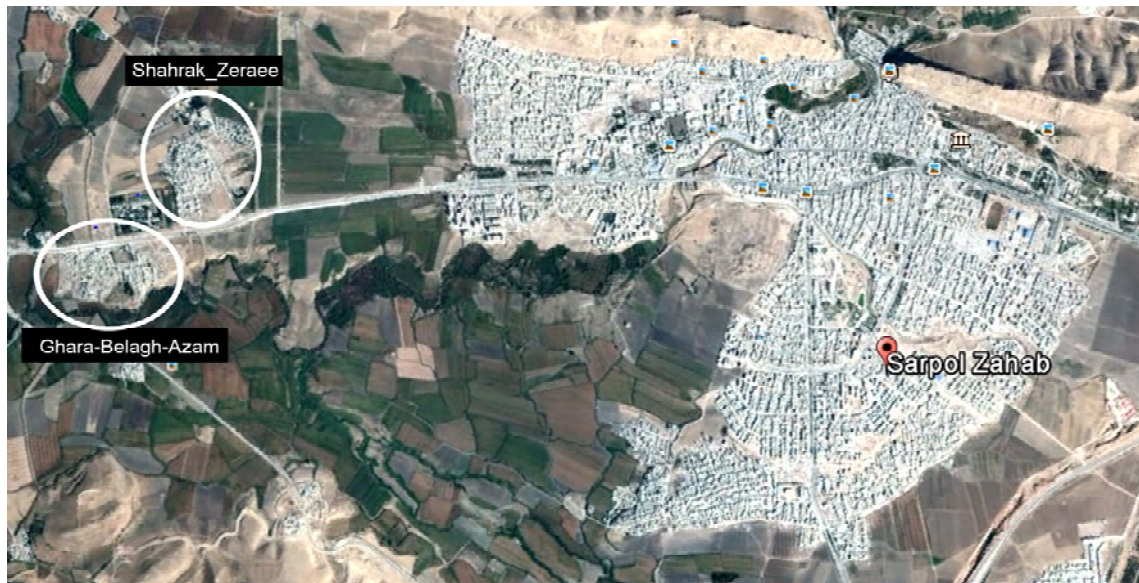
Figure 1. Post-event Google Earth image of study area Ghara-Belagh-Azam and Shahrak Zeraee [10].

area comprised of rather newly built dwellings but without proper earthquake resistance. The southern band of the city contained vulnerable older buildings. Both these areas suffered devastating damages and casualties. Two highly hit villages namely Ghara-Belagh-Azam and Shahrak Zeraee adjacent to the northwest of the city were selected for this study. For this area, a reconnaissance trip has been conducted by the authors where the extent and the general aspects of building damages were observed. The dominant construction types were recognized as low-rise poor masonry or weak steel structures with infill brick walls, **Figure (1)**.

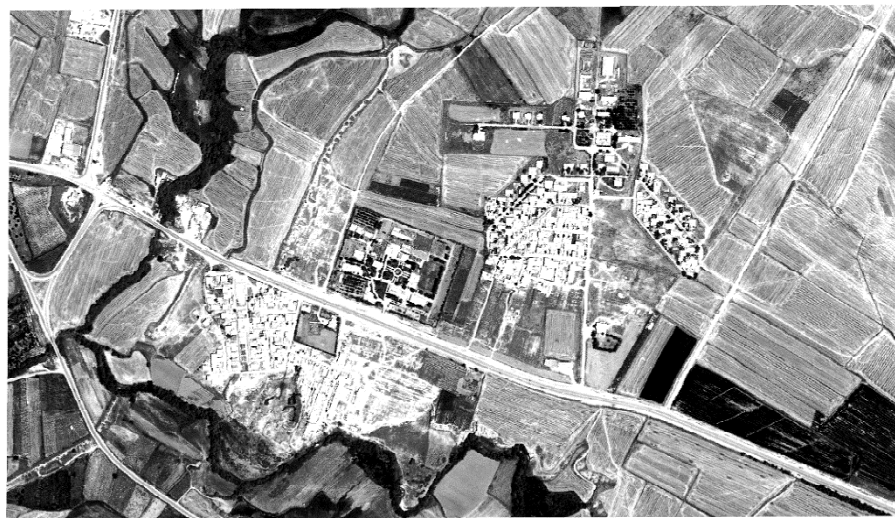
Figure 2. Pre-event panchromatic image of study area (courtesy of TRIPLESAT_2).

satellites were acquired for both before and after the event. The specifications of these satellites are listed in Table (1). TripleSat_2 is a constellation of three identical Beijing-2 satellites. SV1 or SuperView1 is among the latest China high-resolution optical commercial satellites. Parts of the satellite images for both pre-EQ and post-EQ showing the study area are presented in Figures (2) and (3).

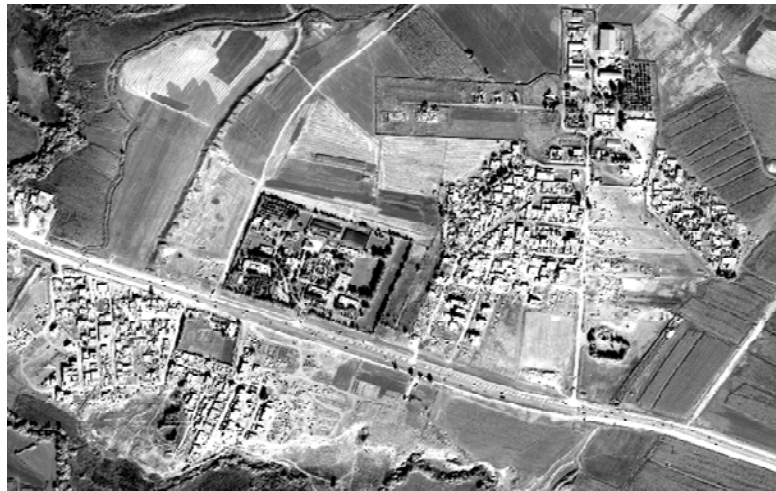
Figure 3. Post-event panchromatic image of study area (courtesy of SV1).

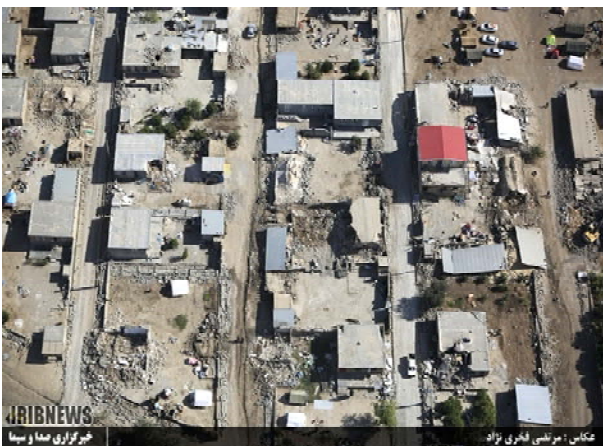
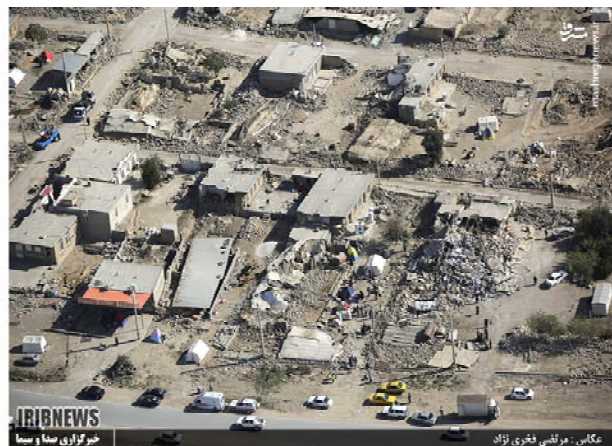
Figure 4. Aerial photography for high hit zones (courtesy of IRIB news agencies).

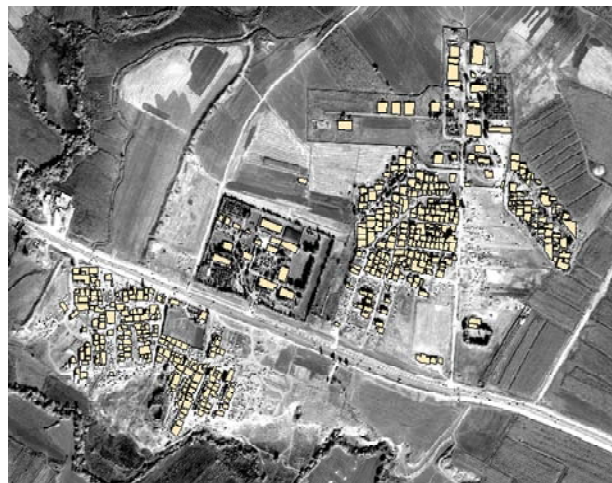
Figure 5. Building mask defined as individual property boundaries (building footprint and yard).

almost all possible building-related damages, the "building objects" have been actually taken as the "property mask" comprised of the building footprints and the associated yards (lands) as shown in Figure (5).

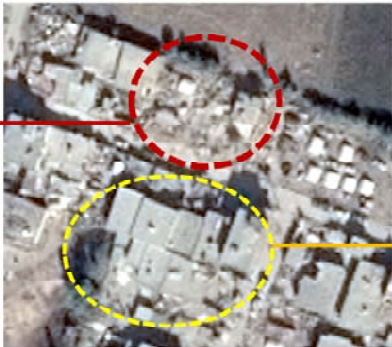
Table 3. Building damage classification according to visual interpretation from post-earthquake satellite image.

Pattern Classification with Visual Interpretation	
Changed (Collapsed) Buildings Shown in Red	Unchanged (No Collapsed) Buildings Shown in Yellow

based damage mapping, the building pool was classified into two classes of "Changed/Collapse" or "Unchanged/No Collapsed". Change/damage patterns for the building footprints are explained in Table (3) where building damage classification are interpreted visually from post-earthquake satellite image.

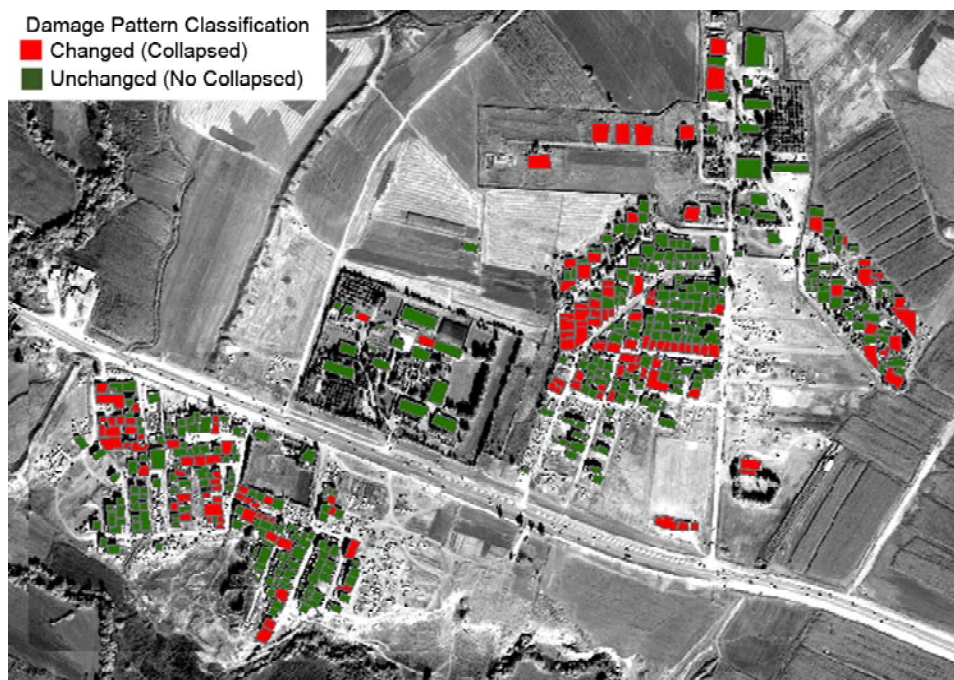
Figure 6. Reference damage map according to the visual interpretation of post-earthquake satellite image.

Since the ground truth information and the survey data of the study area was not available, visual interpretation of post-earthquake satellite image was performed as a reference damage map for evaluating the building damage detection accuracy. One way for creating a reference damage map is by visual interpretation of severely damaged or collapsed buildings by comparing pre- and post-satellite imageries. Usually lower damage grades are difficult to identify, so the pre-event imagery can be helpful in detecting such minute changes through visual interpretation. In this study, only post-event image has been used for visual ground truth due to its better available spatial resolution. For better visualization and manual damage mapping, pansharpened post-event Pleiades-1A has been utilized where the data specification is listed in Table (2). The final reference damage map shown in Figure (6) was produced by inferring the severity of changes and the signatures of the debris within and around the building footprints (modifying and completing the Iranian Space Agency damage map). According to this satellite-

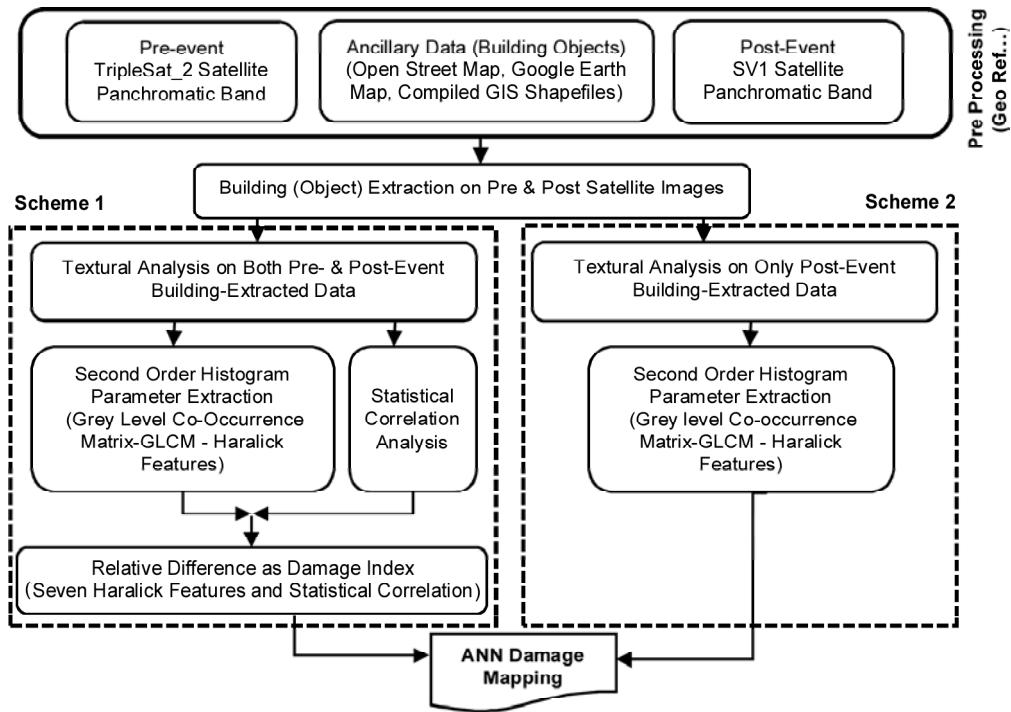
Figure 7. Flowchart of the proposed method.

correlation in addition to the mentioned textural indices were considered as input to the proposed artificial neural network where two classes of "changed" and "unchanged" are specified. In the second method, only the post-event image has been taken into account. This is because in many instances "before" data cannot be accessible for comparison or there is a spatial resolution incompatibility between before and after images. For this, seven Haralick textural indices were computed for the building objects in the post image, and finally the ANN has been trained according to the reference data in order to produce the city-wide damage map. Figure (7) depicts the flowchart describing the steps involved in both schemes for the presented methodology.

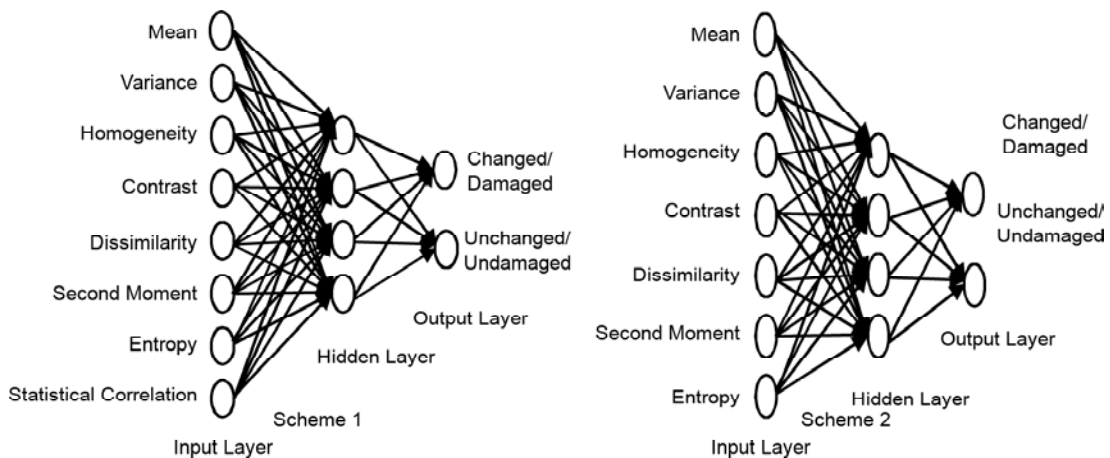
Figure 8. Proposed ANN structure for change/damage detection.

Soft computing ANN is regarded as an effective technique for classification or decision problems. The neural network has many advantages and capabilities such as adaptive learning, generalization, and classification. ANN is usually very systematic and straightforward to implement. In that, the system learns from some train data sets and then sets itself up for systematically classifying the whole entries in an automated fashion. Figure (8) depicts the ANN feed-forward architecture as implemented

in this study where the number of separated input indices are eight for the scheme one, and seven for scheme two, each having a hidden layer of four nodes and an output layer of two nodes indicating two distinct levels of changed (collapsed) and unchanged (no collapsed). A sigmoid transfer function has been used for the activation of the neurons. The above ANN architecture and the associated algorithm were implemented using the Neural Network Toolbox of Matlab computer code.

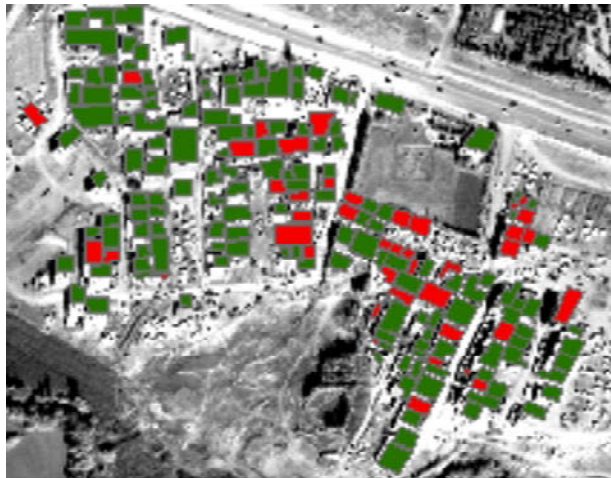
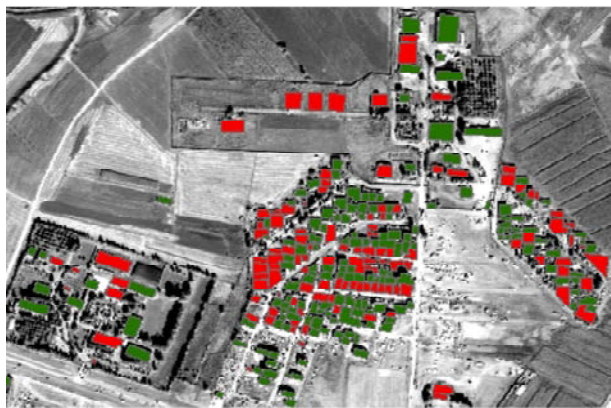
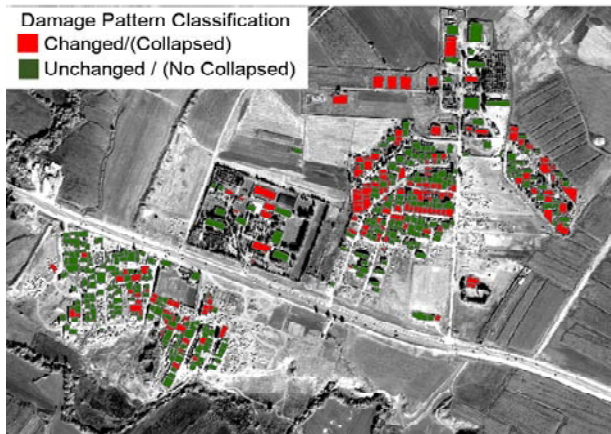
(a) Damage Mapping for Ghara-Belagh-Azam Using Both Pre_Event and Post_Event Images

(b) Dmage Mapping for Shahrak_Zeraee Using Both Pre_Event and Post_Event Images

Figure 9. Damage mapping for two villages using both pre event and post event images.

Scheme 1: Both pre-event and post-event data were utilized and the damage detection algorithm tends to reflect within object changes. The input change indices are set as the relative differences (from pre_ and post_ data) of the seven textural features per individual building objects. In addition to the seven Haralick features, the statistical correlation values have been also computed for each individual objects (building property layout) considering both before and after satellite images having in mind that a higher values would reflect no detectable changes and vice versa.

The proposed model produces an Overall Accuracy of 72%, a Producer's Accuracy of 60% for "Changed" and 76% for "Unchanged", and a User's Accuracy of 48% for the "Changed" and 84% for the "Unchanged" classes in scheme 1. For scheme 2, the overall accuracy is calculated as 75%. The Producer's Accuracy of 68% for "Changed" and 78% for "Unchanged", and a User's Accuracy of 53% for the "Changed" and 87% for the "Unchanged" classes. These figures show that the algorithm was more effective for detecting the "Unchanged" class.

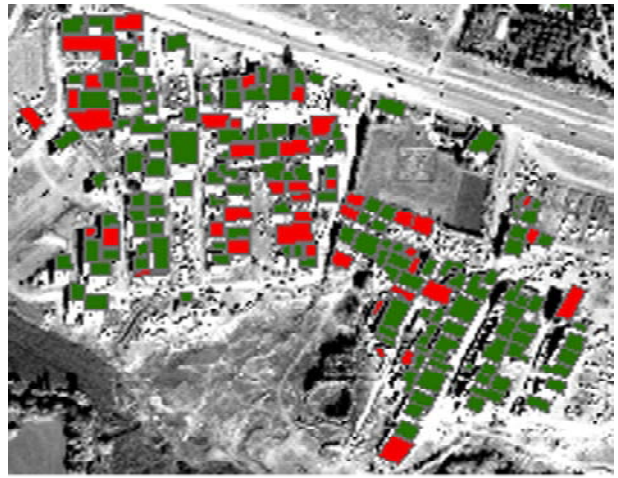
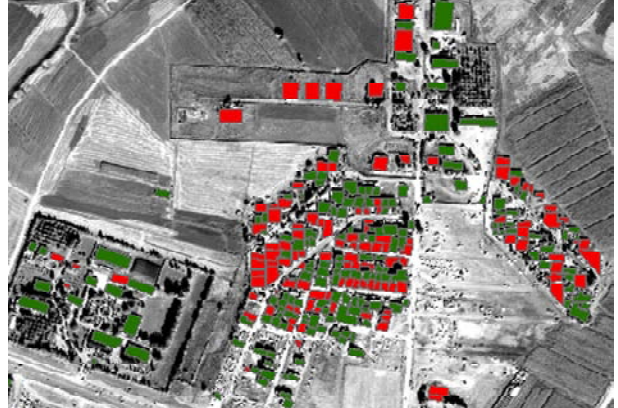
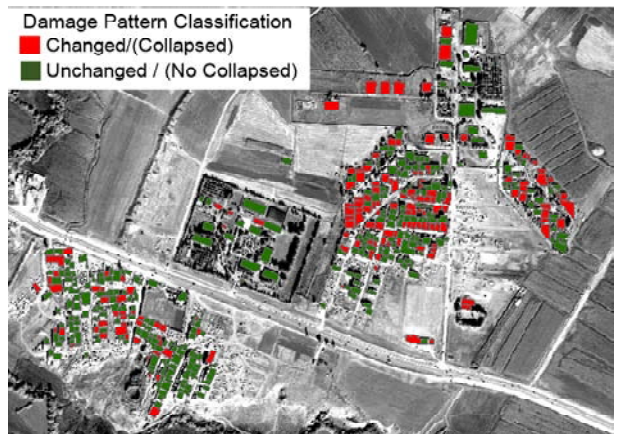
(a) Damage Mapping for Ghara-Belagh-Azam Using Only Post_Event Damage Image

(b) Dmage Mapping for Shahrak_Zeraee Using Only Post_Event Damage Image

Figure 10. Damage mapping for two villages using only post event damage image.

Scheme 2: Only post-event data has been utilized; therefore, the change indices are considered as the pure Haralick features and the comparison in between different objects has been sought.
