Axial Load Collapse of Reinforced Concrete Columns with Light Transverse Reinforcement

Javad Yadegari¹, Omid Bahar^{2*}, and Mohammad Khanmohammadi³

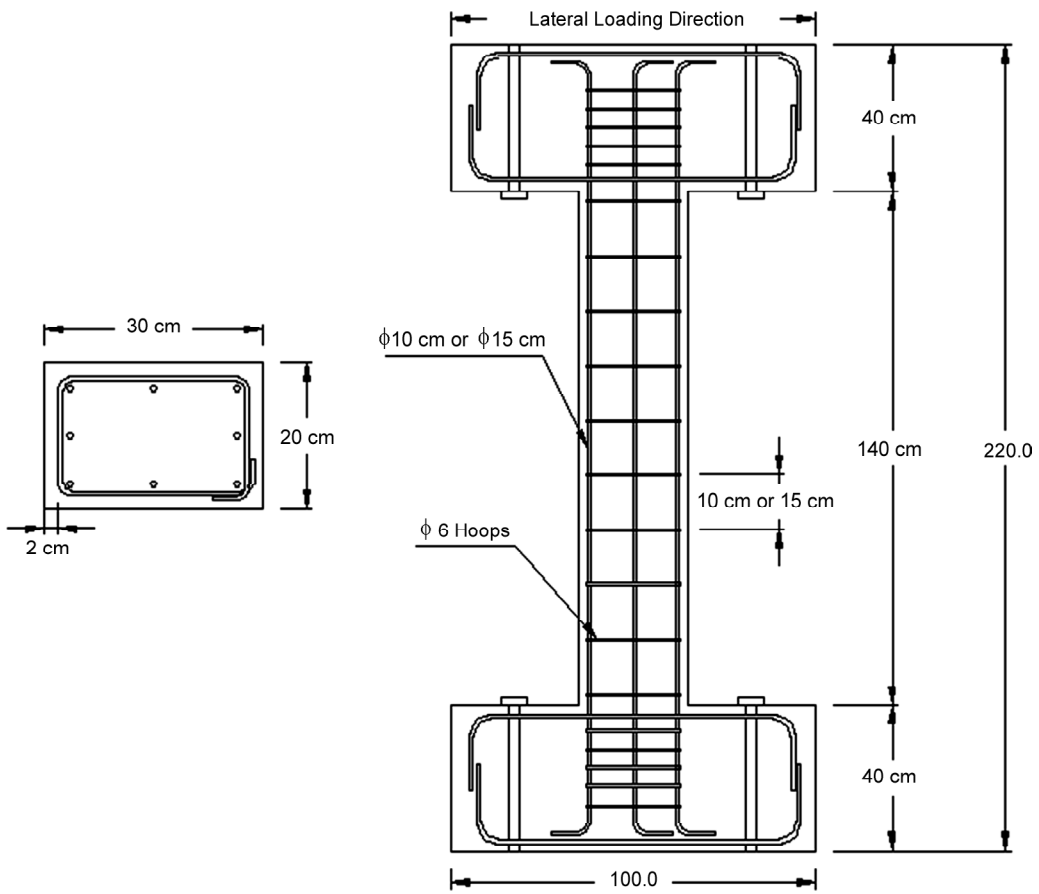
Figure 1. Typical Detail of Specimens.

had a length of 1400 mm and cross section dimension of 200×300 mm. The longitudinal reinforcement consisted of eight bars. Three specimens were reinforced with Φ10 and two specimens with Φ12 (longitudinal reinforcing ratio of 1.05% and 1.51% respectively). In all cases, Φ6 bars were used as a transverse reinforcement.

All five non-ductile specimens had transverse reinforcement consisting of closed hoops with 90 bend. In three cases, they were spaced 150 mm apart, and in two cases, they were spaced 100 mm. In the standard specimen, cross ties were used as well as closed hoops, and both had standard 135 hooks. The concrete cover was 20 mm. Compressive strength of the concrete was measured on the day of the test. Specimen structural properties are listed in Table (1) and arrangement of reinforcement and sectional view are given in Figure (1).

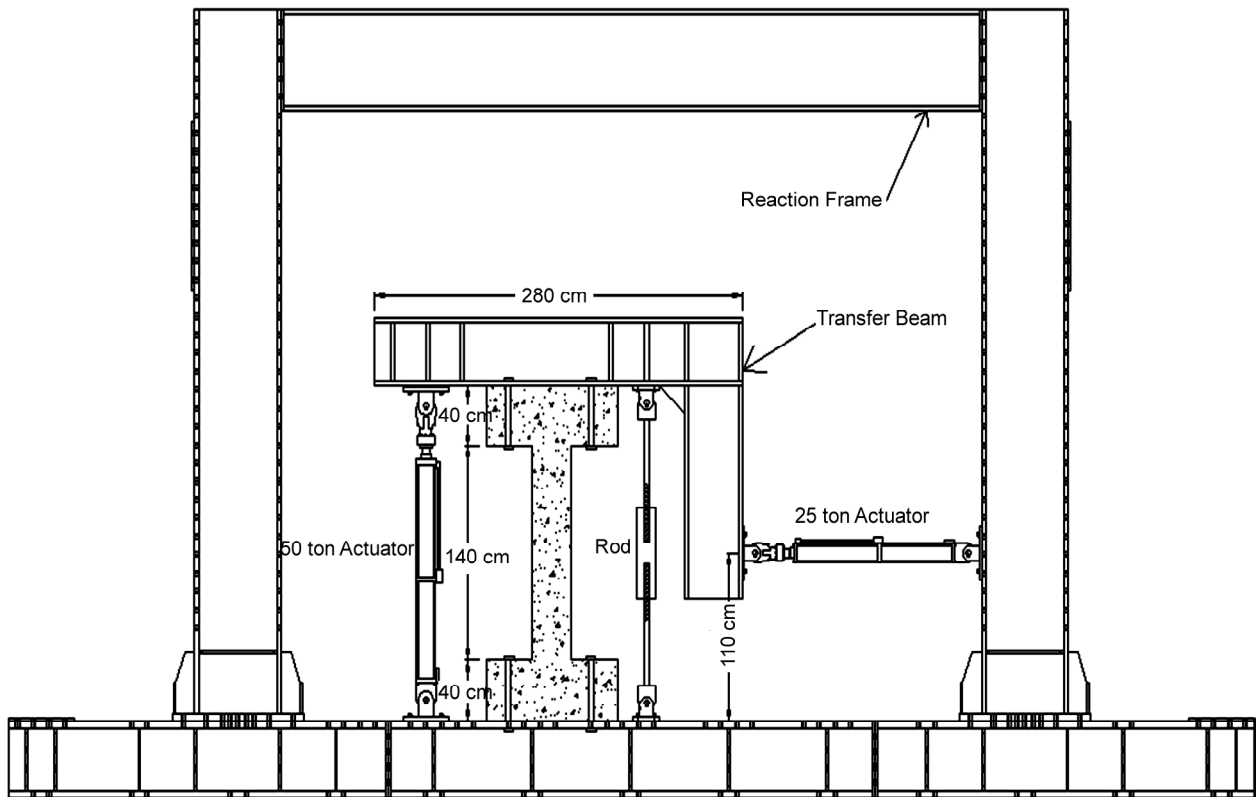
Figure 2. Loading apparatus and details of test setup.

The applied loading setup and apparatus are illustrated in Figure (2). The system was designed to make sure that level of lateral load was exactly at the level of inflection point of the column. A vertical actuator at one side of the column and a vertical rod at the other side were used to provide axial load. Actuator applied constant force through the test. The rod was equipped with strain gauge that measured its axial load during the test. At the beginning, rod and actuator had equal forces.

During each test, upper joint of column rotated slightly and rod force changed. The amount of upper joint rotation and rod force were recorded. A reversible horizontal load was applied to the top of the column, using a 25 ton capacity actuator, which was mounted on a reaction frame. The actuator was pinned at both ends to allow rotation during the test.

The base of the column was fixed to a strong floor by four post-tensioned bolts.

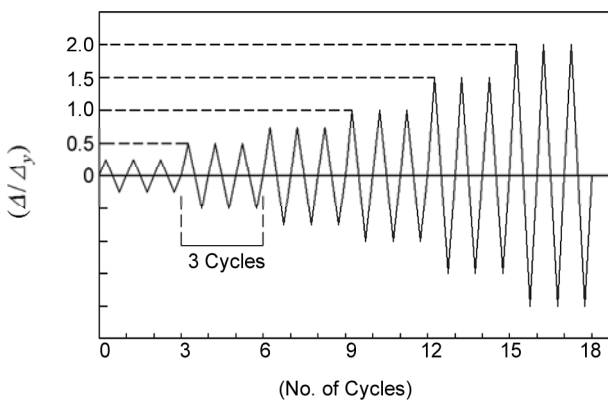
Figure 3. Lateral loading procedure.

The specimens were tested under the combination of a constant vertical force and a cyclic horizontal force. At first, the axial load was applied to the specimens until the designated level was achieved. Then the lateral load was applied cyclically through the horizontal actuator in a quasi-static fashion as shown in Figure (2). The loading procedure consisting of displacement-controlled steps is illustrated in Figure (3).

The prescribed lateral displacement history was a function of the yield displacement. The yield displacement is sum of three components: flexure, slip and shear. Displacement due to flexure was obtained assuming the curvature varied linearly from the yield curvature at the ends to zero at mid height, yielding a value of 3.5 mm. The contribution of bar slip and shear distortion at the yield load were calculated as 3 mm and 0.3 mm, respectively [19]. Based on these calculations, during the tests, a yield displacement D_y of 8 mm was used for the lateral displacement histories. The displacement history was applied initially with three cycles each at one fourth and one half of the calculated yield displacement. Once the yield displacement was reached, the amplitude of the displacement cycles was increased incrementally, i.e., three cycles each at D_y , $1.5D_y$, $2D_y$, $3D_y$, etc., until the specimen failed.

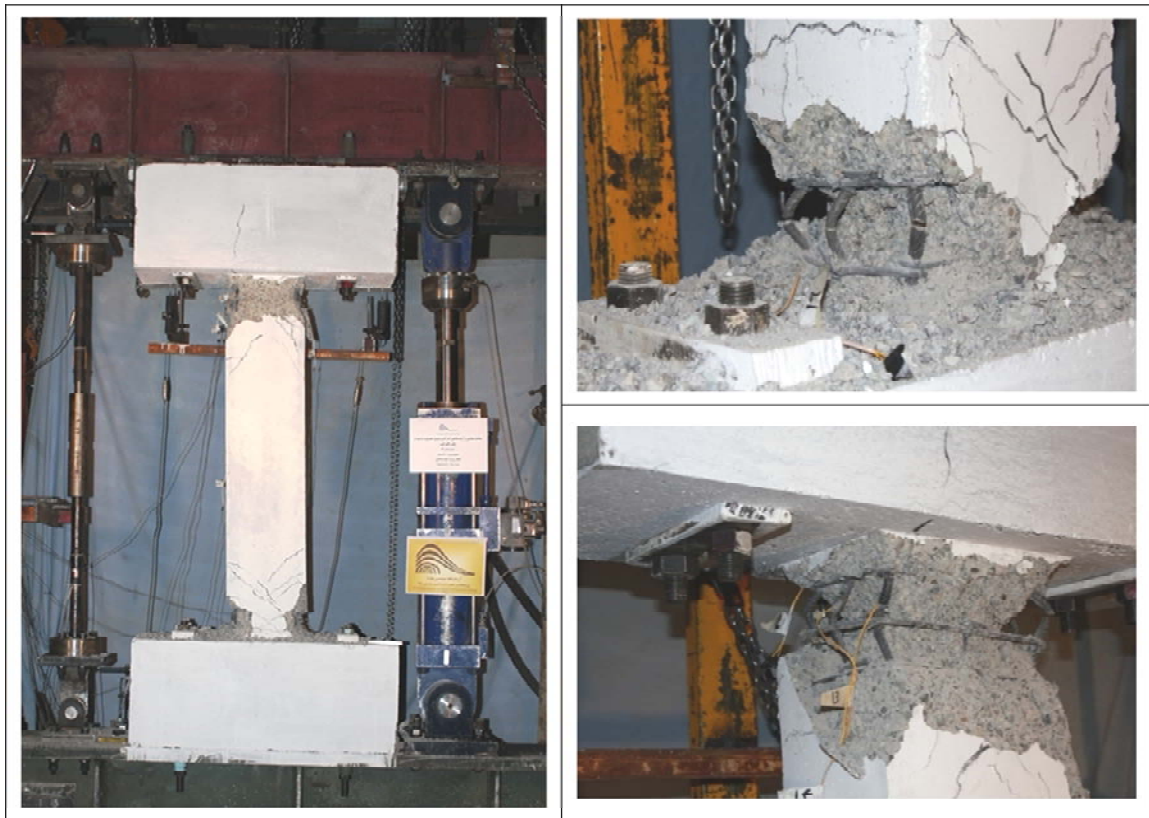
Figure 4. Crack pattern and axial failure in column S1.

Flexural cracks appeared at top and bottom of the columns at the drift of 0.8%. Inclined cracks emerged at the drift of 1.1% and concentrated in $\frac{1}{4}$ lengths of columns at both side under increasing displacement. Spalling of cover concrete was started at the drift of 2.3% and significant spalling was occurred at the drift ratio of 3.6%. Longitudinal reinforcements buckled at the drift of 4.6%. Lateral resistance started to drop at the drift of 4%. Continued cycling caused additional damage and loss of resistance. Test ended at the drift ratio of 5.7%, by which time lateral resistance had degraded effectively to zero but the column continued to support axial load. Figure (4) shows specimen 1 at the end of the test.

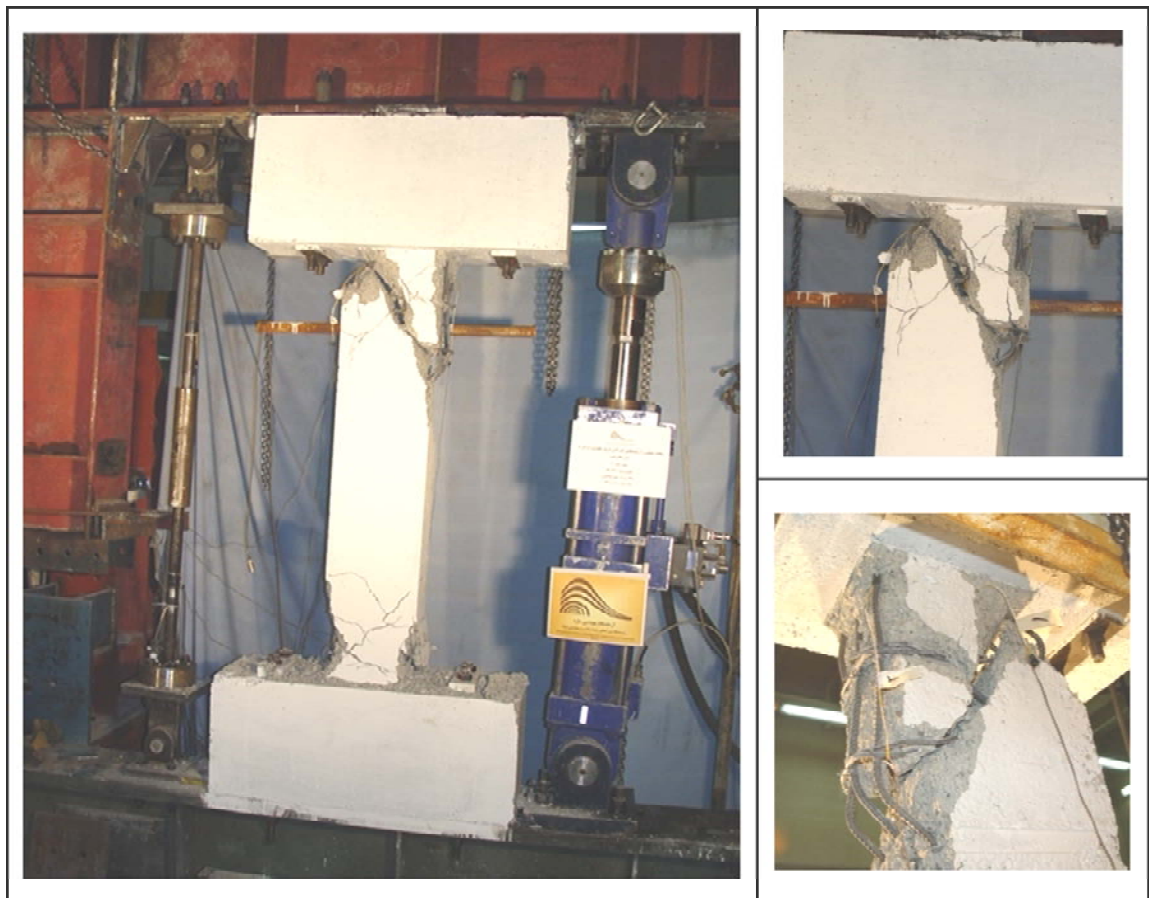
Figure 5. Crack pattern and axial failure in column S2.

Initial lateral stiffness of this specimen and specimen 1 was apparently the same owing to axial load. At the drift of 3.4% spalling of concrete was started and continued by buckling of the longitudinal bars. Lateral and axial failure occurred suddenly with the occurrence of a steep diagonal crack and apparent concrete crushing near the top of the column. Figure (5) shows specimen 2 at the end of the test.

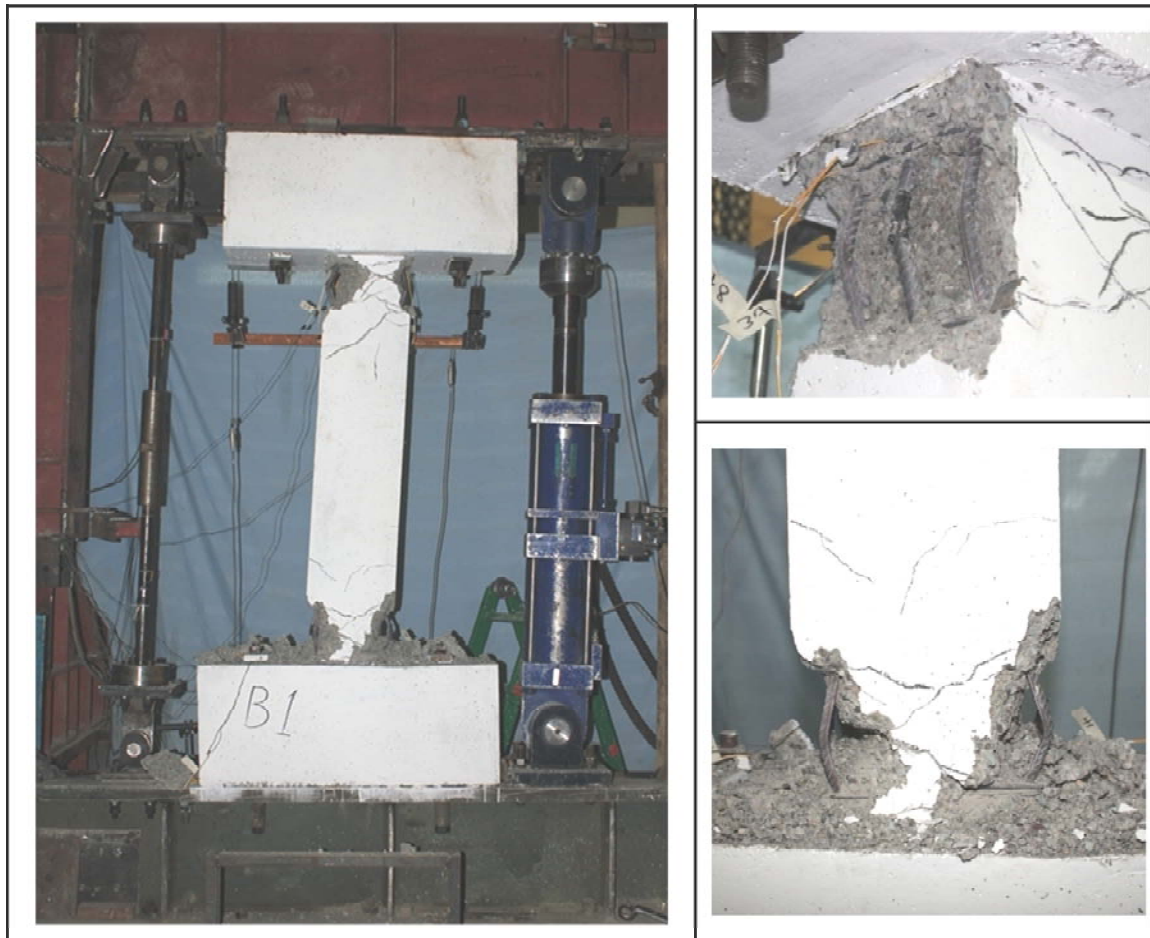
Figure 6. Crack pattern and axial failure in column S3.

Flexural cracks became visible at the drift ratio of 1.1% and then flexural-shear cracks appeared at the drift of 2.9%. At the drift ratio of 3.4% spalling of the cover concrete was started. Longitudinal bars buckled at the drift of 4.6%. The test stopped at the drift ratio of 5.1% when substantial decrease in lateral resistance of column was observed. Figure (6) shows specimen 3 at the end of the test.

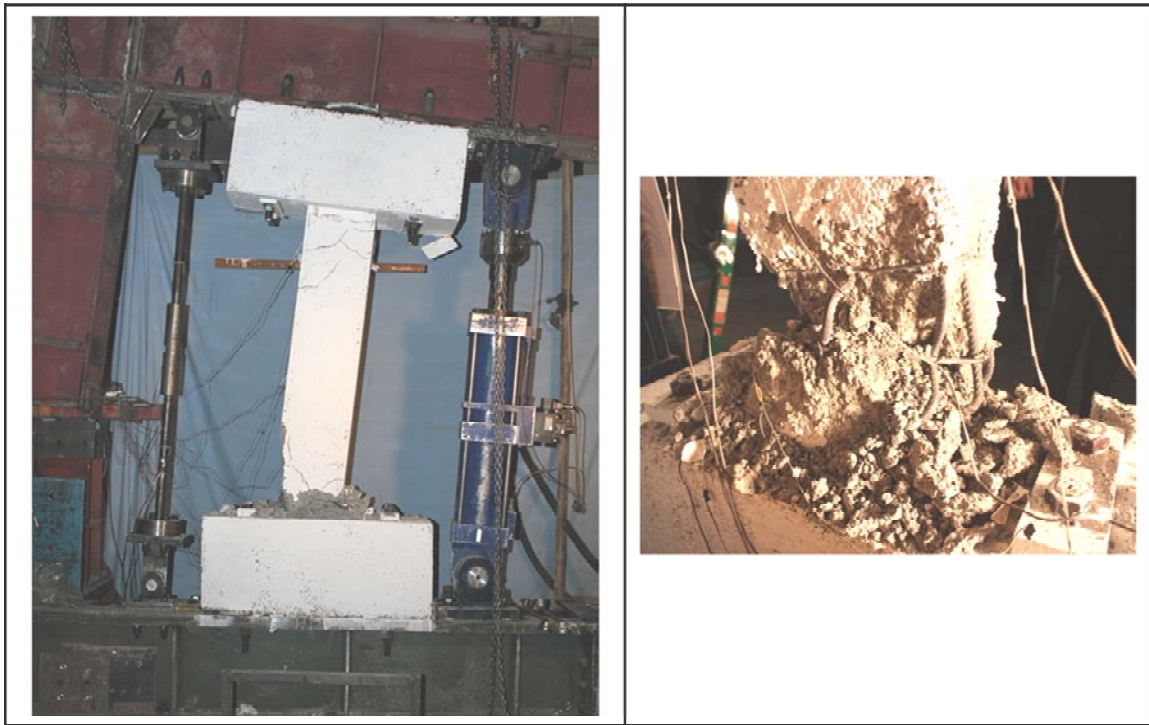
Figure 7. Crack pattern and axial failure in column S4.

obviously higher than that of specimen 3, owing to higher axial load. At the drift ratio of 2.3% main bars buckled and at the drift ratio of 2.9% column collapsed suddenly by crushing of concrete near the bottom of the column. Figure (7) shows specimen 4 at the end of the test.

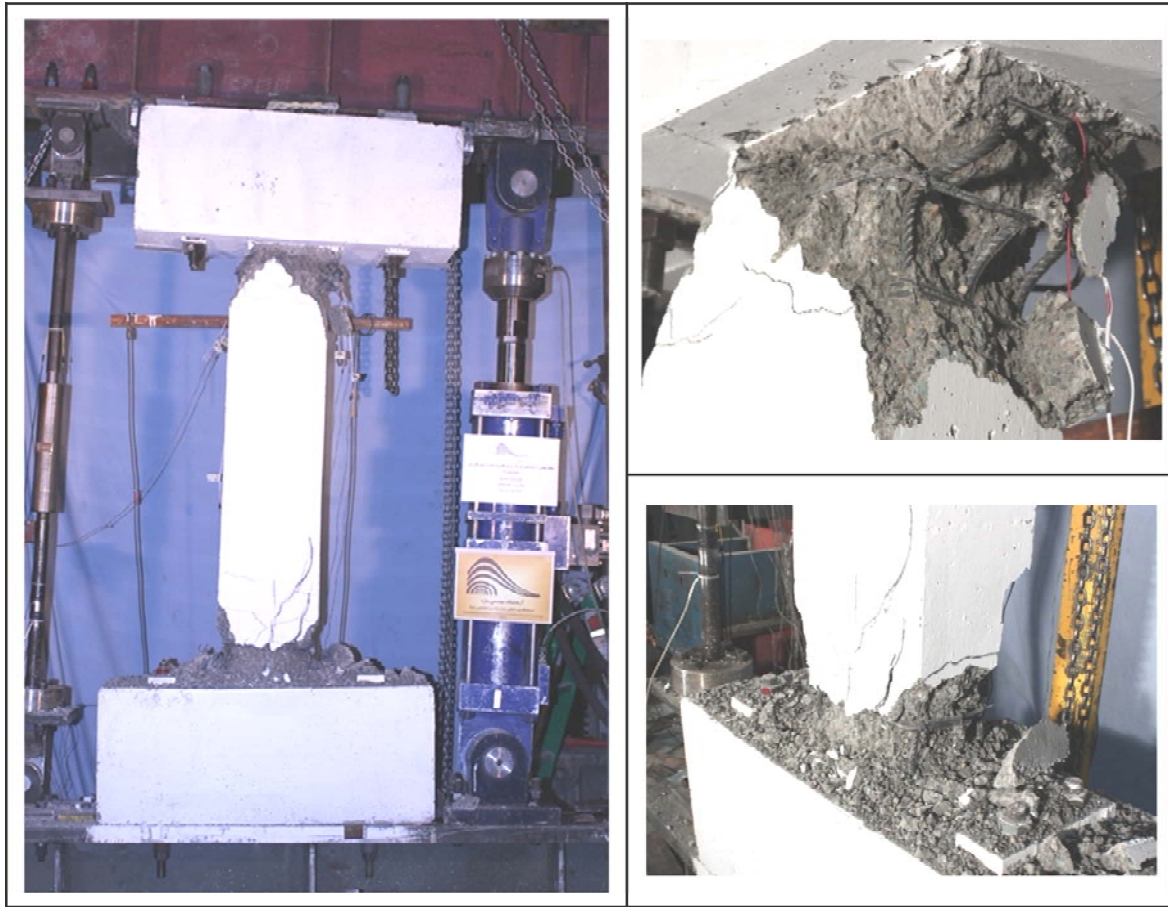
Figure 9. Crack pattern and axial failure in column S6.

Specimen 6 and 5 were exactly identical in details and properties. Initial lateral stiffness of specimen 6 was higher than that of specimen 5, owing to higher

axial load. At the drift ratio of 2.9%, significant spalling of cover concrete occurred. At the drift of 4%, column lost its gravity load carry capacity and axial failure happened. Figure (9) shows specimen 6 at the end of the test.

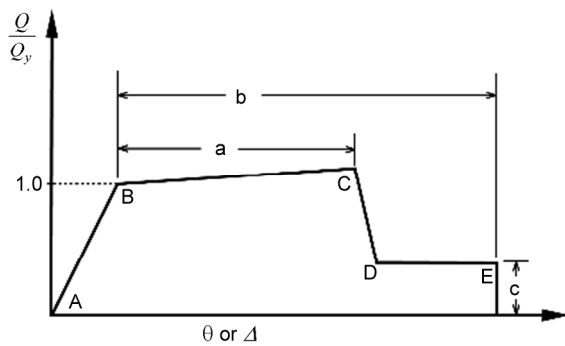
Figure 11. General load and deformation according to ASCE/SEI 41-06.

Seismic assessment and rehabilitation of existing buildings are generally performed with aid of ASCE/SEI 41-06 [21] standard. The provision for concrete structures in chapter 6 of ASCE/SEI 41 and its predecessor document, FEMA 356 [23], was basically the same. Figure (11) shows general load-deformation for reinforced concrete columns. Modeling parameters (a, b and c) as well as acceptance criteria for concrete columns are also provided in Tables (6) to (8) of ASCE/SEI 41-06 standard. Load-deformation relationship for a specific column can be generating by using provided guidelines in the ASCE/SEI 41-06 standard.

In order to generate a load-deformation relationship for a given column as shown in Figure (11), points B, C, D and E need to be determined. Point B is defined by determining initial stiffness, displacement and/or lateral load at yielding. According to ASCE/SEI 41-06, the slope from point B to C can be either zero or 10% of initial slope. In this study, the slope is assumed to be zero. Point C, D and E is determined by calculating plastic hinge rotation angles "a" and "b" as well as residual strength ratio "c". Parameters "a" and "b" depend on axial load, nominal shear stress and reinforcement details are extracted from table 6-8 of ASCE/SEI 41-06. Parameter "c" is equal to 0.2.
