The Main Reasons for Great Damages of Reinforced Concrete Buildings on 12th November 2017, Sarpol-e Zahab Earthquake

ABSTRACT

Sarpol-e Zahab Earthquake; Reinforced concrete buildings; Seismic performance; Vulnerability assessment

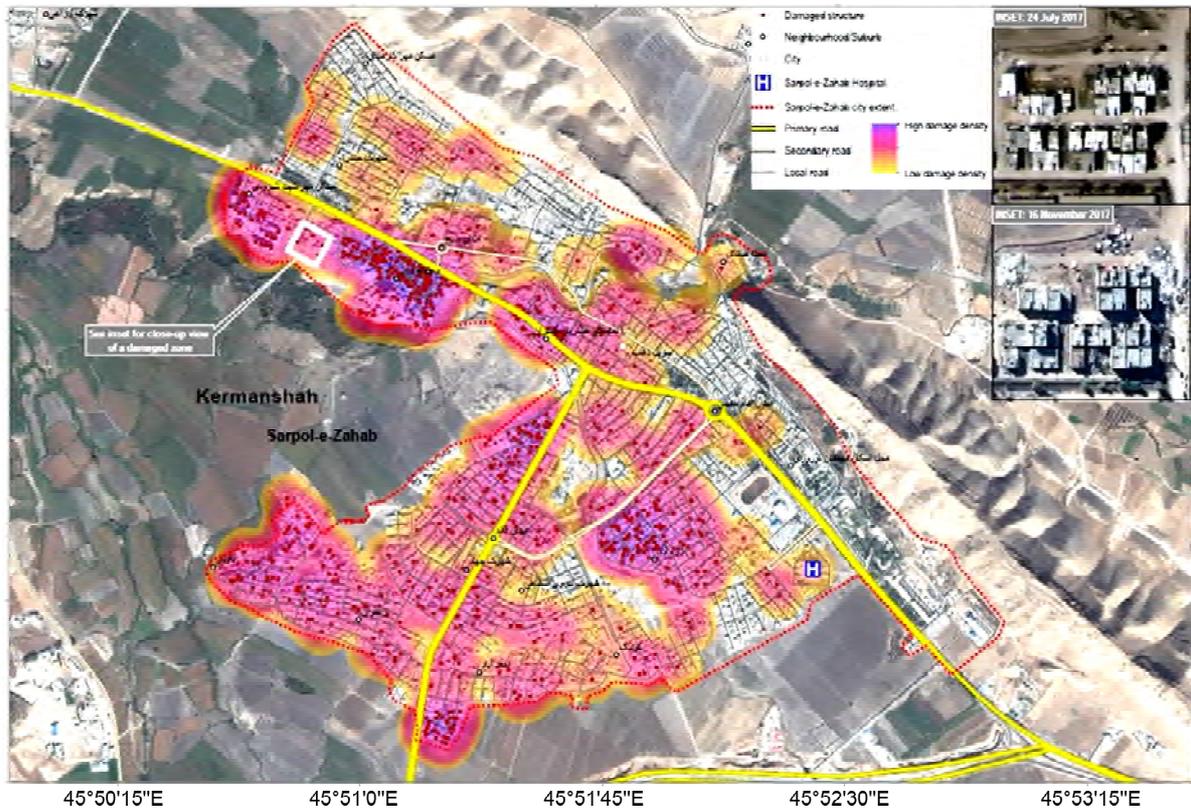
Figure 4. Distribution of damaged structures in Sarpol-e Zahab structures [14].

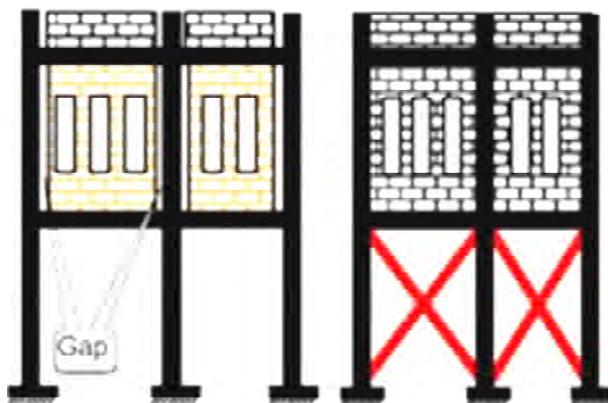
Figure 10. The rehabilitation methods proposed for this failure mode.

In general, to mitigate the effect of this type of irregularity caused by wall affects, separating the infill panels from margin columns by gaps, and adding cross structural elements in the weak story can help the structure to withstand under strong ground motions. Figure (10) shows the rehabilitation methods proposed to improve the resistance factors of the weak-story [27].

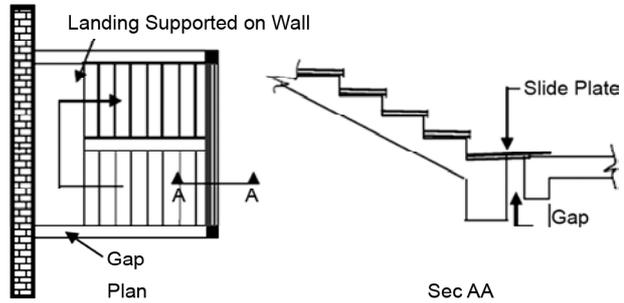
Figure 17. Rehabilitation method used to make a gap between the structure and the staircase [37].

To rehabilitate this part of the structure used in emergency activities after earthquakes, a solution has been presented in this paper as follows:

When an intermediate landing of a staircase is supported on a wall and other ends are rested on the span between columns, a gap on three sides of the

staircase can be provided to separate it from the rest of the building. Therefore, the staircase with gaps covered by a slide plate in landings is capable of sliding and reducing the axial forces created by surrounding structural elements. It should be noted that the configuration of this method should allow inter-story displacement of the staircase in all directions. The general shape of this rehabilitation method has been illustrated in Figure (17) [37].

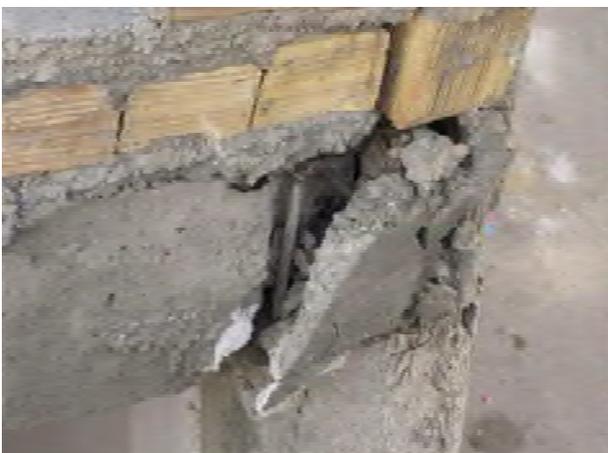
- Imperfection in using 90 degree hooks at the end of the longitude bars. Generally, in concrete components, in order to achieve ductile performance and transmit of the forces between concrete and the bars, it is essential to use hooks at the end of the structural components. The Iranian National Building Codes, Design and Implantation of RC buildings, Part 9, in sections 9-21-2-2 and 9-21-2-3 as Figure (28), present the rules that guarantee the seismic performance of the structural elements [8-17].

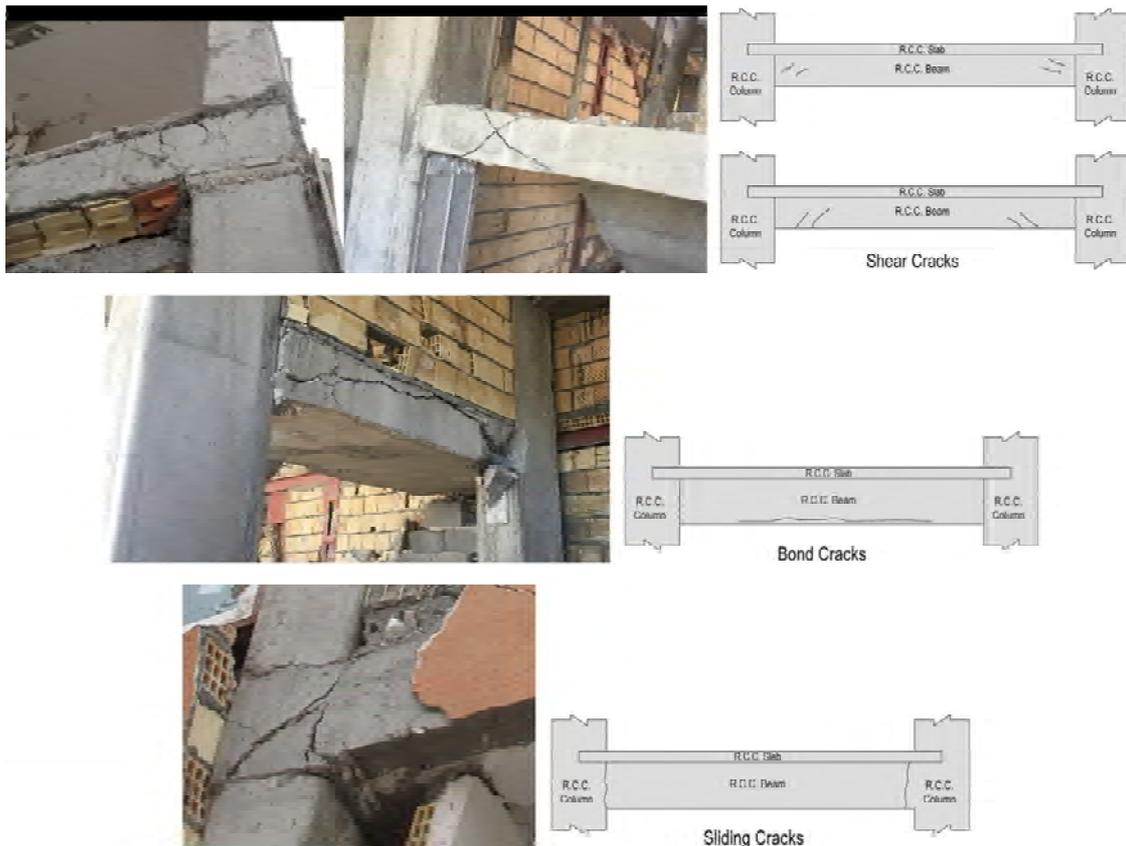
Beams in moment frames are responsible for dissipating the induced energy to the structure by developing flexural plastic hinges and are expected to do so in an earthquake. A standard feature of flexural damage in plastic hinges is mostly associated with through-depth crack at the face of the supporting beam and cutting off of the concrete fragment and yielding of the reinforcement. In addition, flexural failure comes with disintegration of concrete beyond the cover, often with buckling (or even rupture) of bars. Figure (32) shows an

Figure 32. Damage patterns of RC beams under Sarpol-e Zahab earthquake [37].

occurrence at the bottom flange of a beam. It should be noted that the slab provides the top flange with abundant cross-sectional areas of the concrete and steel reinforcements [37].

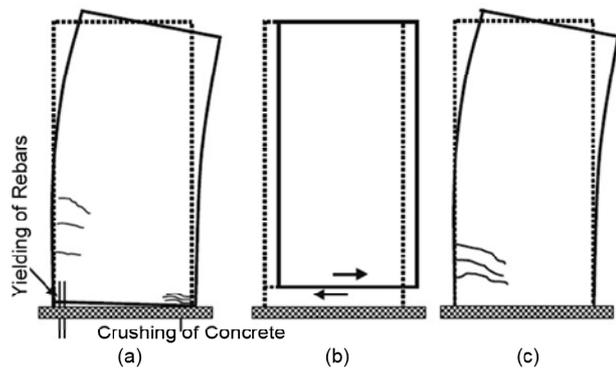
Figure 35. Typical failure modes of shear walls (a) Flexure failure, (b) Sliding failure, (c) Shear failure [37].
