# Reconnaissance Report of July 16, 2007 Niigata-Ken Chuetsu-Oki, Japan, Earthquake

**M.R. Ghayamghamian<sup>1</sup>, Tetsuo Tobita<sup>2</sup>, Susumu Iai<sup>2</sup>, and Gi-Cheon Kang<sup>2</sup>**

**Keywords:** Damage survey; Niigata-Ken Chuetsu-Oki of July 16, 2007; Directional damage; Geotechnical and structural damage

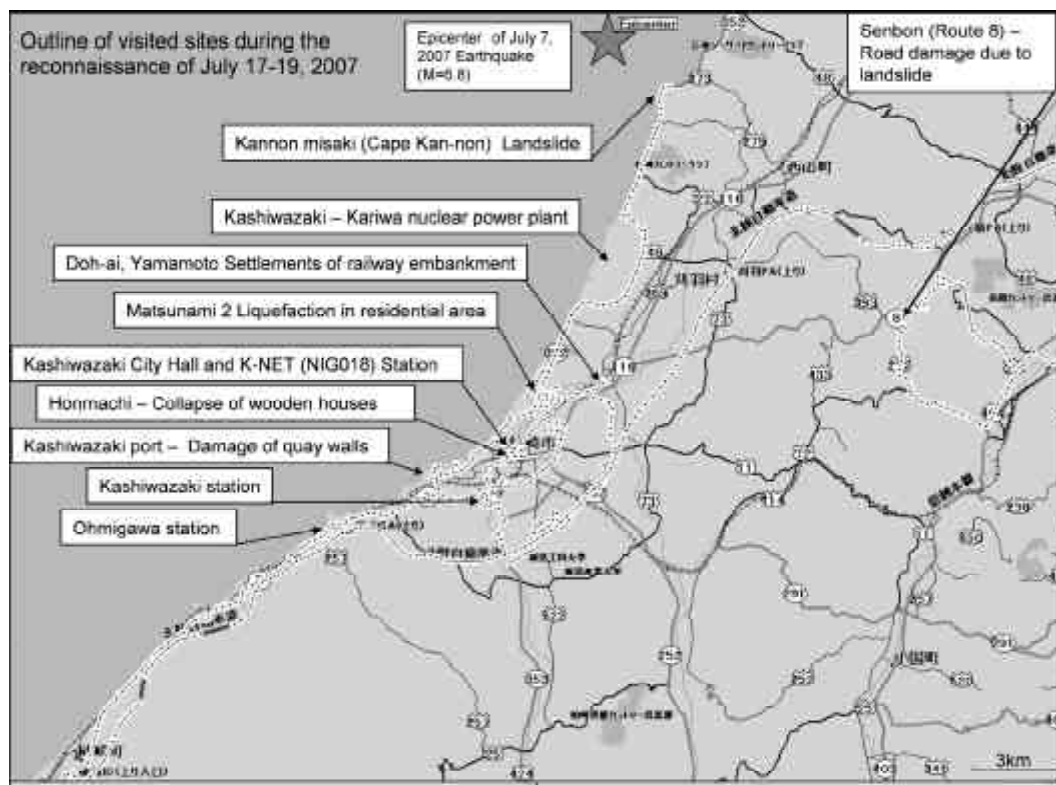
**Figure 2.** Map of the investigated area during reconnaissance of July 17-19 and the location of important features observed in the area.

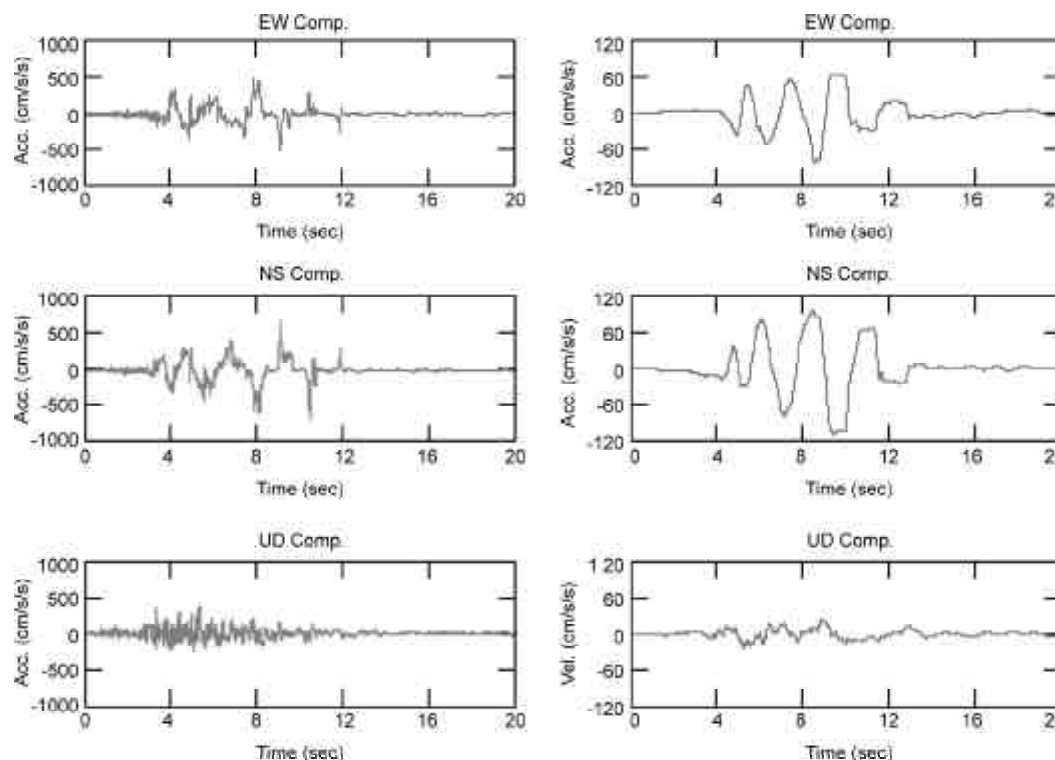
391 K-net strong motion stations in epicentral distance range of 15km to 440km were triggered by the mainshock. Figure (6) shows the distribution of observed peak ground acceleration (PGA) based on K-net free-field strong motion stations. The maximum peak ground acceleration (PGA) of about  $667\text{cm/s}^2$  was recorded in NS component at Kashiwazaki station, which was the nearest station to the epicenter (15km), see Figure (4). Figure (7) shows the recorded acceleration time histories together with the calculated velocity time histories for different components of ground motion at Kashiwazaki station. The interesting feature in the horizontal components of ground motion can be seen as a low-frequency motion modulated by the spiky shape motion. This type of motion is typically seen for dense sands under the state of cyclic mobility caused by liquefaction. The PGA of  $667\text{cm/s}^2$  and  $512\text{cm/s}^2$  for NS and EW components, respectively, were observed when the

Figure 7. Strong motions recorded in Kashiwazaki K-net station and calculated velocity time histories (high passed filter of 0.08 Hz).

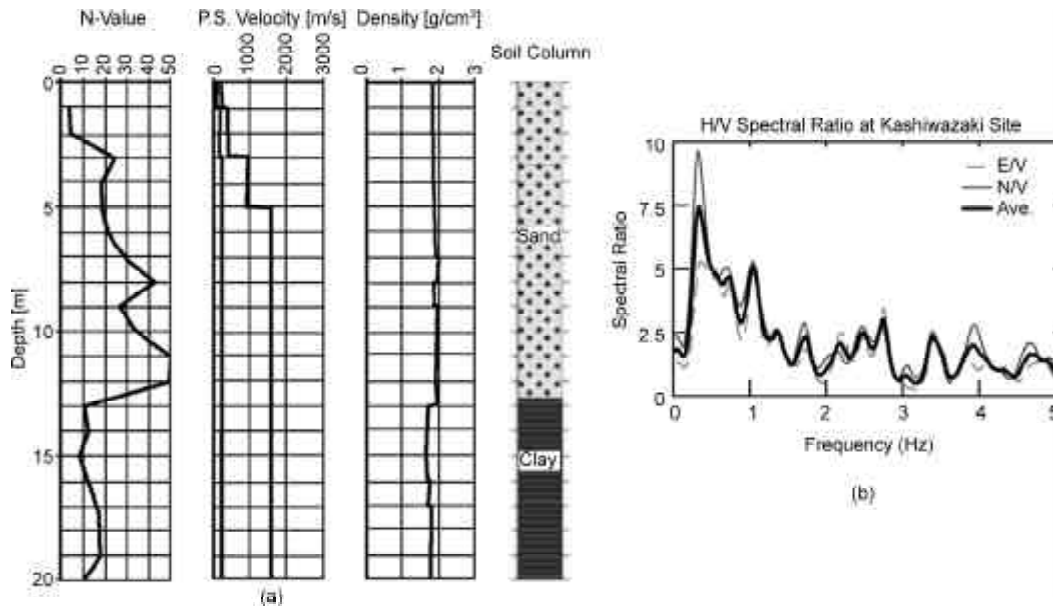
spiky motions are dominant at 25s to 28s. The soil profile at Kashiwazaki site also indicates the dominance of dense sands at shallower depth (<5m), see Figure (8a). The site effect is also estimated using horizontal to vertical spectral ratio (HVS) at Kashiwazaki site as shown in Figure (8b). The predominant frequency found to be 0.55Hz, which means that the subsoil condition in the Kashiwazaki city is soft, and might be categorized as D type in

2003 UBC. This type of soils usually associated with much seismic damage, especially when dominated by sand at surface.

**Figure 8.** (a) Soil profile in Kashiwazaki strong motion station; (b) the horizontal to vertical spectral ratio (HVSr) for different directions and the average in Kashiwazaki strong motion station.

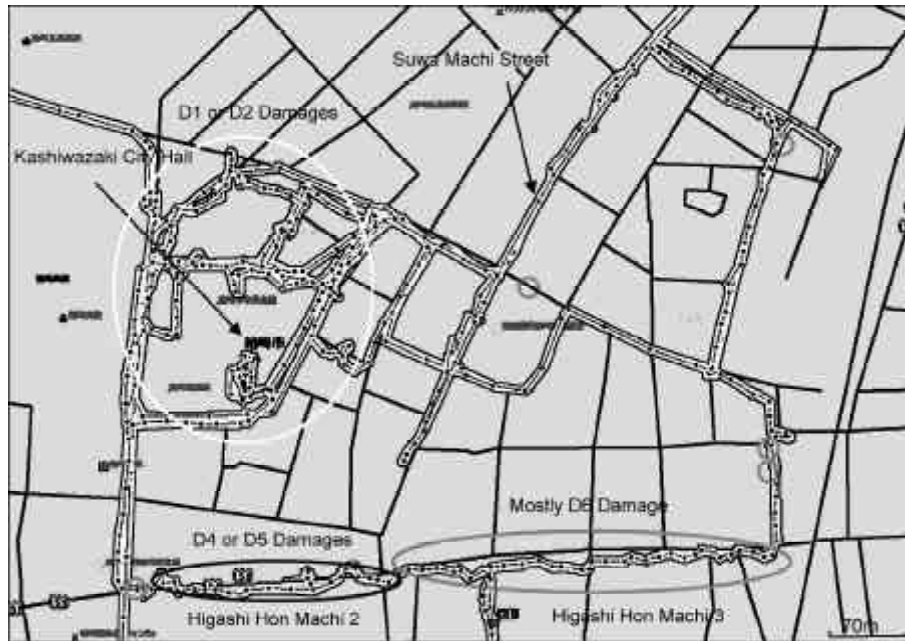
The building damage was mostly concentrated in Kashiwazaki city and Kariwa village. A building damage survey in Kashiwazaki city around Kashiwazaki city hall was performed, see Figure (14).

Figure 14. The area around Kashiwazaki city hall where the building damage survey was performed. The damage type and their distribution are also shown in the figure.

structural damage or collapsed). Most of the building damage is classified as *D1* and *D2* near the Kashiwazaki city hall. However, many wooden houses with Grade 5 and 6 damage were observed along the Higashi Hon Machi street (regions 2 and 3). Figure (16) shows typical collapse of wooden houses together with their collapse direction observed in this street. The Highashi Hon Machi street was almost directed along *EW* direction with a lenient slop in its south side. Besides this observation, the scares damage along the other streets was found that is mostly categorized as a *D2* or *D3* types. The place that damage *D6* was observed is shown in the map in Figure (14). Although it was not possible to visit all the damaged buildings, the ntensity based on collapsed buildings seems to be lower than the one announced based on instrumental *JMA* seismic intensity (6+ comparable to *IX* in *MMI* scale).

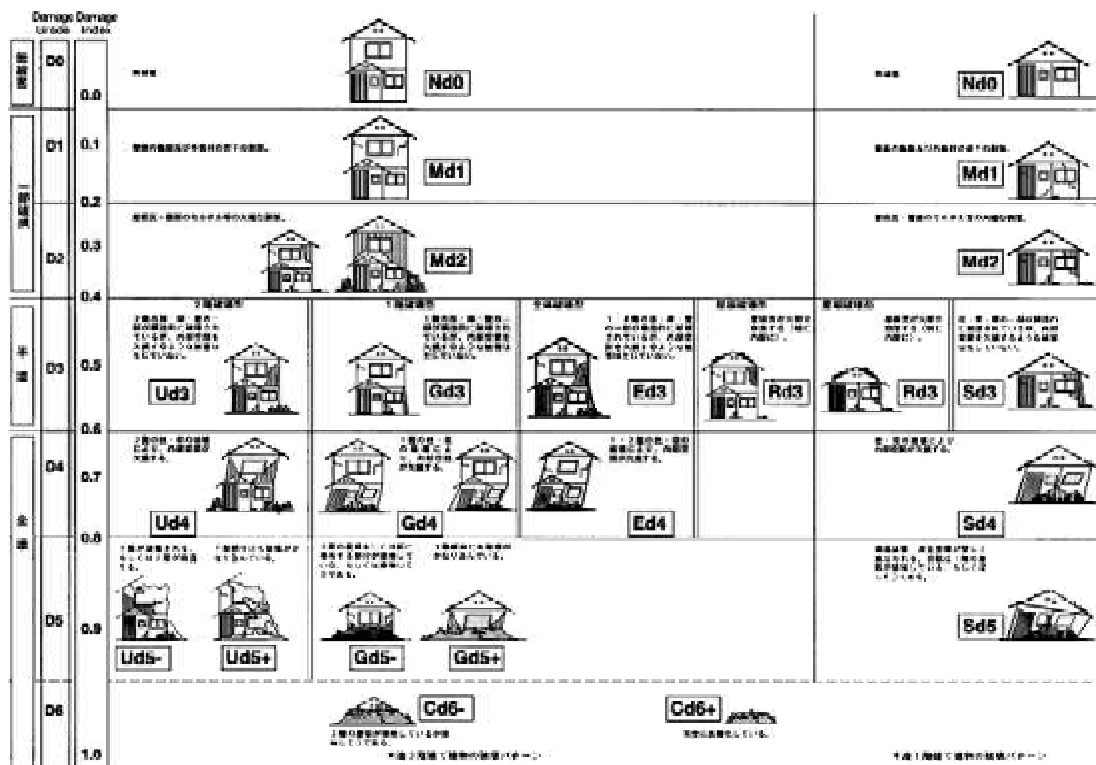
We also measured the direction of collapsed buildings in the area. The damage grade of buildings was evaluated using Okada and Takai [2] classification of wooden houses, as shown in Figure (15) [2]. In this classification, building damage is categorized into 7 grades from D0 (no damage) to D6 (very heavy

Figure 15. Damage grade and classification for wooden houses in Okada and Takai [2].

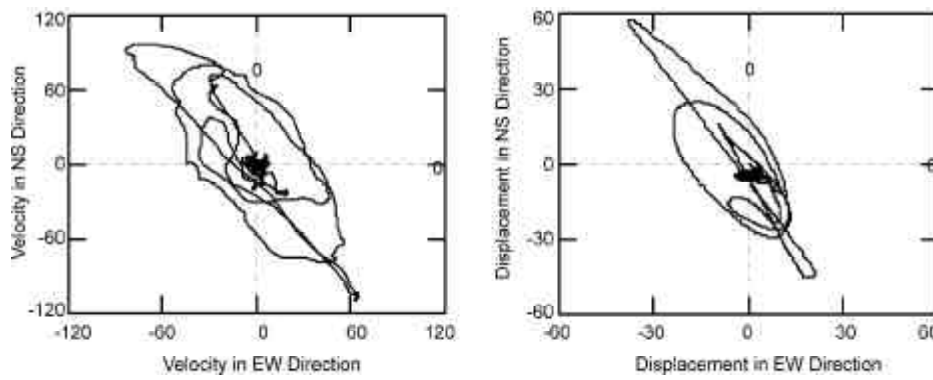
An investigation of damage to the buildings revealed that most of the collapsed wooden houses are directed in *EW* directions fallen to the west. This indicates that the motion may polarize in especial direction due to either deep geological irregularity or near-source effects [1]. To provide more facts, the velocity and displacement time histories are calculated from the recorded acceleration time histories in the Kashiwazaki station. Then, the particle motion in horizontal plane is investigated as shown in Figure (19). This figure reveals a strong polarization of motion in *NW-SE* direction that is in accordance with the observed direction of collapsed buildings.

**Figure 19.** 2-D particle motion of calculated velocity (cm/s) and displacement (cm) time histories for the mainshock recorded at Kasiwazaki K-net station (high passed filter of 0.08 Hz).
