Preliminary Assessment of the Operational Dam's Performance in November 12, 2017 Sarpol-e Zahab Earthquake

Sarpol-e Zahab earthquake;
Tange-Hamam Dam;
Instrumentation data;
Dam settlement

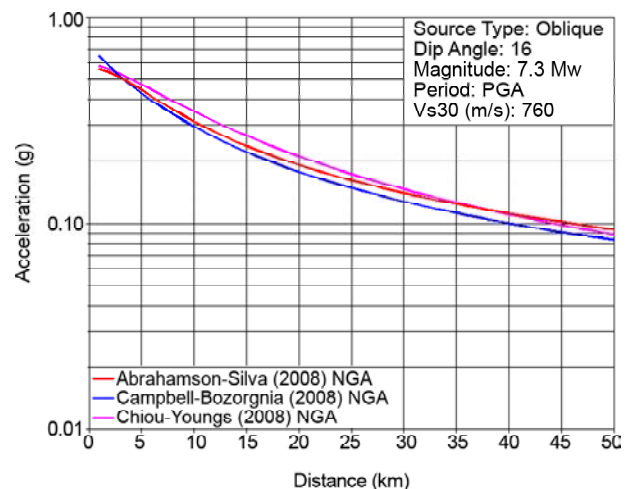
Figure 9. Attenuation of PGA based on NGA relationships for an earthquake with *M* = 7.3.

rock site in foot wall side of an oblique source with the dip angle of 16° and magnitude of 7.3 in terms of the rupture distance. As can be seen, all the presented relationships propose the PGA values of more than 0.3 g for distances less than 10 km to the site without considering the near-field effects. Accordingly, a PGA range between 0.3 g to 0.6 g can be considered for the dam site location.
