Sarpol-e Zahab Earthquake Damages to Roadway Bridges

ABSTRACT

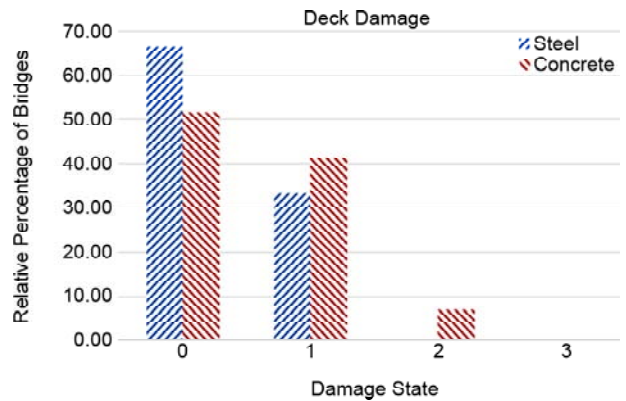
Figure 7. Deck damages at different levels.

superstructure. As shown in this figure, the concrete superstructures were more vulnerable than the superstructures with steel girder. 52 percent of the concrete superstructures experienced no damage (level 0) as compared to 67 percent for steel girder superstructures, while 48 percent of concrete superstructures experienced minor or moderate damage (level 1 and 2) as compared to 33 percent for steel girder superstructures, which experienced only minor damage (Level 1).

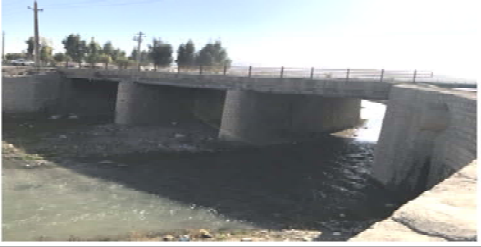
Table 5. Bridge A4B2-13.

Structure Type: Multi Span Simple Concrete Girder	River Intersection: Yes			
Latitude: 34.463518	Longitude: 45.856203			
Material and Structural Specifications				
Deck	Superstructure		Bent	Substructure
	Type: Girder	Width: 8m		Type: Wall
	Material: Concrete	Span Length: 32m		Material: Masonry
	No. of Spans: 3	Span Length : 10m	Abutment	Type: Closed
				Material: Masonry
Damage Comments				
- Damage to the Deck and Large Crack on It (a, c)		Deck: 1		
- Subsidence of the Soil of Abutment (b)		Abutment: 2		
- Separation of Wing Wall (d)		PGA: 0.53g

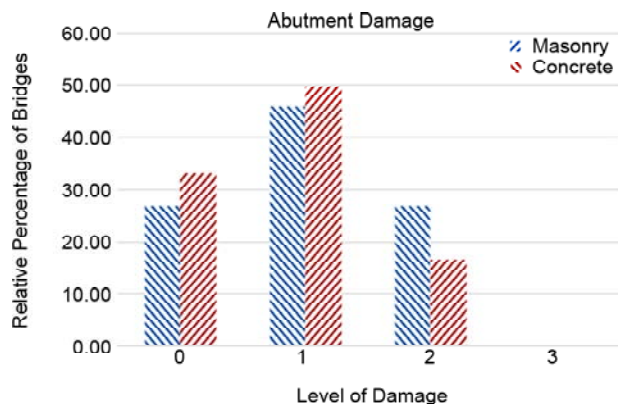
Figure 8. Abutment damages at different levels.

Figure (8) shows the state of damage to the abutments. As shown in this figure, masonry abutments were damaged more severely than

concrete abutments. 27 percent of masonry abutments experienced moderate damage (level 2) as compared to 17 percent for concrete abutments.

The level 2 damages were mainly due to settlement and rotation of the abutment. The walls of masonry abutments were also damaged significantly in some cases. A comparison of Figures (7) and (8) indicates that the abutments were damaged more extensively than the decks.

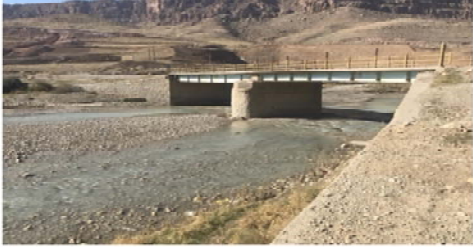
Table 7. Bridge A6B2-27.

Structure Type: Multi Span Steel Girder	River Intersection: Yes			
Latitude: 34.840319	Longitude: 45.901841			
Material and Structural Specifications				
Deck	Superstructure		Substructure	
	Type: Ggirder	Width: 7m	Bent	Type: Wall
	Material: Steel	Span Length : 32m		Material: Masonry
No. of Spans: 2	Span Length : 16m	Abutment	Type: Closed Material: Masonry	
Damage Comments				
- Fault Offset (a)		Damage Level	Deck : 0	PGA: 0.29 g
- Damage and Separation of Abutment (b, c, d)			Abutment : 2

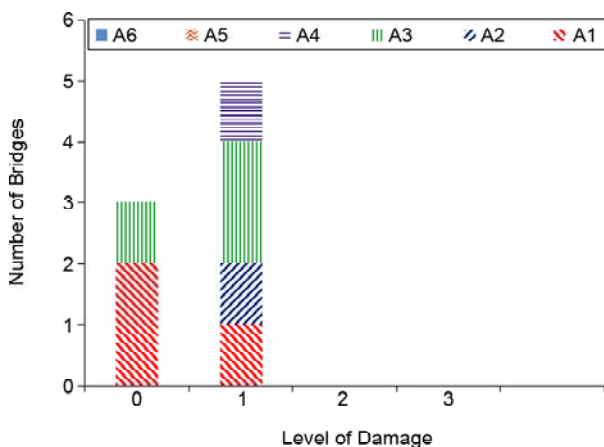
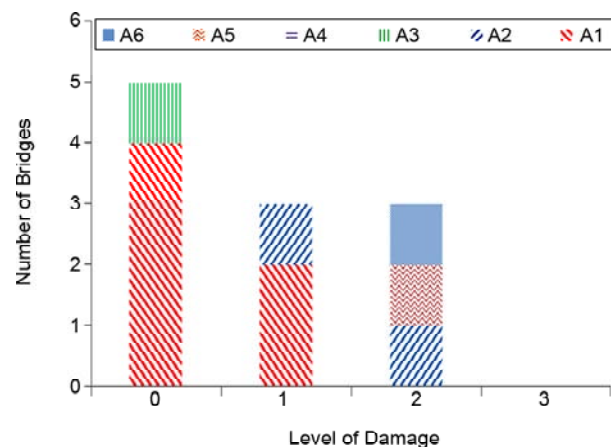
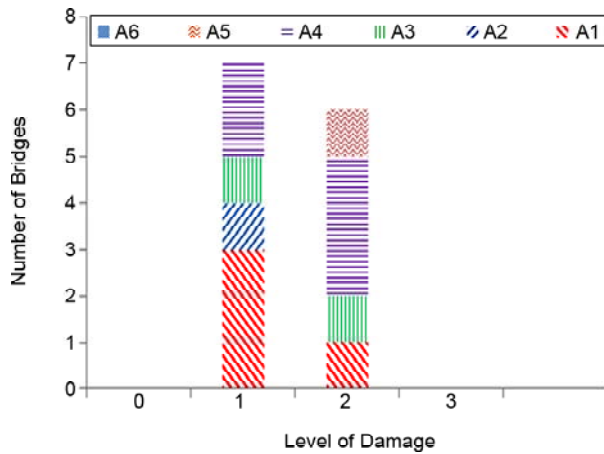
Figures (9) to (11) show the overall bridge damage level in low hazard zone, moderate hazard zone, and high hazard zone respectively. Figure (9) shows that in the low hazard area ($\text{PGA} < 250 \text{ cm/s}^2$) five bridges experienced minor damage (level 1). Figure (10) indicates that in the moderate hazard area ($250 \text{ cm/s}^2 < \text{PGA} < 500 \text{ cm/s}^2$) three bridges experienced minor damage and three bridges were moderately damaged. Figure (11) shows that all

bridges located in the high hazard area ($PGA > 500 \text{ cm/s}^2$) experienced either minor or moderate damages.

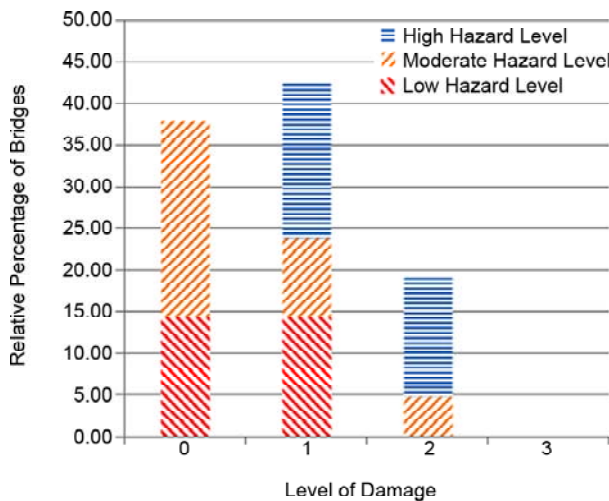
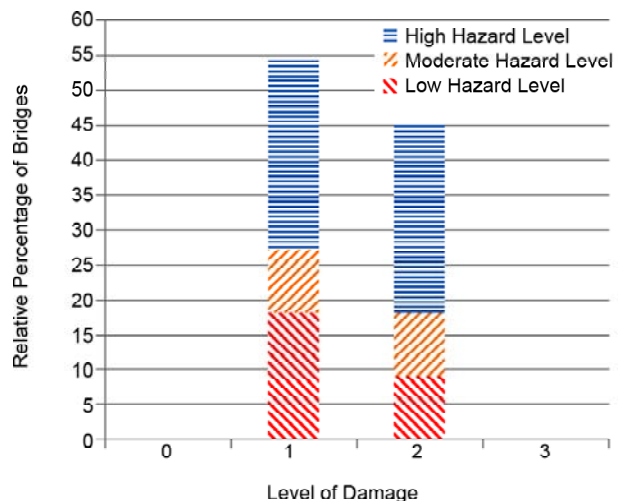
Overall damages to single span bridges and multi-span bridges are also evaluated separately. Figures (12) and (13) show the overall bridges damages to single span bridges and multi-span bridges in the three hazard zones. Figure (12) shows

that 38% of single span bridges experienced no damage, 43% experienced minor damage (level 1) and 19% experienced moderate damage (level 2). Figure (13) shows that 55% of multi span bridges experienced minor damage (level 1) and 45% experienced moderate damage (level 2). This indicates that multi span bridges were more vulnerable in comparison to single span bridges.

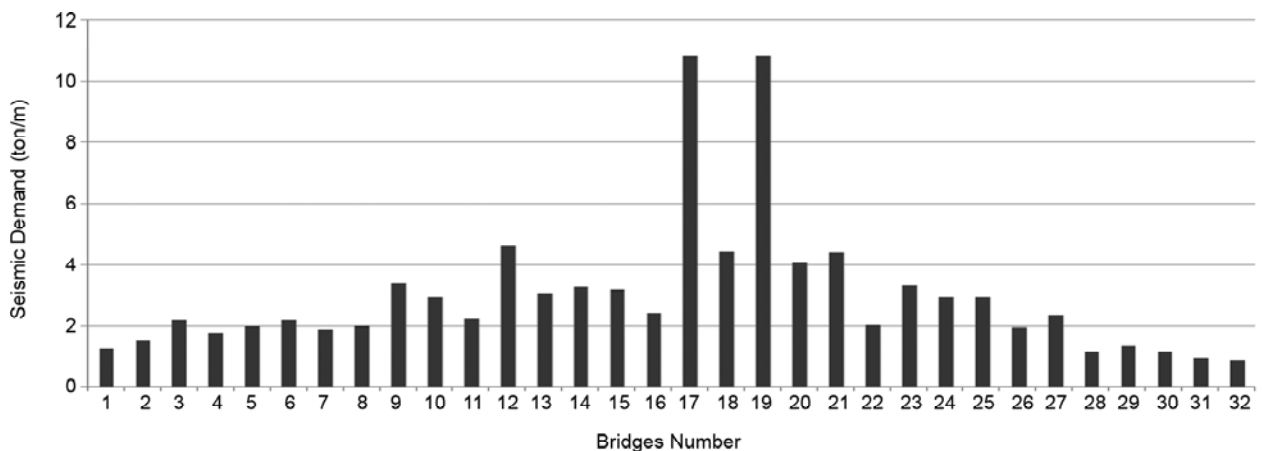
Figure 14. Seismic demands on the abutments.

Figure (14) shows the seismic demands on the bridge abutments. This figure indicates that except for two relatively long span bridges (Bridges no. 17 and 19), seismic demands on abutments are less than 4.3 ton/m. Seismic demands on abutments of the two long span bridges are approximately

10.8 ton/m. These two bridges are single span steel girder bridges with span lengths of 30 and 40 meters. They experienced relatively high seismic intensity (PGA = 0.48 g and 0.54 g) and the abutments experienced level 2 damages as indicated in Table (9). The span lengths for the rest of bridges are less than 16 meters.

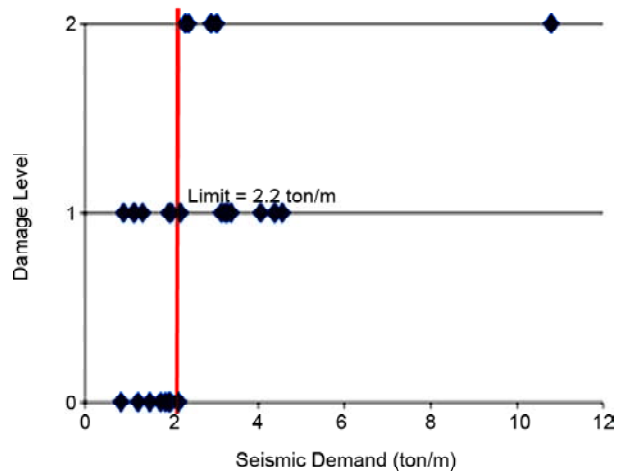
Figure 15. Abutment damage level vs. seismic demand.

Figure (15) which correlates the seismic demand with the damage level indicates that the level of damage increases with increasing seismic demand. Based on these data, a threshold for seismic demand on abutment is defined beyond which the abutment may experience level 2 (moderate)

damage. The corresponding limit for seismic demand on abutment is 2.2 ton/m. Figure (15) indicates that below this limit, none of the bridges experienced moderate damage (level 2) and only 15% of bridges experienced minor damage (level 1).
