# Performance of Lifeline Systems in Bam Earthquake of 26 December 2003

**Masoud Moghtaderi-Zadeh<sup>1</sup>, Farrokh Nadim<sup>2</sup>, and Mohammad Javad Bolourchi<sup>3</sup>**

**ABSTRACT:** *At 5:26 am local time, Friday, December 26, 2003, an earthquake with moment magnitude 6.5 hit the city of Bam in southeast Iran. The earthquake caused more than 26,000 deaths, 30,000 injuries, and left 70,000 homeless. It caused extensive damage to residential and commercial buildings and emergency response facilities. In contrast to the inflicted human loss and suffering and extended building damage, lifeline systems, although damaged, performed much better. Transportation systems, i.e., roads, bridges, railways, and the airport, although slightly to moderately damaged, were generally operational soon after the earthquake to support emergency response and recovery effort. There were several breaks in the water distribution systems and minor damage to deep wells. However, the traditional qanat systems, which bring water from foothills tens of kilometers away via underground tunnels, were mostly damaged. The Bam area is served via connection to countrywide electric grid system. There was

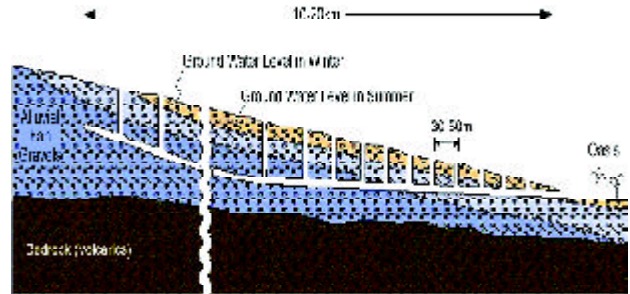
Figure 2. Principles of water transport by a qanat.

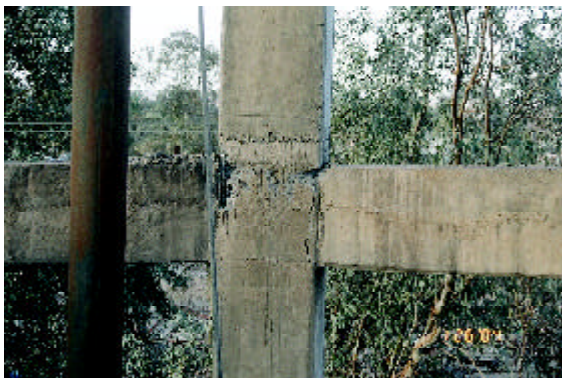
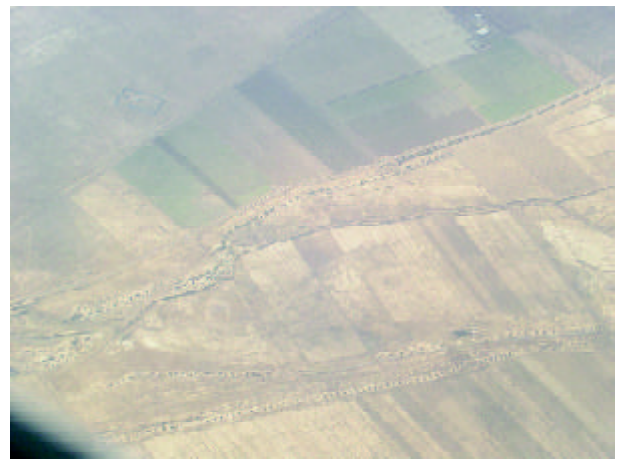
Figure 3. Aerial photo of several chains of ancient qanat systems, which typically bring water from foothills of mountainous area to more dried desert towns and villages in Iran.

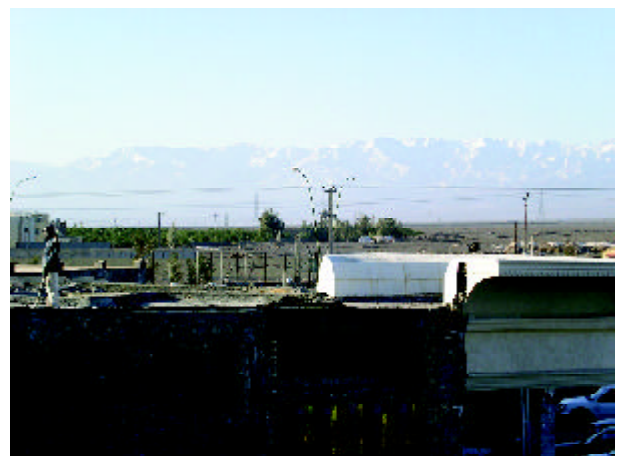
Figure 4. Snow-capped Jebal Barez mountain range is located in southwest of city of Bam as seen from Azadi hotel in Bam. About 126 qanat chains bring irrigation water from foothills of Jebal Barez to Bam region.

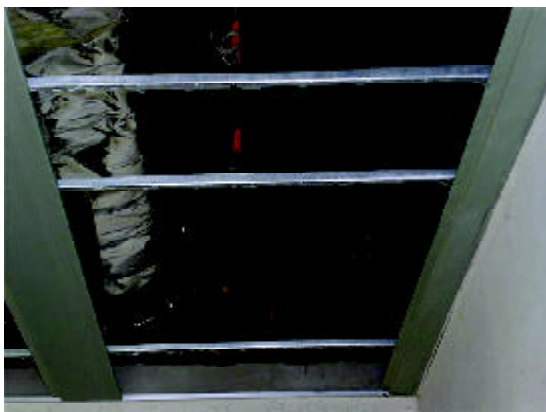
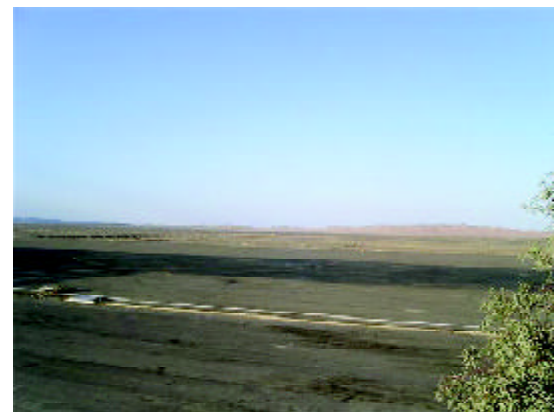
The main terminal building at the Bam airport had moderate damage, but the runway was operational immediately after the earthquake, see Figures (12). The steel frame terminal building was moderately damaged, but it withstood the quake. The masonry infill walls were damaged. The false ceilings were severely damaged. There was moderate damage to stairway to the second floor. There was nonstructural damage to airport control tower (broken windows). The airport runway had little damage and came to be extremely useful for emergency response and recovery effort. Hundreds of flights from inside of Iran and around the world landed in this airport immediately after the earthquake to bring search and rescue teams and equipment as well as much needed medical, food, blankets, tents and other supplies.

**Figure 12.** The engineered steel frame terminal building at Bam airport was moderately damaged. The masonry infill walls were damaged. The false ceilings were severely damaged. The airport runway had little damage.
